2018

Michigan Local Agency Culvert Inventory Pilot Evaluation Report

PURPOSE OF LOCAL AGENCY CULVERT INVENTORY PILOT

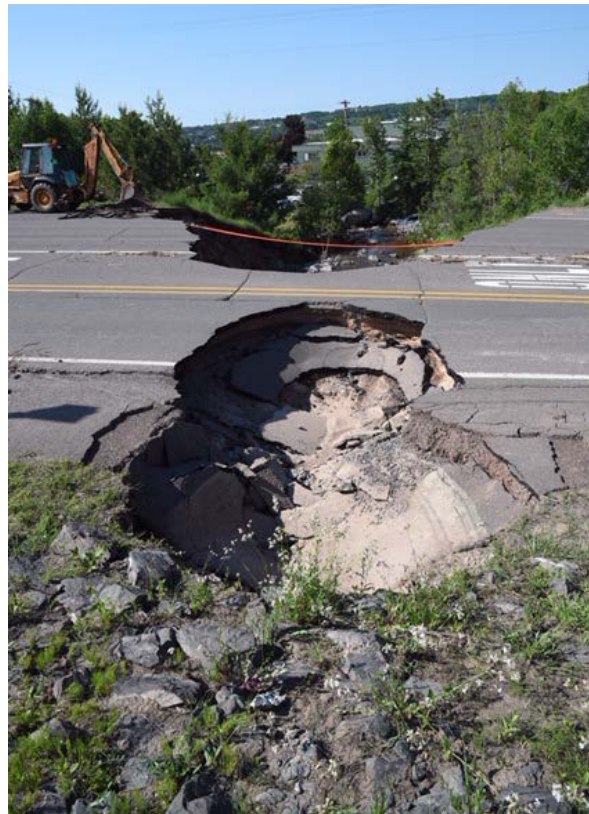
The need for culvert asset management is clear; there have been numerous documented culvert collapses in recent years that have led to damage and injuries, costing agencies significant money in emergency repairs and public safety concerns. In the early morning of June 17, 2018, Houghton County experienced an extreme rainfall (1000-year event) causing widespread damage in which many culverts failed, resulting in damage to surrounding areas, as depicted in Figure 2-1 and Figure 2-2. These culverts failed due to an extreme event that could not have been prevented through sound asset management, but they are representative of the roadway damage that can occur from culvert failures.

Figure 2-1: Culvert failure in Houghton, Michigan leading to roadway damage

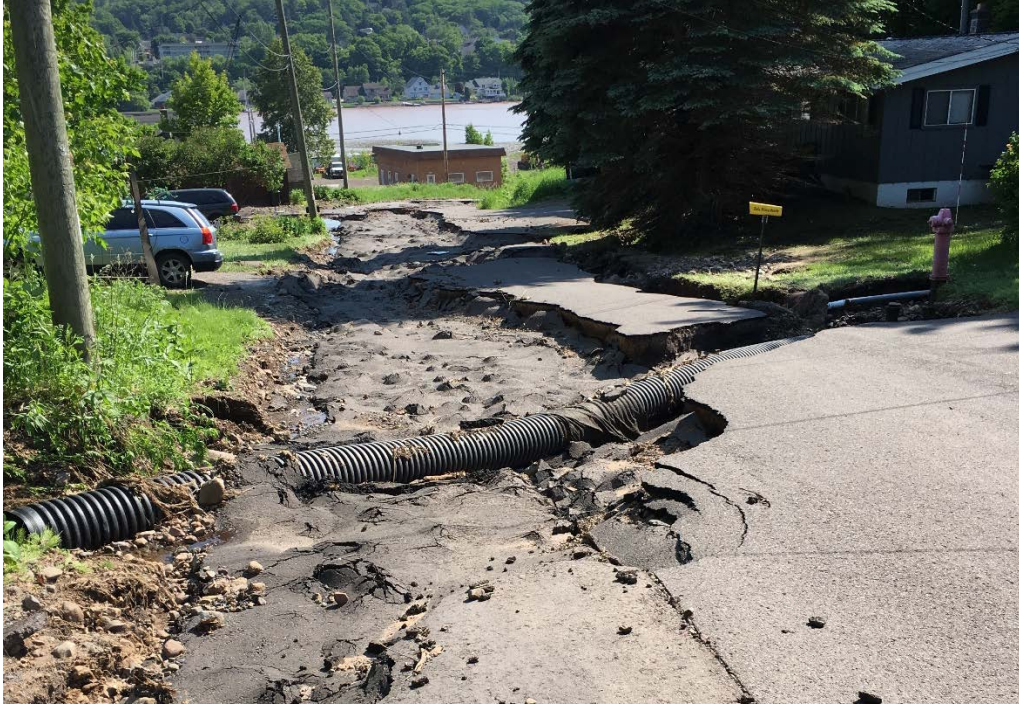
Figure 2-2: Houghton county culvert failure in Ripley, Michigan

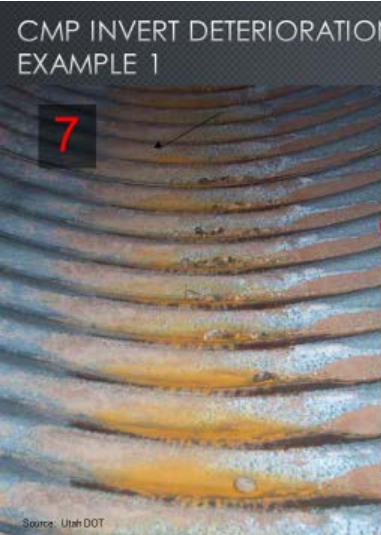
CMP INVERT DETERIORATION EXAMPLE 1

CMP	Closed Bottom Invert Deterioration
10	New condition; galvanizing intact; no corrosion.
9	Discoloration of surface. Galvanizing partially gone along invert. No layers of rust.
8	Discoloration of surface. Galvanizing gone along invert but no layers of rust. Minor section loss at ends of pipe not located beneath roadway.
7	Galvanizing gone along invert with layers of rust. Moderate section loss at ends of pipe not located beneath roadway. Moderate section loss: Less than 4% of invert area.
6	Heavy rust and scale throughout. Heavy section loss with perforations in invert not located under the roadway. Heavy section loss: Up to 10% of invert area.
5	Extensive heavy rust and scaling throughout. Perforations throughout invert with an area less than 20% of invert area. Overall thin metal, which allows for an easy puncture with chipping hammer.
4	Extensive heavy rust and scaling throughout. Perforations throughout invert with an area less than 25% of invert area.

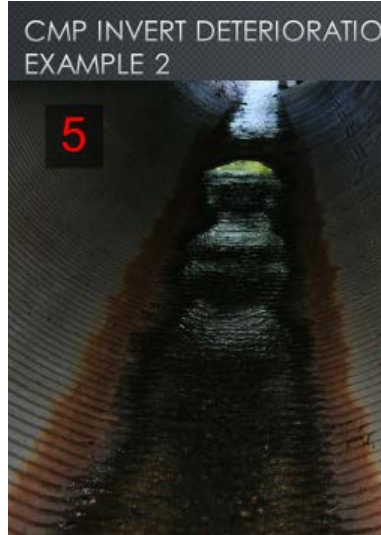
CMP	Closed Bottom Invert Deterioration
10	New condition; galvanizing intact; no corrosion.
9	Discoloration of surface. Galvanizing partially gone along invert. No layers of rust.
8	Discoloration of surface. Galvanizing gone along invert but no layers of rust. Minor section loss at ends of pipe not located beneath roadway.
7	Galvanizing gone along invert with layers of rust. Moderate section loss at ends of pipe not located beneath roadway. Moderate section loss: Less than 4% of invert area.
6	Heavy rust and scale throughout. Heavy section loss with perforations in invert not located under the roadway. Heavy section loss: Up to 10% of invert area.
5	Extensive heavy rust and scaling throughout. Perforations throughout invert with an area less than 20% of invert area. Overall thin metal, which allows for an easy puncture with chipping hammer.
4	Extensive heavy rust and scaling throughout. Perforations throughout invert with an area less than 25% of invert area.

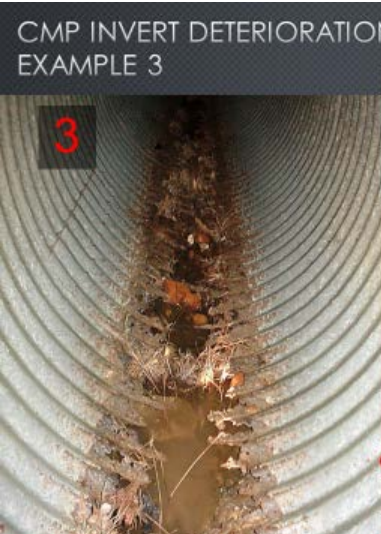
CMP	Closed Bottom Invert Deterioration
10	New condition; galvanizing intact; no corrosion.
9	Discoloration of surface. Galvanizing partially gone along invert. No layers of rust.
8	Discoloration of surface. Galvanizing gone along invert but no layers of rust. Minor section loss at ends of pipe not located beneath roadway.
7	Galvanizing gone along invert with layers of rust. Moderate section loss at ends of pipe not located beneath roadway. Moderate section loss: Less than 4% of invert area.
6	Heavy rust and scale throughout. Heavy section loss with perforations in invert not located under the roadway. Heavy section loss: Up to 10% of invert area.
5	Extensive heavy rust and scaling throughout. Perforations throughout invert with an area less than 20% of invert area. Overall thin metal, which allows for an easy puncture with chipping hammer.
4	Extensive heavy rust and scaling throughout. Perforations throughout invert with an area less than 25% of invert area.

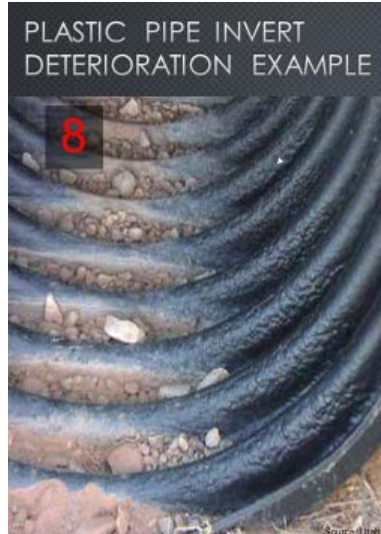
Plastic Pipe	Invert Deterioration
10	New Condition.
9	Minor discoloration at isolated locations.
8	Perforations caused by abrasion located within 5 feet of outlet and not located under roadway.
7	Perforations caused by abrasion located within 5 feet of inlet and outlet and not located under roadway.
6	Substantial perforations caused by abrasion located within 5 feet of inlet and outlet and not located under roadway.
5	Perforations caused by abrasion located throughout pipe.
4	Section losses caused by abrasion located throughout pipe.
3	Section loss caused by abrasion located throughout pipe with at least a 2 foot in length by 1/2 foot in width invert section eroded away.
2	Pipe partially collapsed or collapse is imminent.
1	Total failure of pipe.

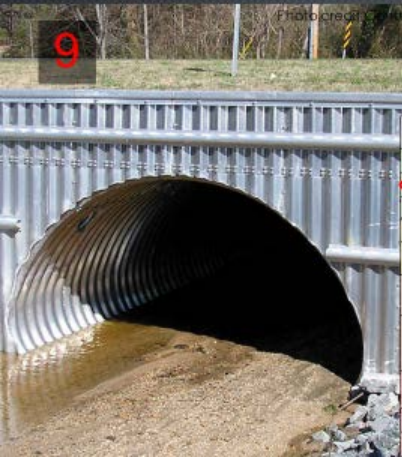
CMP	Open Bottom Invert Deterioration
10	New condition
9	Good with no invert erosion
8	Good with only minor invert erosion
7	Minor erosion near footings
6	Moderate erosion along footing; protective measures may be required
5	Erosion along footing with slight undermining, protection required
4	Severe undermining with slight differential settlement causing minor cracking or spalling in footing and minor distress in walls
3	Severe undermining with significant differential settlement causing severe cracks in footing and distress
2	Structure partially collapsed or collapse is imminent.
1	Total failure of structure.

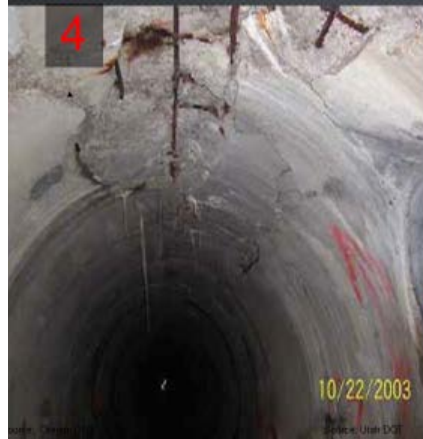
Concrete Pipe	Structural Deterioration
10	New Condition. Superficial and isolated damage from construction.
9	Minor cracking without staining or delamination(s). Surface in good condition.
8	Minor cracking less than 1/8th inch wide parallel to traffic without staining. Light scaling less than 1/8th inch deep with less than 10% of exposed area. Delamination or Spalling less than 2% of surface area. Note: each hole less than 1/2 inch has a single large crack less than 1/8th inch on each surface parallel to traffic direction.
7	Minor and deep cracking. Cracks less than 1/8th inch parallel to traffic with minor efflorescence or minor amounts of scaling. Scaling less than 1/2th inch deep or 20% of exposed area. Applied areas with exposed reinforcing less than 10% of surface area. Total delamination and spalled areas less than 2% of surface area.
6	Deep cracking with hairline cracks less than 1/8th inch parallel to traffic or less than 1/8th inch transverse to traffic with efflorescence, or rust stains, or leakage or oil. Scaling greater than 1/2 inch deep on less than 20% of surface area. Applied areas with exposed reinforcing on greater than 20% of surface area. Total delamination and spalled areas less than 2% of surface area.

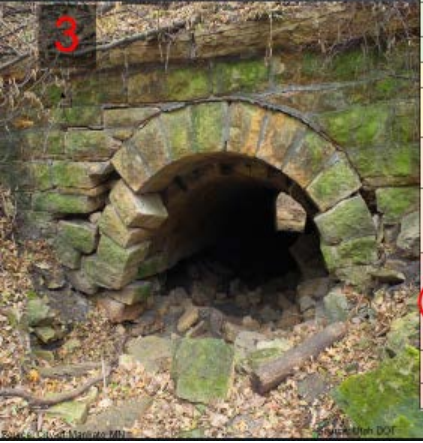
Masonry	Structural Deterioration
10	New Condition
9	No cracking. No missing or dislocated masonry. Surface in great condition.
8	Surface deterioration at isolated locations.
7	Minor cracking in masonry units
6	Minor cracking. Slight dislocation of masonry units. Large areas of surface scaling. Split or cracked stones.
5	Extensive cracking. Significant dislocation of masonry units. Large areas of surface scaling. Split or cracked stones.
4	Severe cracking with spalling. Delamination(s). Slight differential movement. Individual lower masonry units of structure missing or crushed.
3	Cracking very severe with significant spalling, delamination, and differential movement. Individual masonry units in lower part of structure missing or crushed. Individual masonry units in top of culvert missing or crushed.
2	Structure partially collapsed or collapse is imminent.
1	Total failure of structure.

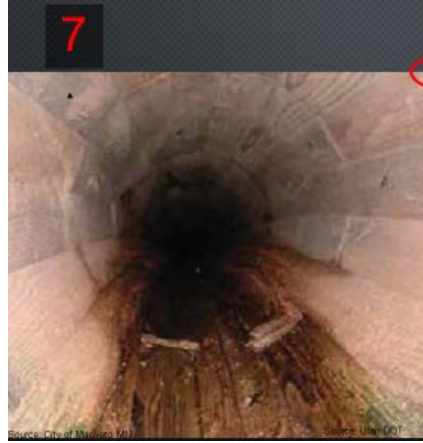
Timber	Structural Deterioration
10	New condition
9	No evidence of decay or abrasion/wear. Connections are in place and functioning as intended.
8	Little to no evidence of decay. Minor abrasion/wearing. Connections are in place and functioning as intended. No issues with structural members. Check's/Cracks penetrate 10% of the member thickness. Member has splits or shakes.
7	Some evidence of decay, moderate abrasion/wearing. Top edge section loss in structural members. Affects less than 20% of member section. Loose fasteners but the connection is in place and functioning as intended. Check's/Cracks penetrate 5-50% of the member thickness and not in tension zone.
6	Some evidence of decay, moderate abrasion/wearing, negligible section loss in structural members. Affects less than 20% of member section. Loose fasteners or pack nuts without dispersion is greater but the connection is in place and functioning as intended. Check's/Cracks penetrate 5-20% of the member thickness and not in tension zone. Member has splits/shakes with length less than member depth.

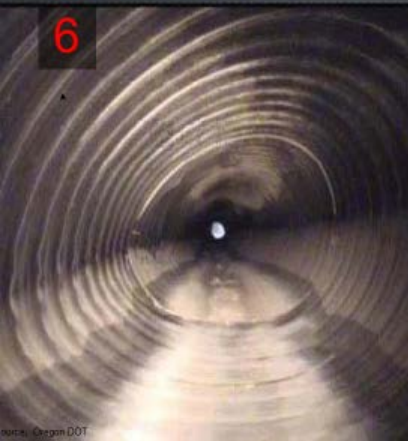
Plastic Pipe	Section Deformation
10	Smooth wall. Span dimension up to 2% greater than design.
9	Smooth wall. Span dimension up to 5% greater than design.
8	Relatively smooth wall. Span dimension up to 7.5% greater than design.
7	Minor dimpling appearing at an isolated small area. Less than 1/32th of circumference area and 1 foot in length. Dimples less than 1/4 inch deep. Span dimension up to 10% greater than design.
6	Minor dimpling appearing over 1/4 to 1/2 of circumference area and 2 feet in length. Dimples between 1/8 and 3/16 inch deep. Pipe deflection less than 12.5% from original shape.
5	Wall crushing or hinging occurring with lengths less than 3 feet. Pipe deflection less than 15% from original shape.
4	Wall crushing or hinging occurring with lengths greater than 3 feet. Moderate degree of dimpling appearing. Dimples more than 1/8 inch deep. Wall tearing or cracking in the buckled region. Pipe deflection less than 20% from original shape.

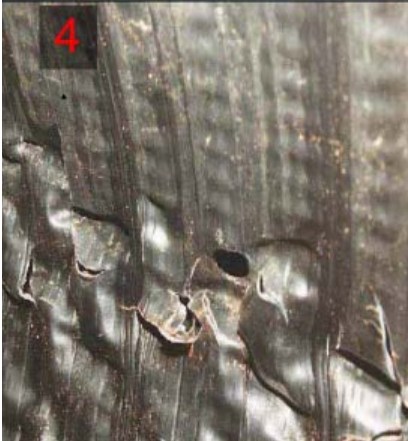
Plastic Pipe	Section Deformation
10	Smooth wall. Span dimension up to 2% greater than design.
9	Smooth wall. Span dimension up to 5% greater than design.
8	Relatively smooth wall. Span dimension up to 7.5% greater than design.
7	Minor dimpling appearing at an isolated small area. Less than 1/32th of circumference area and 1 foot in length. Dimples less than 1/4 inch deep. Span dimension up to 10% greater than design.
6	Minor dimpling appearing over 1/4 to 1/2 of circumference area and 2 feet in length. Dimples between 1/8 and 3/16 inch deep. Pipe deflection less than 12.5% from original shape.
5	Wall crushing or hinging occurring with lengths less than 3 feet. Pipe deflection less than 15% from original shape.
4	Wall crushing or hinging occurring with lengths greater than 3 feet. Moderate degree of dimpling appearing. Dimples more than 1/8 inch deep. Wall tearing or cracking in the buckled region. Pipe deflection less than 20% from original shape.

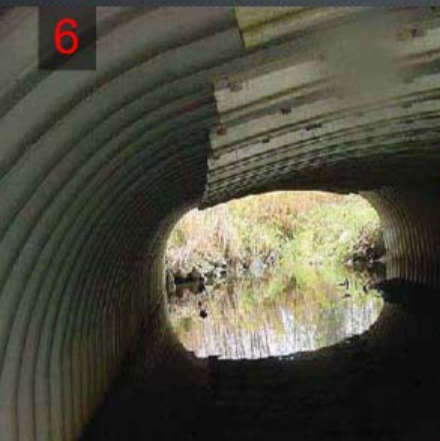
CMP Shape	Low Profile Long Span *
10	New Condition
9	Good appearance, smooth symmetrical curvature. Top arc mid-ordinate within 12 percent of original design. Horizontal span within 5 percent of original design.
8	Generally good, curvature is smooth and symmetrical. Top arc mid-ordinate within 15 percent to 22 percent of original design. Horizontal span within 6 percent of original design.
7	Smooth curvature, shape is non-symmetrical. Top arc mid-ordinate within 15 percent to 22 percent of original design. Horizontal span within 6 percent of original design.
6	Generally fair, significant distortion and deflection in one section, half top of invert beginning to flatten. Mid-ordinate of half top arc 20 percent less than original design. Top arc mid-ordinate within 15 to 20 percent of original design. Horizontal span more than +/- 6 percent of original design.
5	Marginal, top arc inversion and deflection throughout, mid-ordinate of half top arc less than 50 percent of original design. Top arc mid-ordinate within 15 to 20 percent of design. Horizontal span more than +/- 6 percent of design.

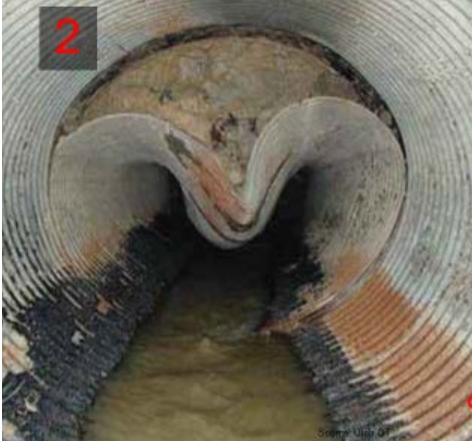
CMP Shape	Round / Vertical Elongated Pipes
10	New Condition
9	Good, smooth curvature in barrel. Horizontal diameter (span) dimension within 30% of original design.
8	Generally good, top half of pipe smooth but inner flattening of bottom. Horizontal diameter (span) dimension within 30% of original design.
7	Fair, top half has smooth curvature but bottom half has flattened significantly. Horizontal diameter (span) dimension within 10% of original design.
6	Generally fair, significant distortion at isolated locations, top half and extreme flattening of the invert. Horizontal diameter (span) dimension 10% to 15% greater than original design.
5	Marginal significant distortion throughout length of pipe, lower third may be kinked. Horizontal diameter (span) dimension 10% to 15% greater than original design.
4	Poor with extreme deflection at isolated locations, flattening of the crown, crown radius 20 to 30 feet. Horizontal diameter (span) dimension in excess of 20% greater than original design.

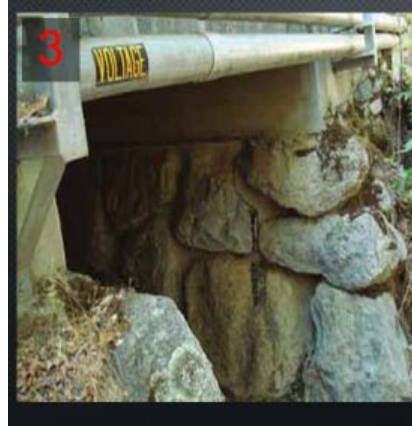
Slab/Superstructure & Abutment	Masonry Abutment
10	No signs of distress. Minor spalling of stone surface.
9	Minor spalling of stone surface. Scaling of stone surface less than 1/8 inch.
8	Diagonal or vertical shear crack in isolated stones. Fracture of stone surface less than 2 inches.
7	Diagonal or vertical shear cracks through several courses of stone with some minor displacement. Spalls along edge of seat area.
6	Diagonal or vertical shear cracks through several courses of stone with displacement. Displacement may be bulge or leaning stones. Total displacement is less than 1/4 of stone depth.
5	Settlement causing diagonal or vertical shear cracks through several courses of stone with displacement. Total displacement is less than 1/4 of stone depth. Large fractures or erosion of stone surfaces less than 5 inches on adjacent stones. Spalls on beam seats cause reduced bearing area.
4	Large unsound areas. Several stones are displaced or missing. Misalignment of mortar joints. Large fractures or erosion of stone surfaces greater than 5 inches. Spalls on beam seats causing reduced bearing area.
