Substructures

Michigan Bridge Week 2023

Case 1 – B03-27022 – US-2 over Big Presque Aisle

Case 2 – R01-23152 – I-96WB over GTW RR

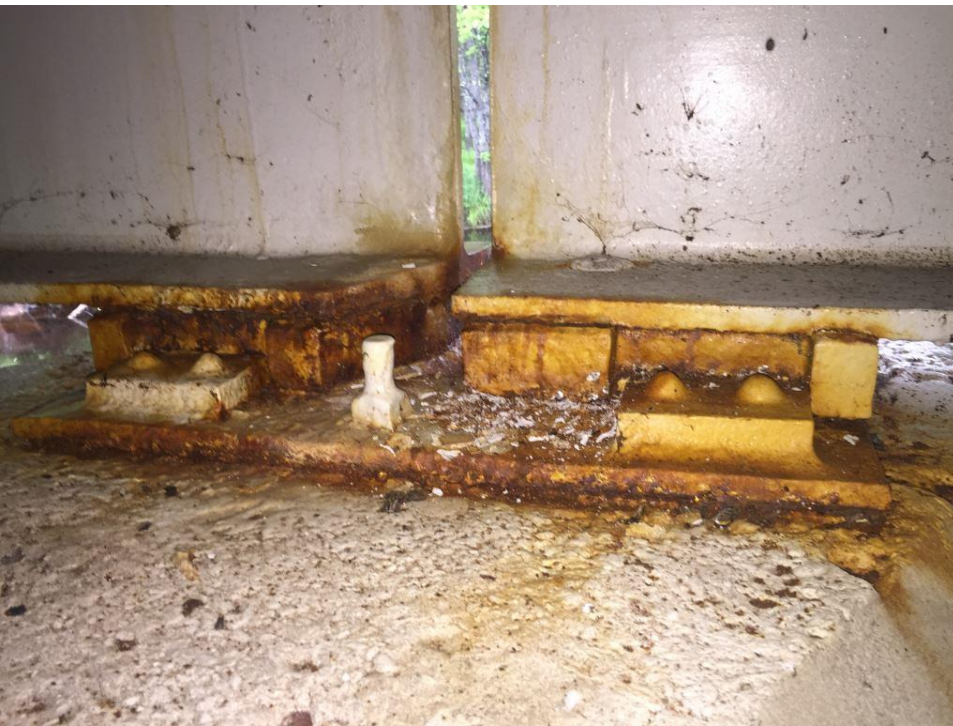
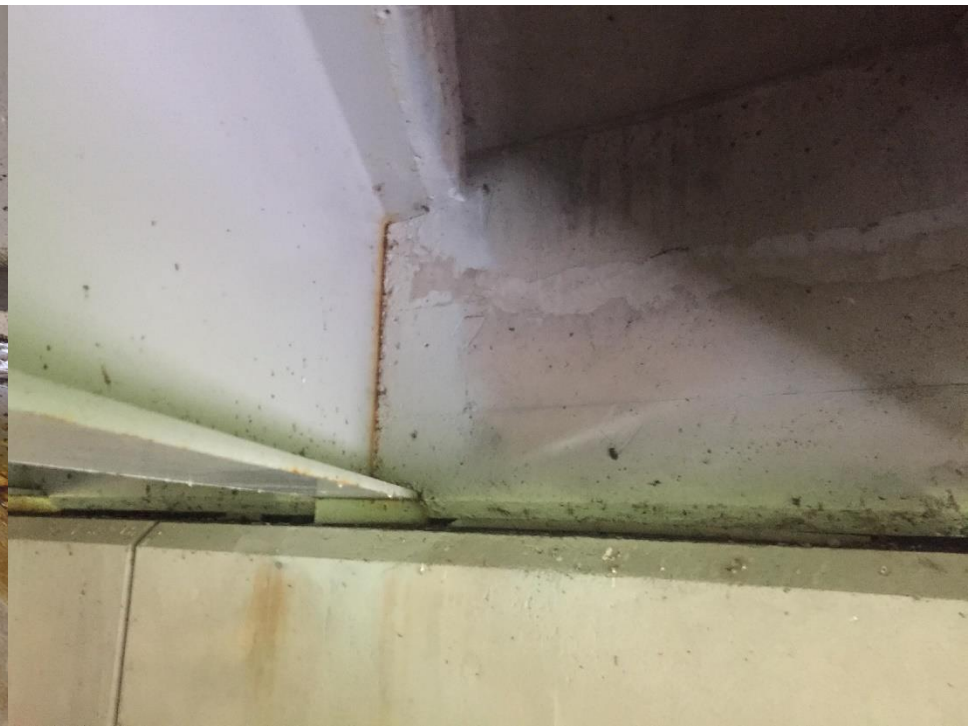
- Deck Replacement in 2000
 - Moved Expansion Joint off bridge.
 - Original Bridge Fixed Pier with Expansion Abutments for bearings.

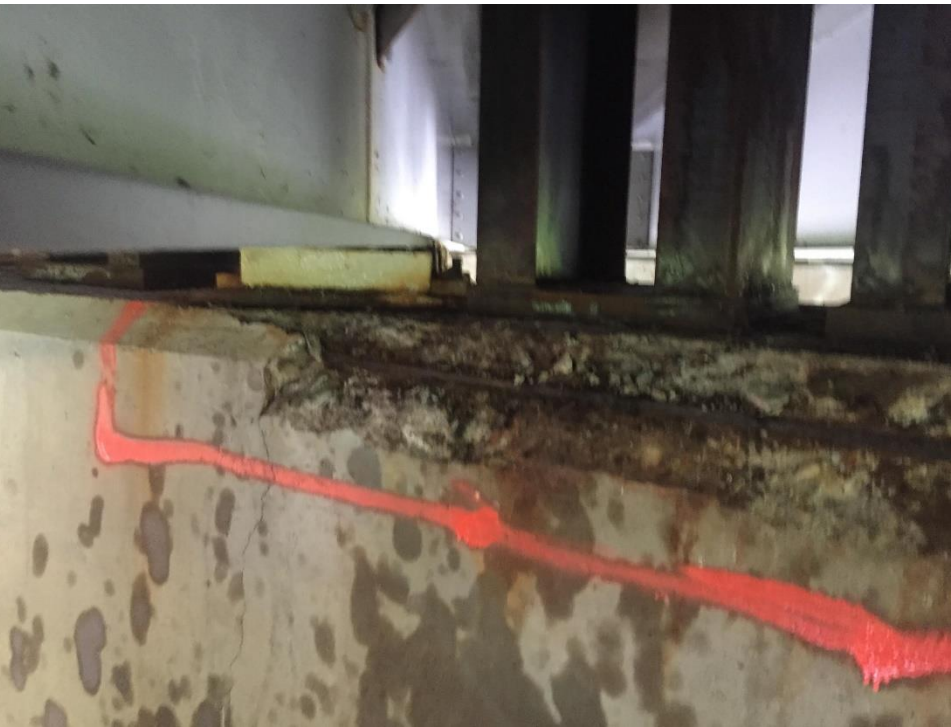
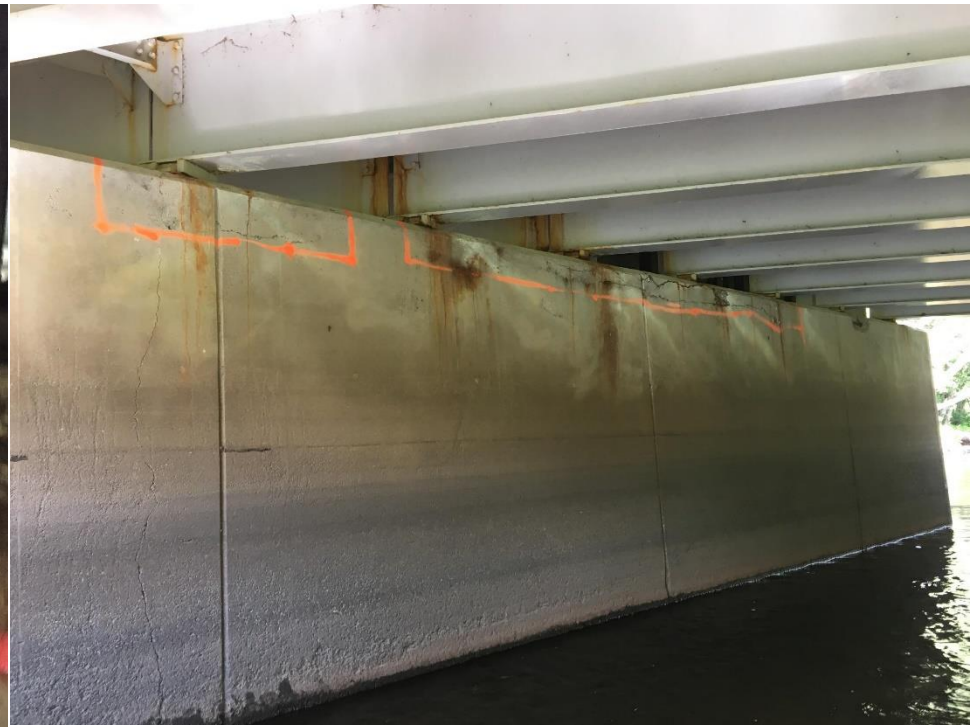
- Did the bridge move as expected?

- Did the bridge move as expected?
 - RFA Submitted 8-19-2015
 - RFA - JN 204336 – Let 1/10/2020
 - \$401,000 – Put expansion joints at reference lines, substructure repairs.

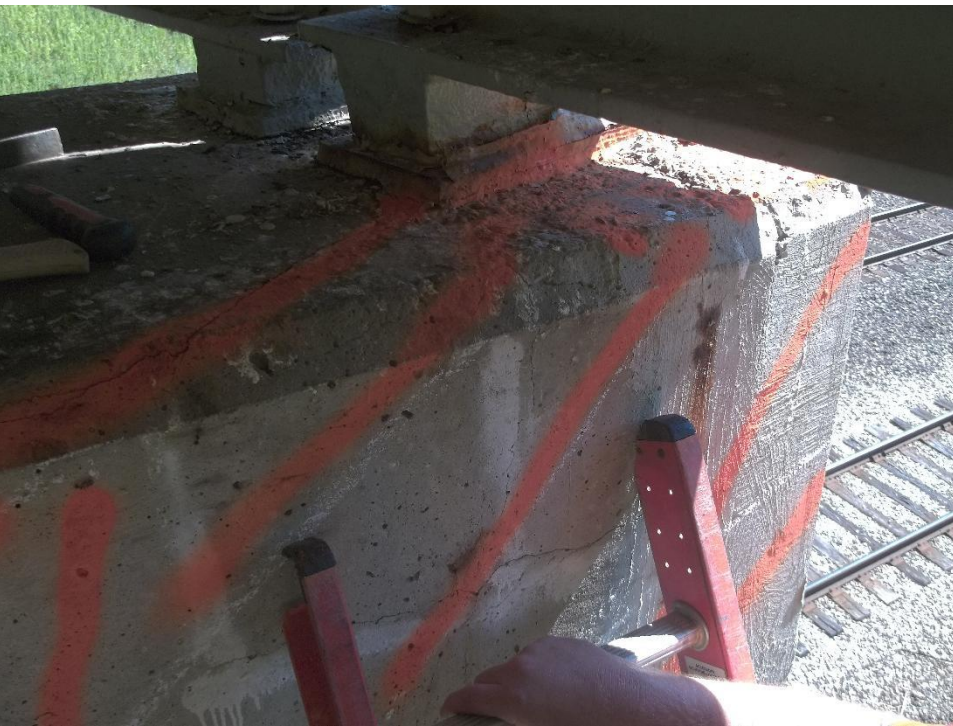
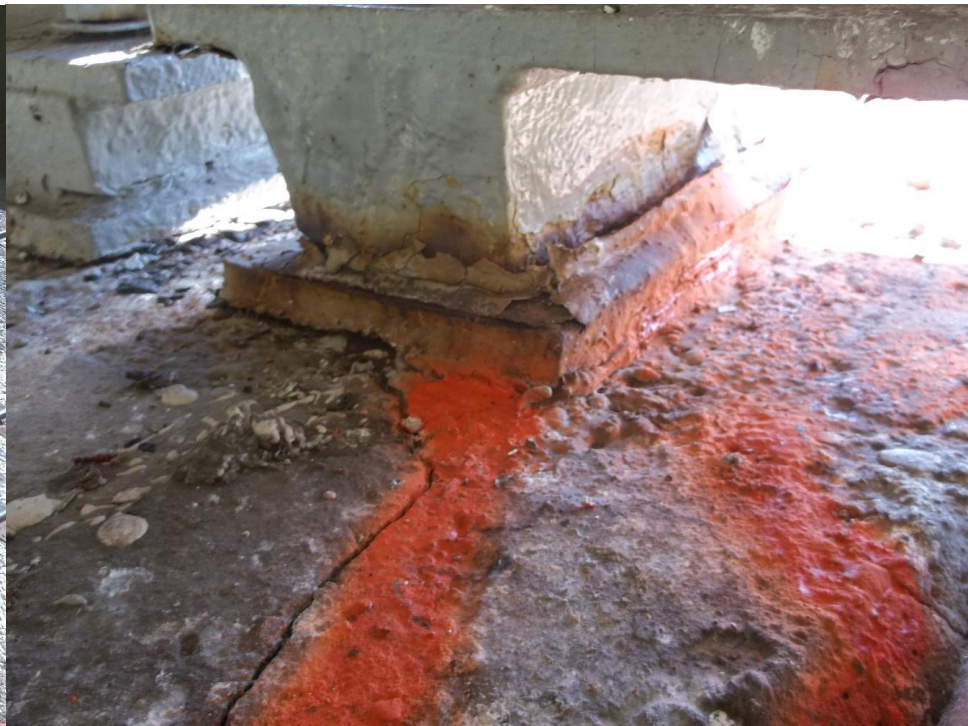
- Substructure Patching
 - RFA 8/12/2016

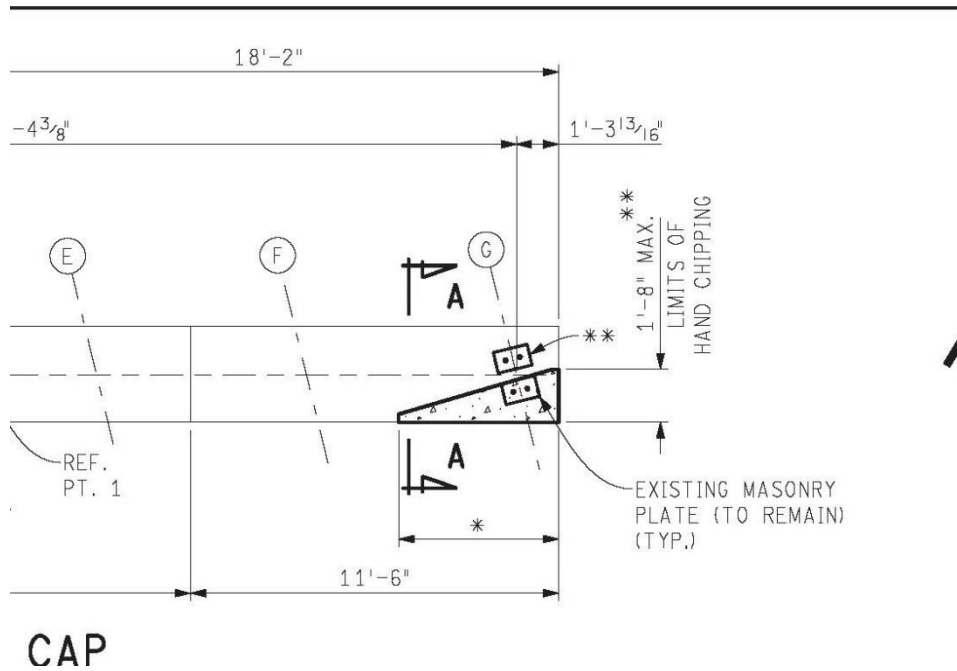
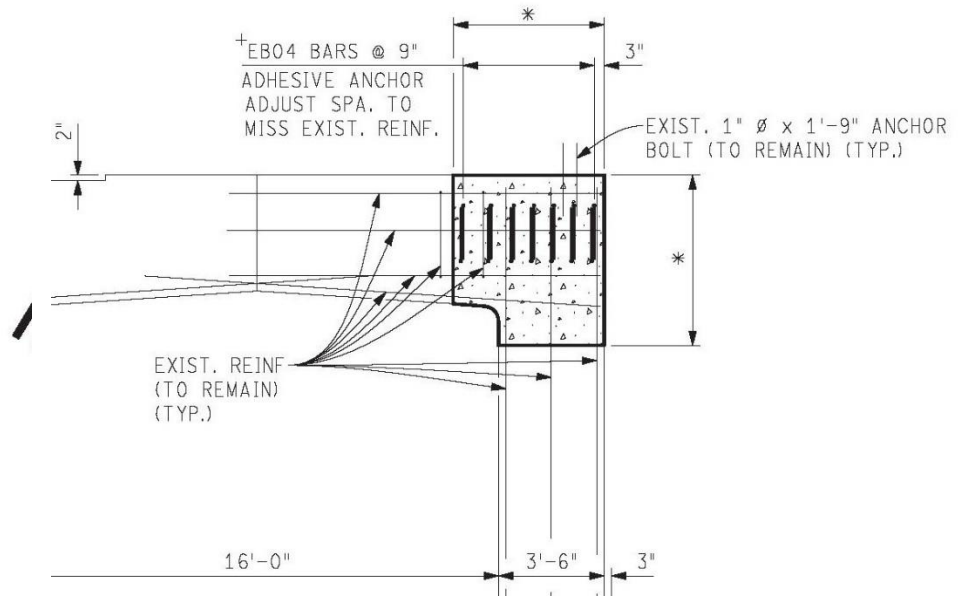
- **Substructure Patching**
 - 200411 – Substructure Patching – 2018
 - Will the standard repair give us the life we expect?

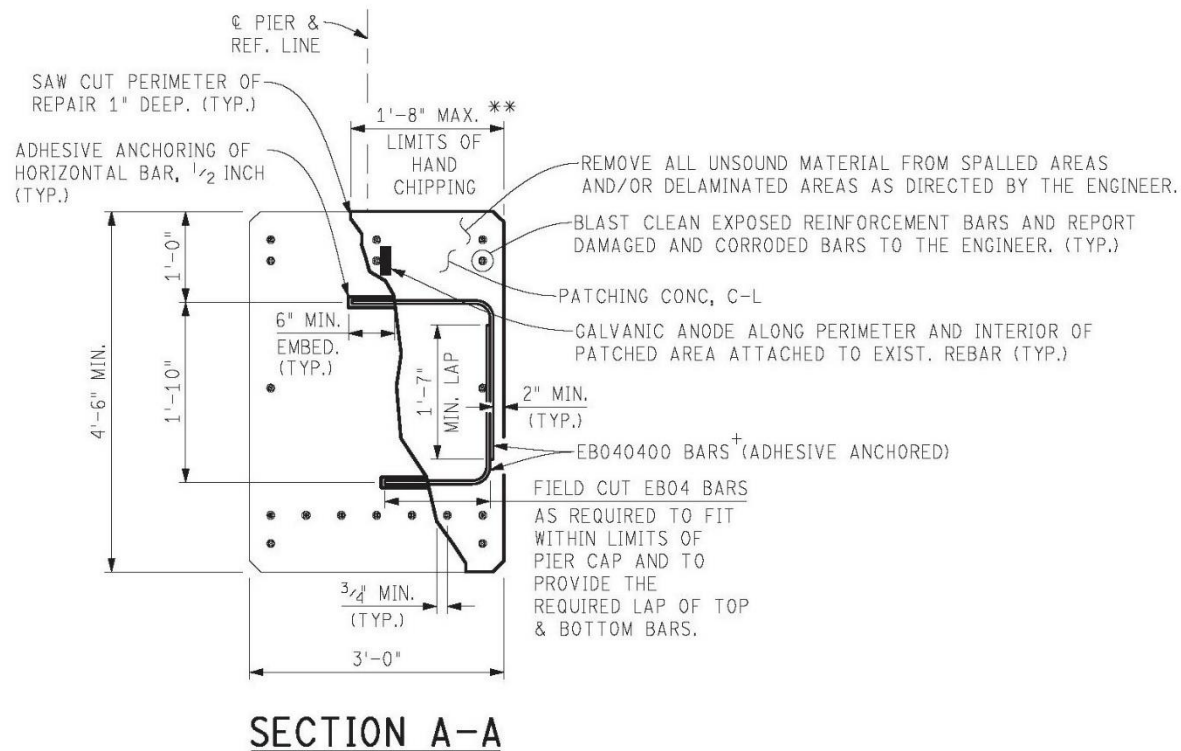
- Substructure Patching
 - 200411 – Substructure Patching – 2018
 - Will the standard repair give us the life we expect?

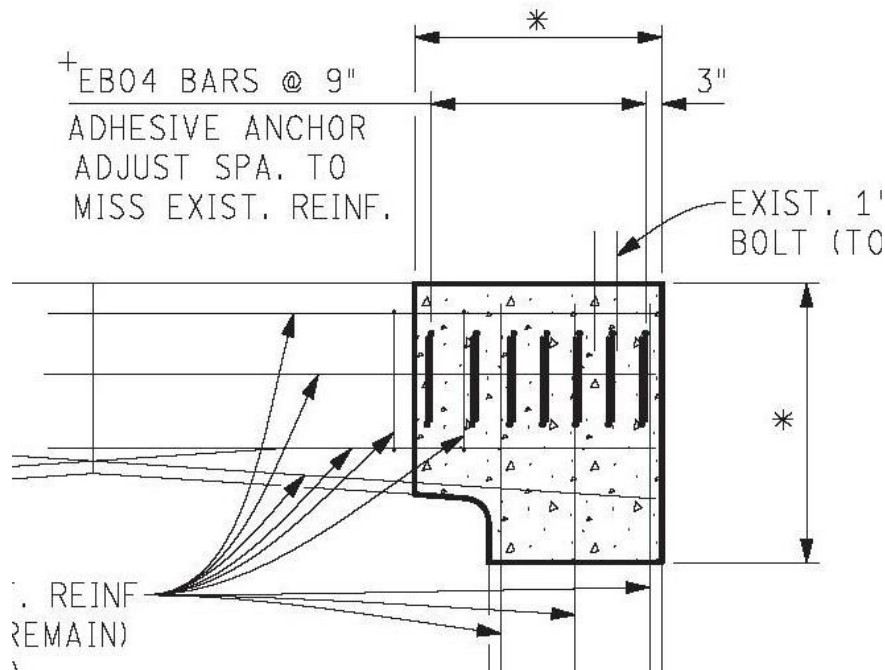
- **Substructure Patching**
 - Was minimum 12d Embedment enough?
 - Were #4 Bars Sufficient to hold new patch to existing concrete?

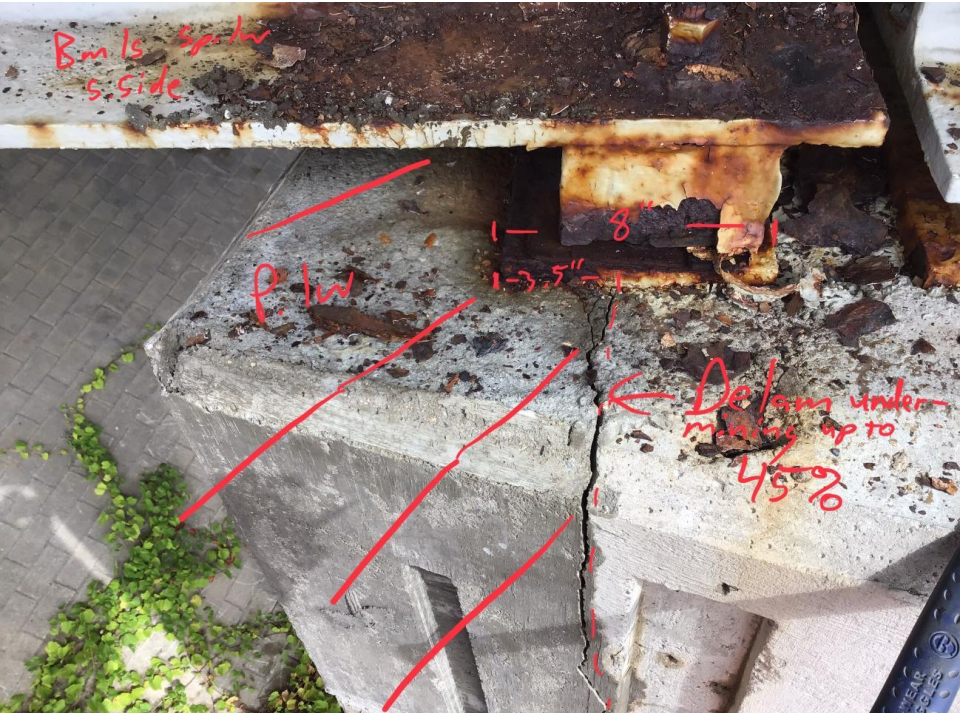
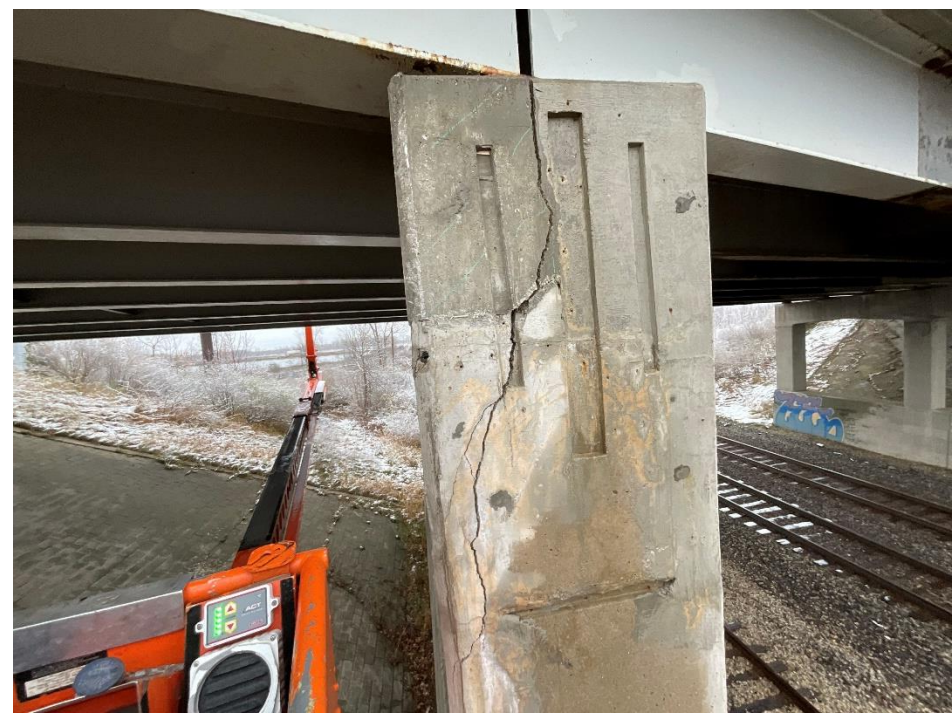
- Substructure Patching
 - RFA 9/22/2022 – 4 years after construction

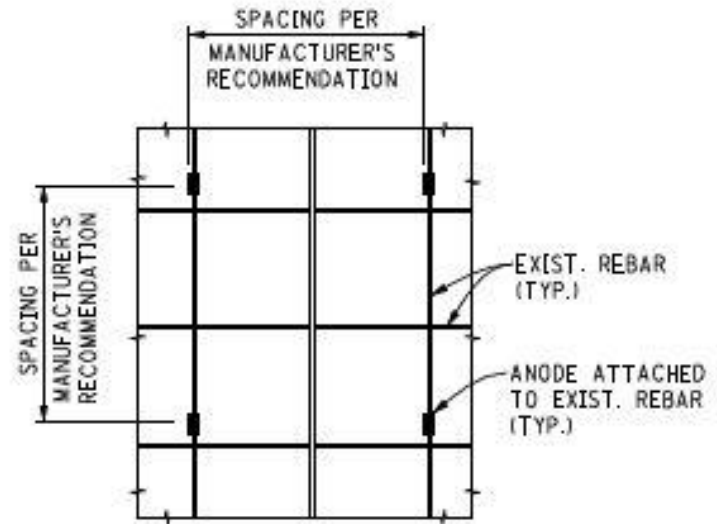
GALVANIC ANODE DETAIL

- **Substructure Patching**
 - What about the Anodes?
 - Base Quantity on 24 inch spacing?
 - Call for Contractor to place per Manufacturer?

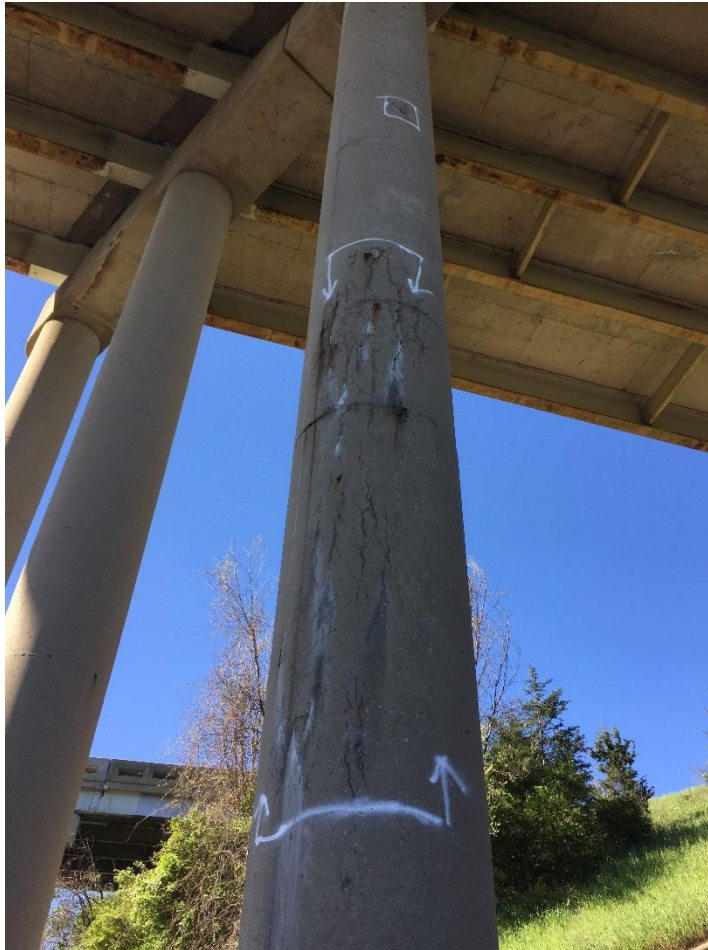
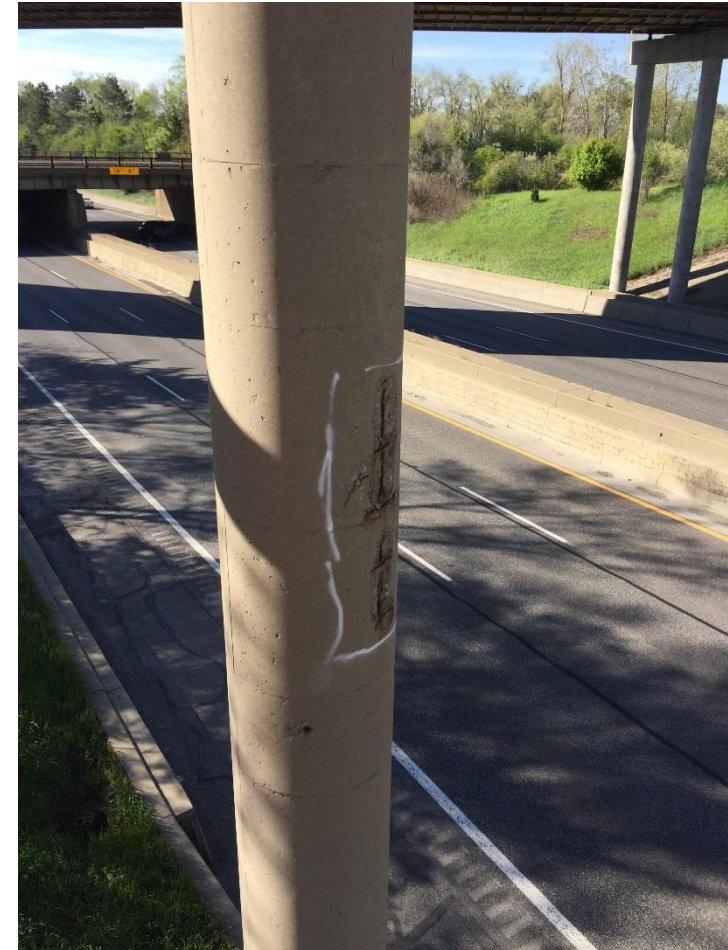
S-13 of 25042

Column Repair - SB I-75 Ramp to EB I-69
