# Collaboration for Success

*Temp Support of NSTM Pier Cap  
MDOT JN 218323*

# I-196 WB to US-131 SB over I-196 EB (Ramp F)

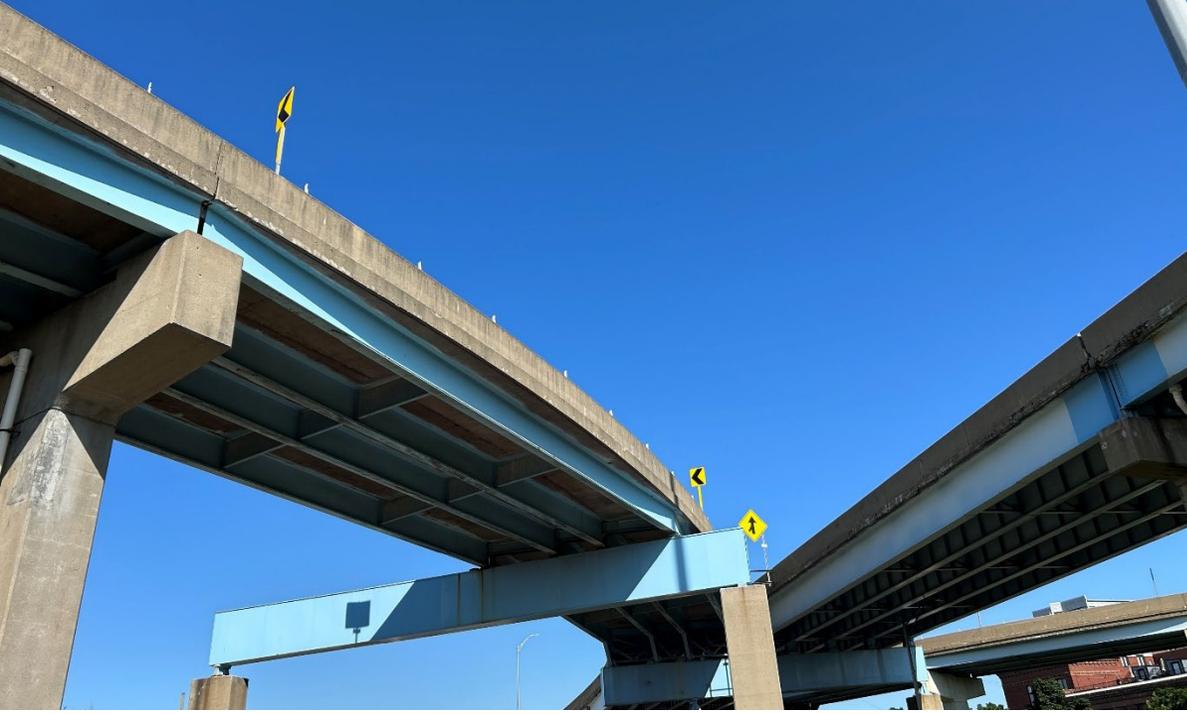
- Pier F7 – NSTM Box Girder Cap
  - 60" x 3/8" Webs
  - 34" x 1-1/2" Top and Bottom Flange
  - 1/2" Internal Diaphragms
  - Design Fix-Fix

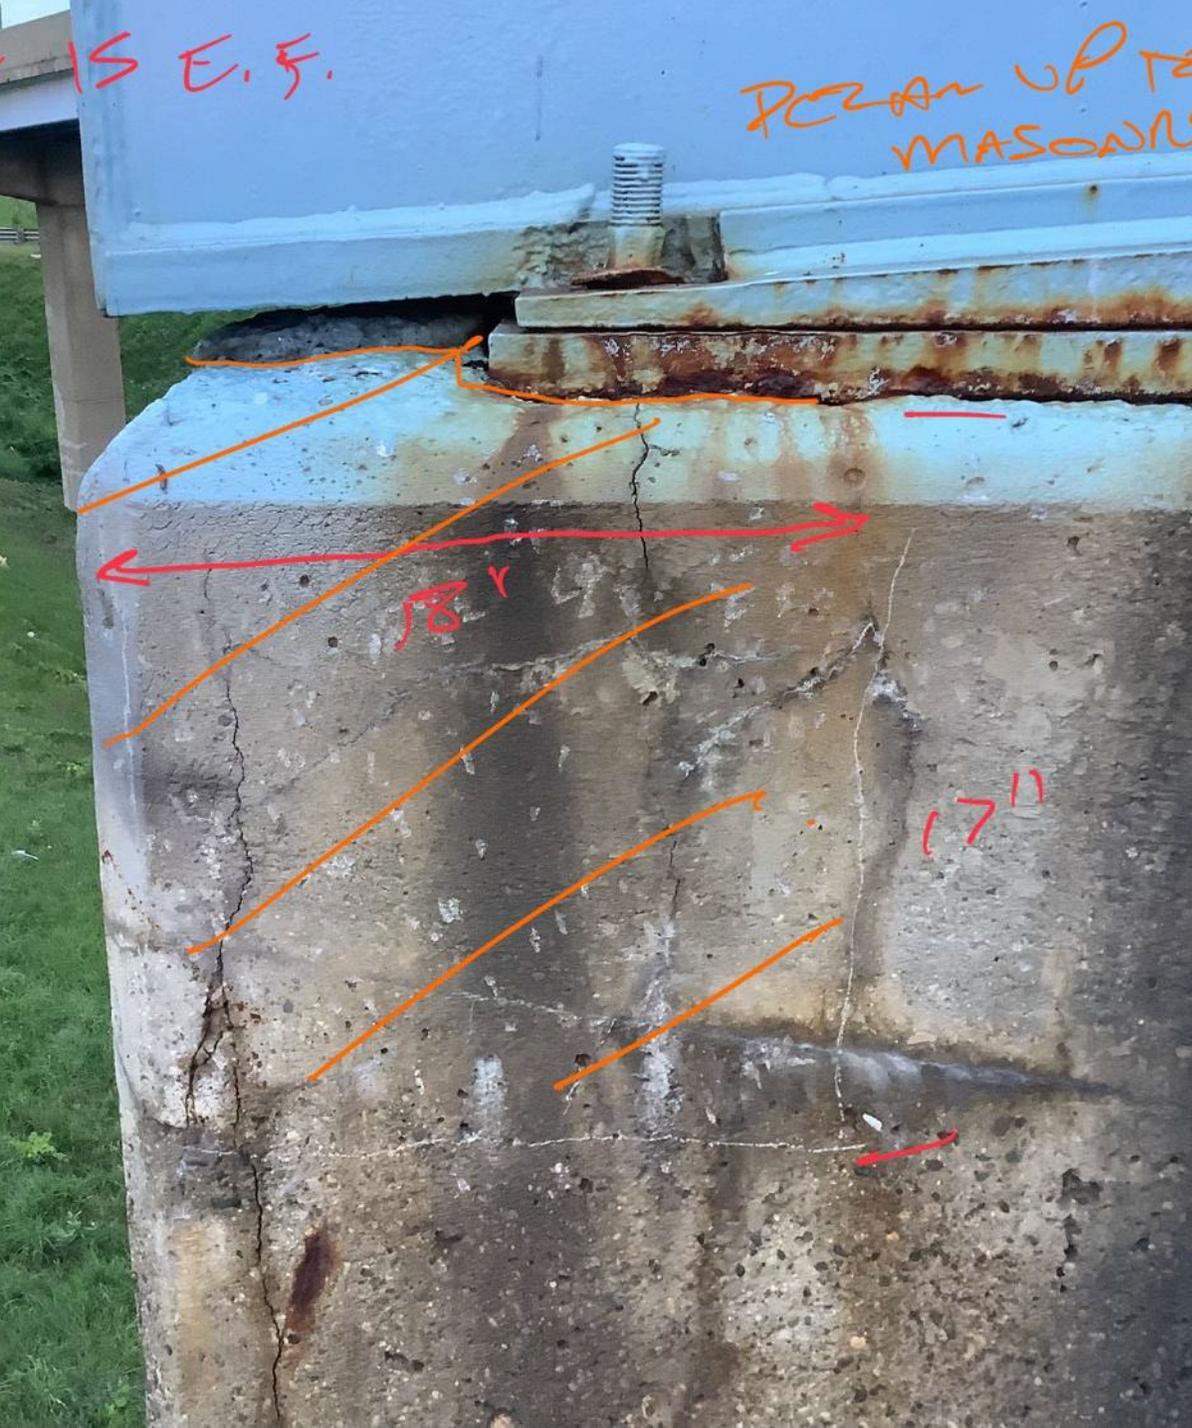
- 9/17/2022
  - 17" delamination / incipient spall projecting beyond anchor bolt.
  - Previously patched
  - RFA Committee Comment

*Suggest protecting the columns with waterproofing coating and investigate carbon fiber wrap with Dr. Grace. Epoxy injection of cracks possibly. **Assign intermediate to Jason DeRuyver for developing a repair strategy.** Committee suggests scaling off the loose concrete and sounding remaining concrete to determine soundness as part of the repair. (Mike Halloran - 09/20/2022)*

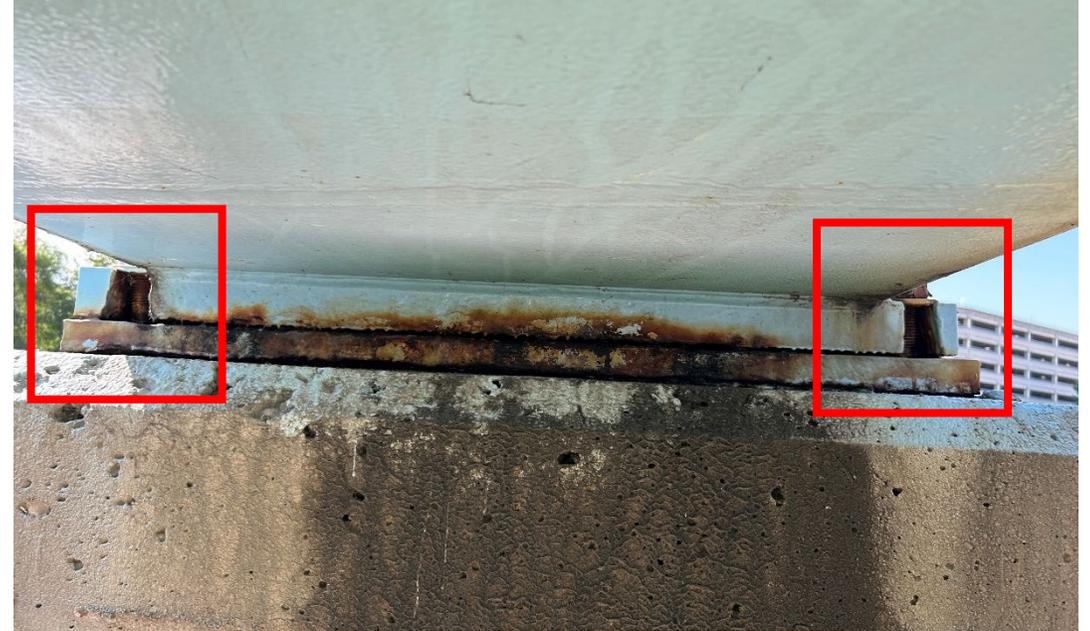
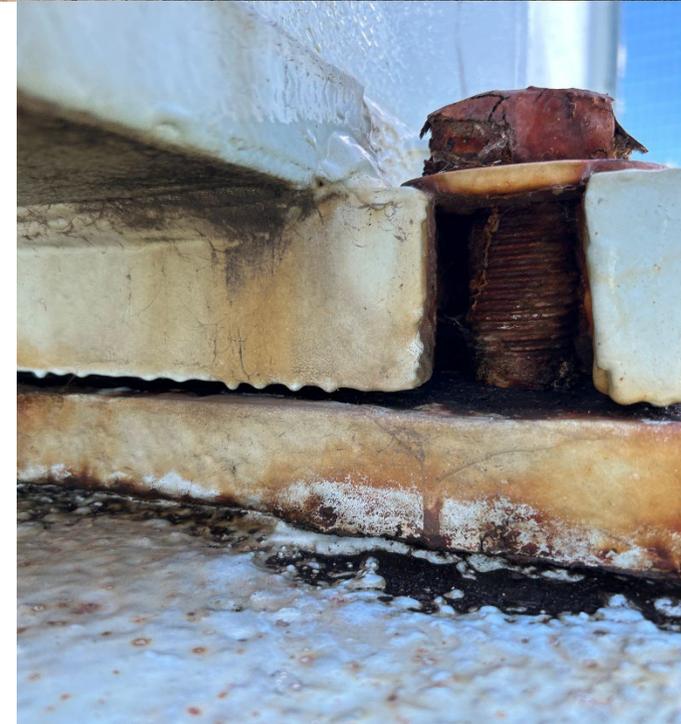
## Field Visit 6/12/24

- Project Scope – Remove and replace top 2 feet of column.
- Remember
  - Previously failed patches and fix-fix bearing design
- RFA Project Philosophy
  - ALWAYS - Look for items causing the RFA and other ancillary damage.
  - Project Success = Closure of RFA
- Previous retrofit - Slotting bolt holes not meant to be slotted.

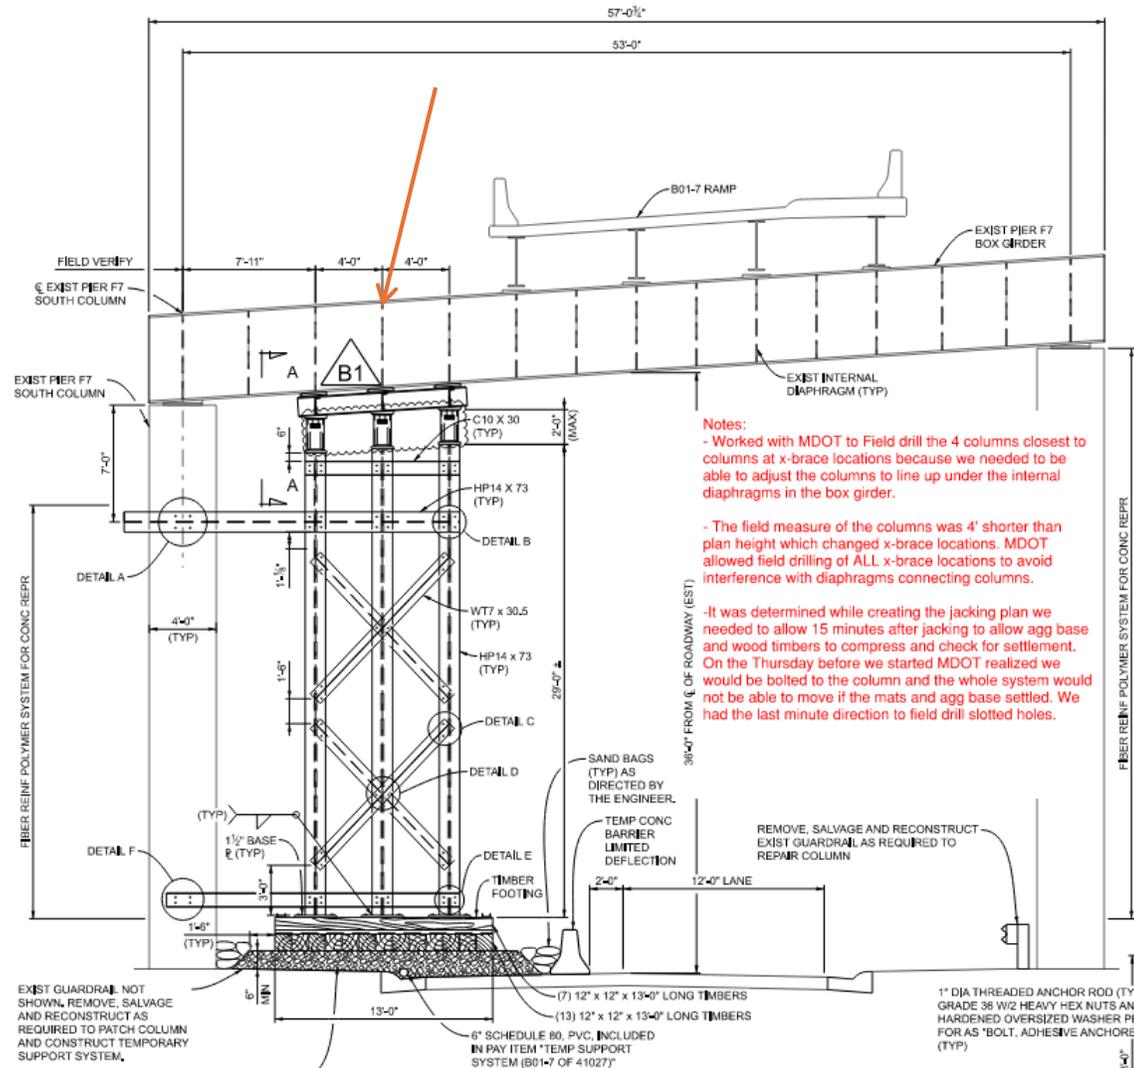
**PIER F7 ELEVATION**

- The field measure of the columns was 4' shorter than plan height which changed x-brace locations. MDOT allowed field drilling of ALL x-brace locations to avoid interference with diaphragms connecting columns.

- It was determined while creating the jacking plan we needed to allow 15 minutes after jacking to allow agg base and wood timbers to compress and check for settlement. On the Thursday before we started MDOT realized we would be bolted to the column and the whole system would not be able to move if the mats and agg base settled. We had the last minute direction to field drill slotted holes.

- Worked with MDOT to Field drill the 4 columns closest to columns at x-brace locations because we needed to be able to adjust the columns to line up under the internal diaphragms in the box girder.

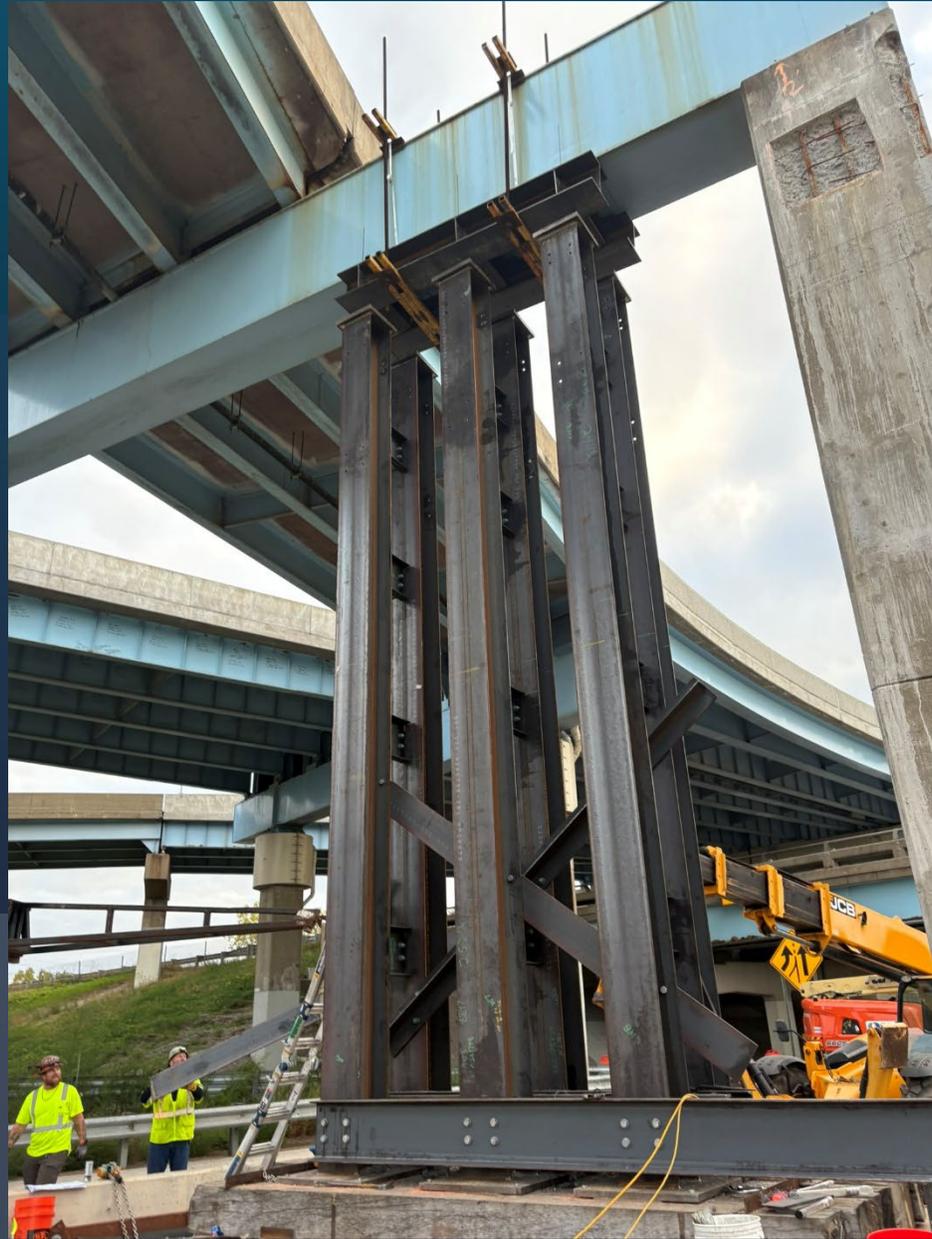
One of many messages to the designer that weekend, confirming the orientation of the cross braces.

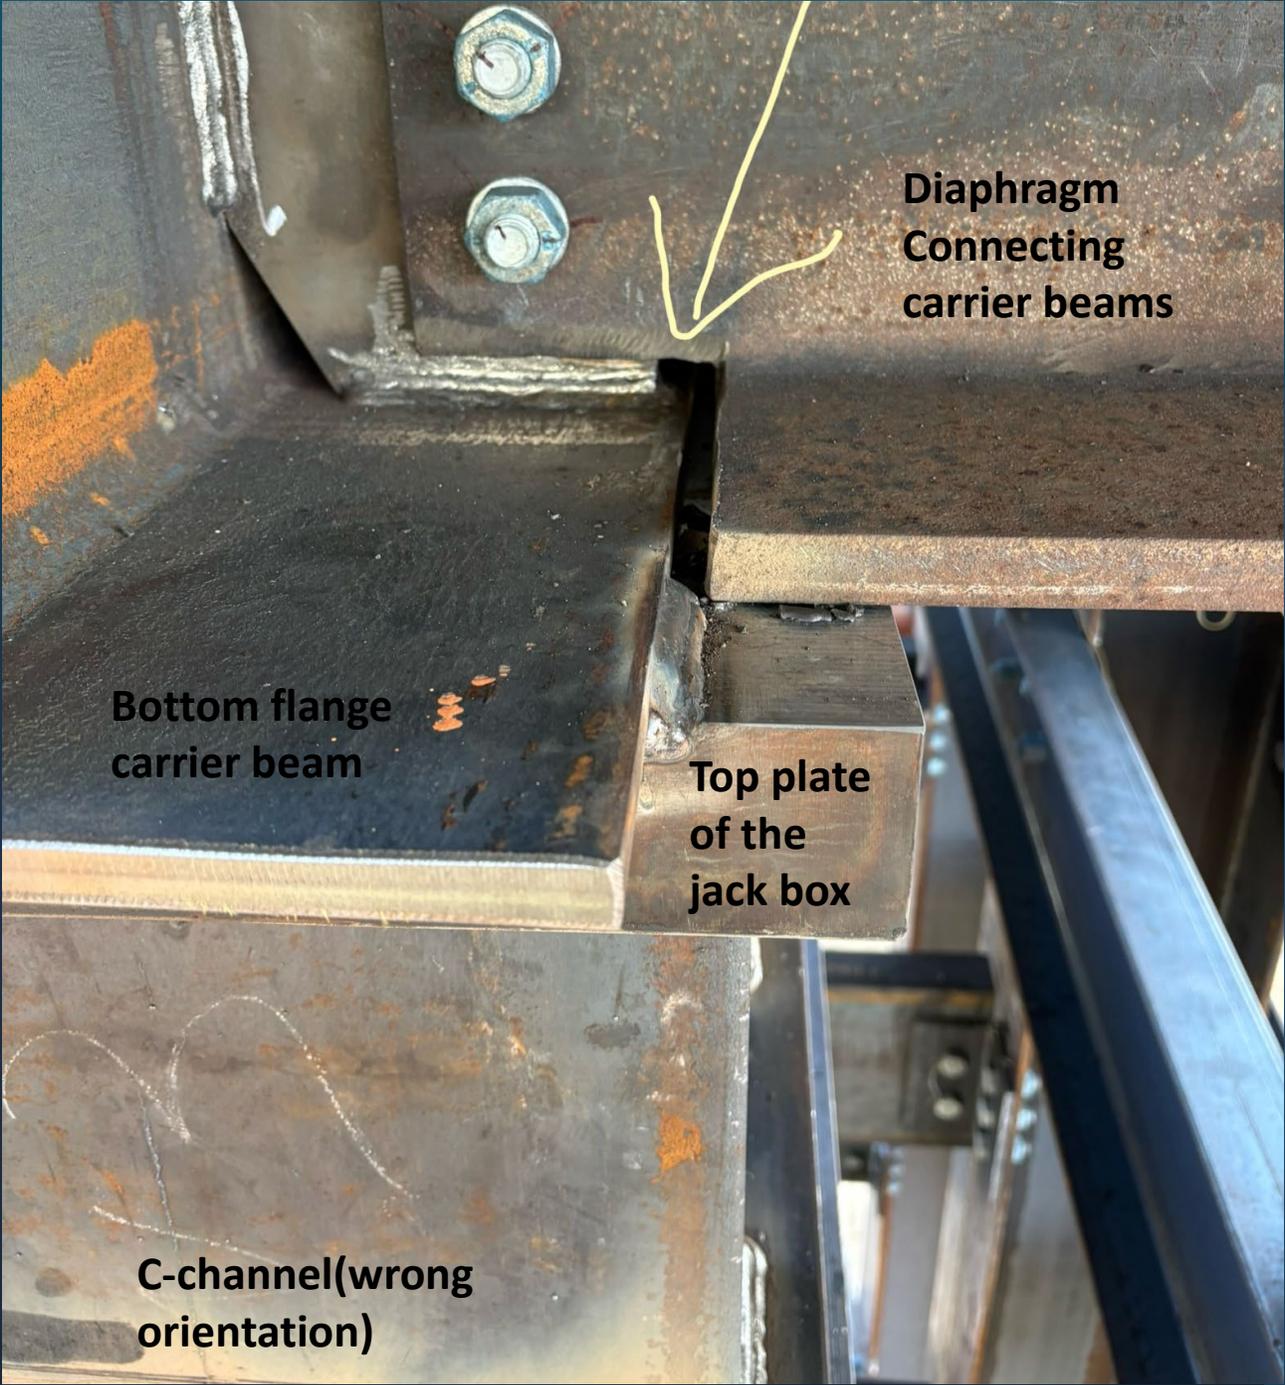
C-channel(wrong  
orientation)
