Sherman Ave Over US-31 Deck Deterioration

Statewide Region Support Bridge Preservation

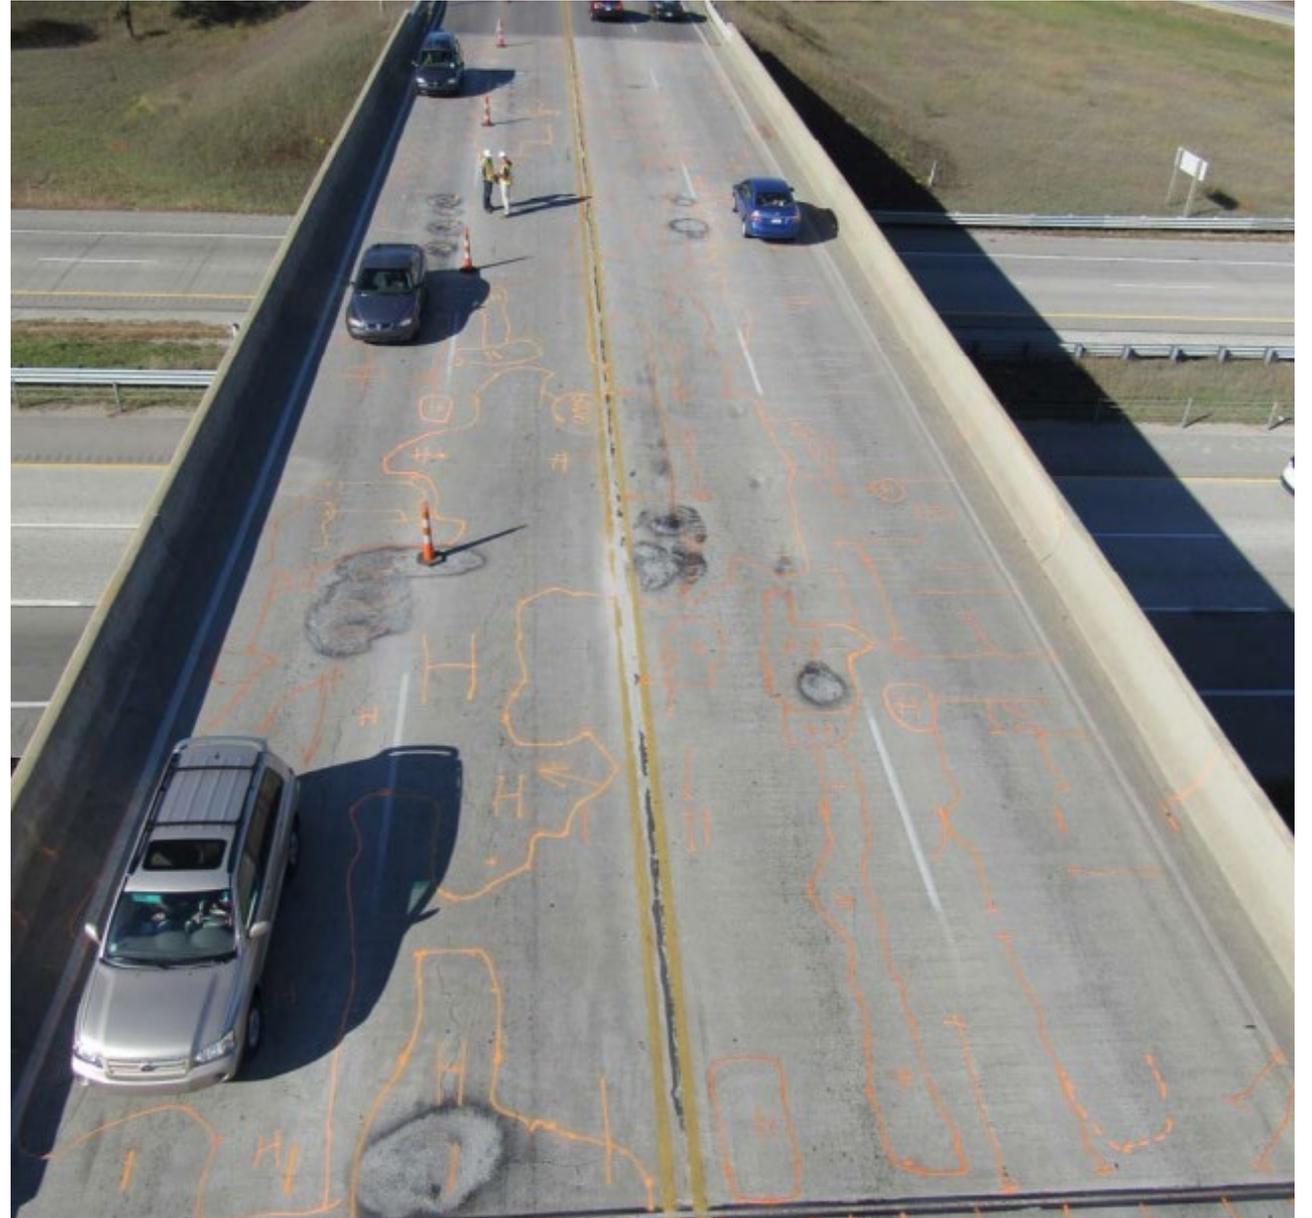
Structure Condition in 2015

Deck Surface was approx.
9% Delaminated

Deck Bottom was approx.
3% Delaminated

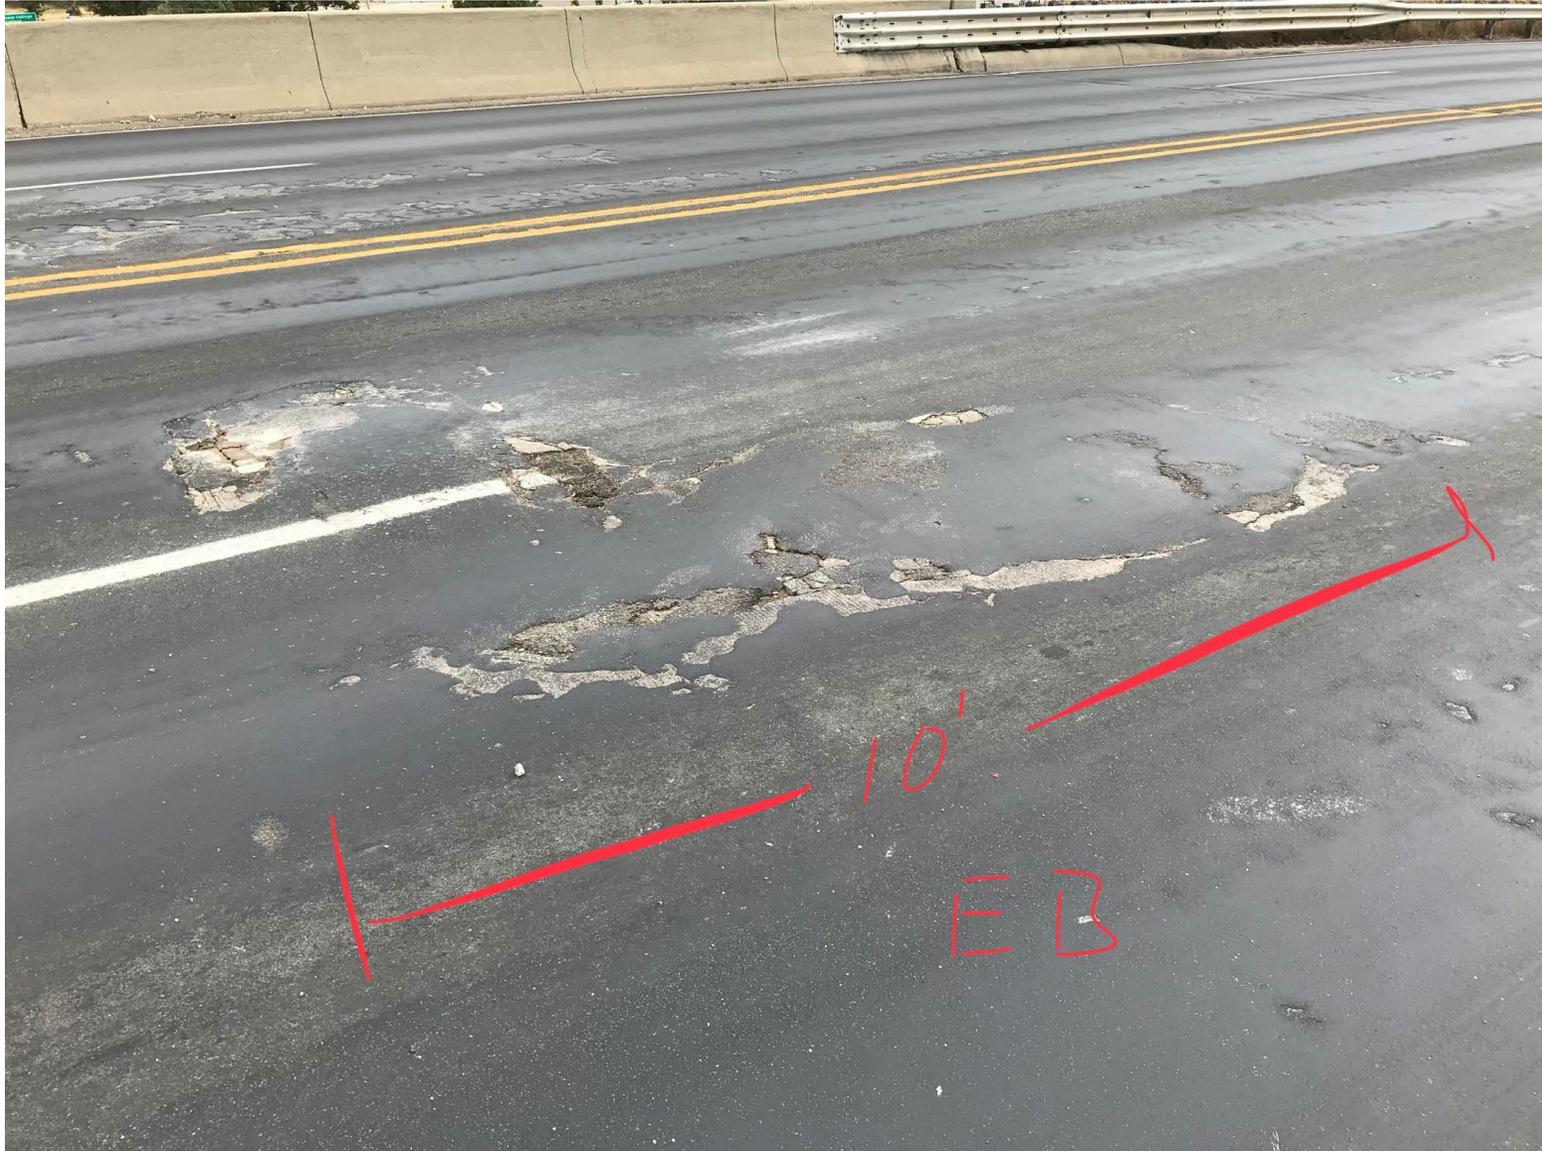
Structure Condition in 2018

- On October 2018 Maintenance scope of work included:
 - Stage 1 - Milled off existing bit chip seal on the deck & 25ft butt joints (night 1)
 - Stage 2 - Deck Patched = 1060 Rapid Set concrete mix (night 2)
 - Stage 3 - Placed 1 ¼" HMA overlay on deck surface without a membrane. (night 3)

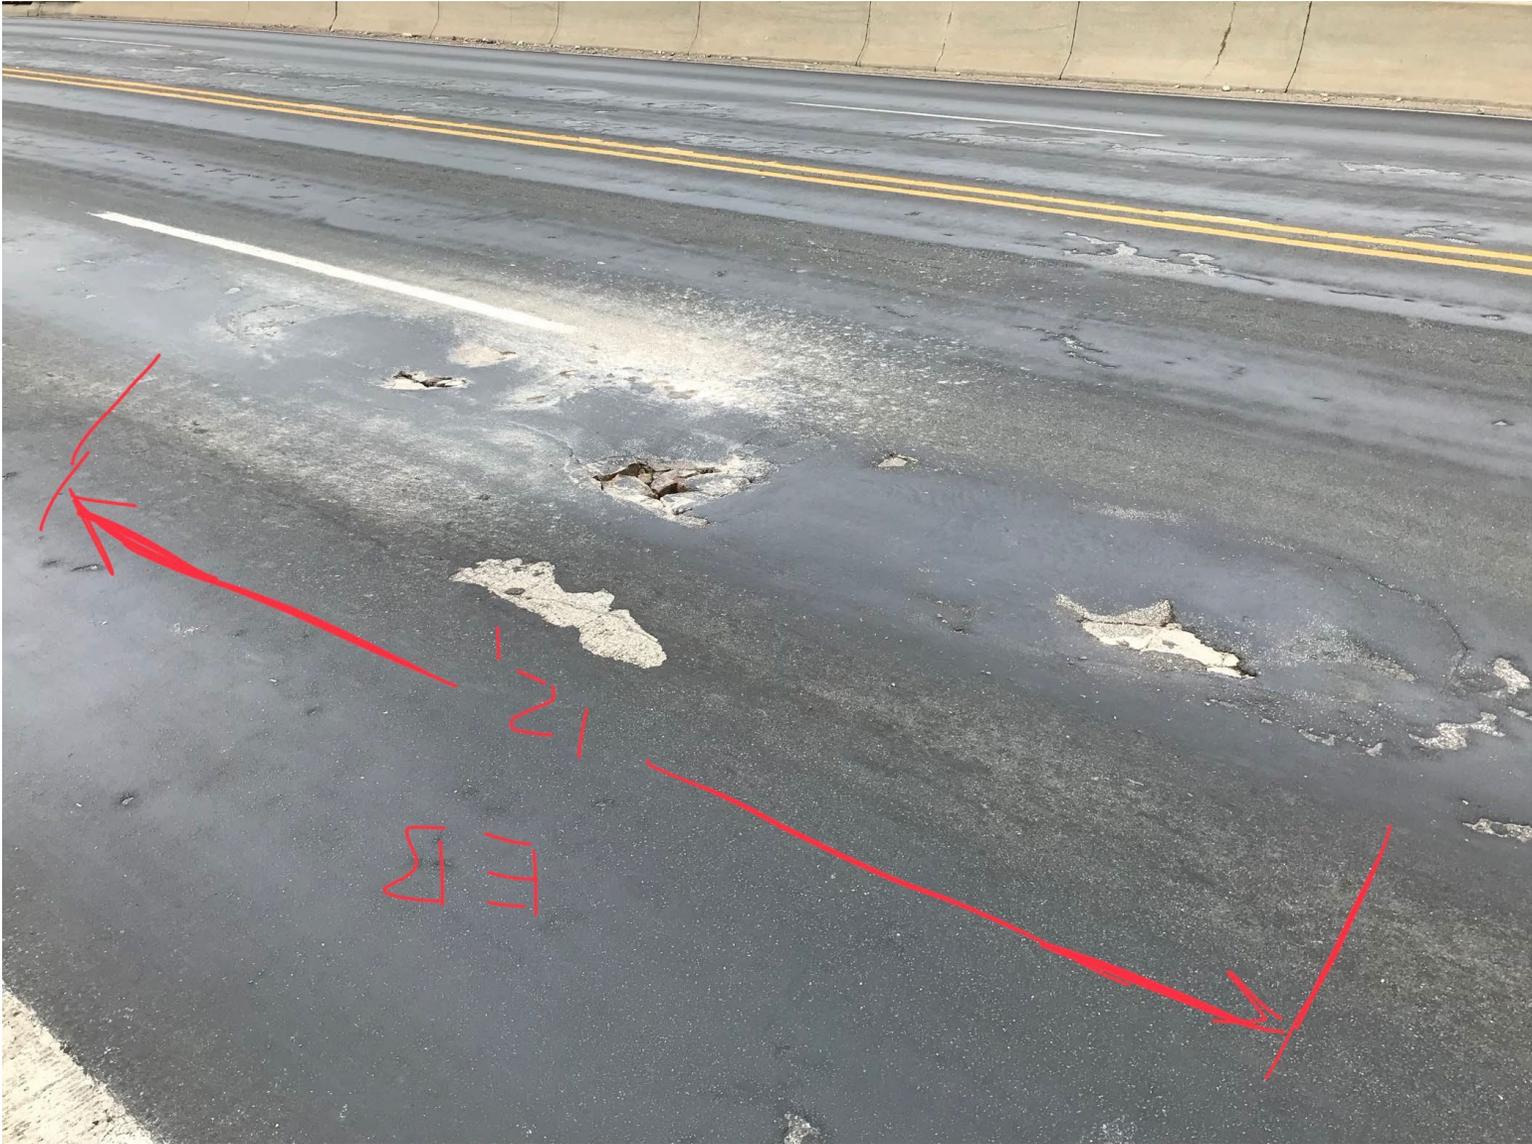
Structure Condition in 2021

- On October 2021 work included:
 - Stage 1 - Milled off existing HMA Overlay on the deck & 25ft butt joints
 - Stage 2 - Deck Patched = 1060 Rapid Set concrete mix
 - Stage 3 - Placed 1 ¼" HMA overlay on deck surface without a membrane.

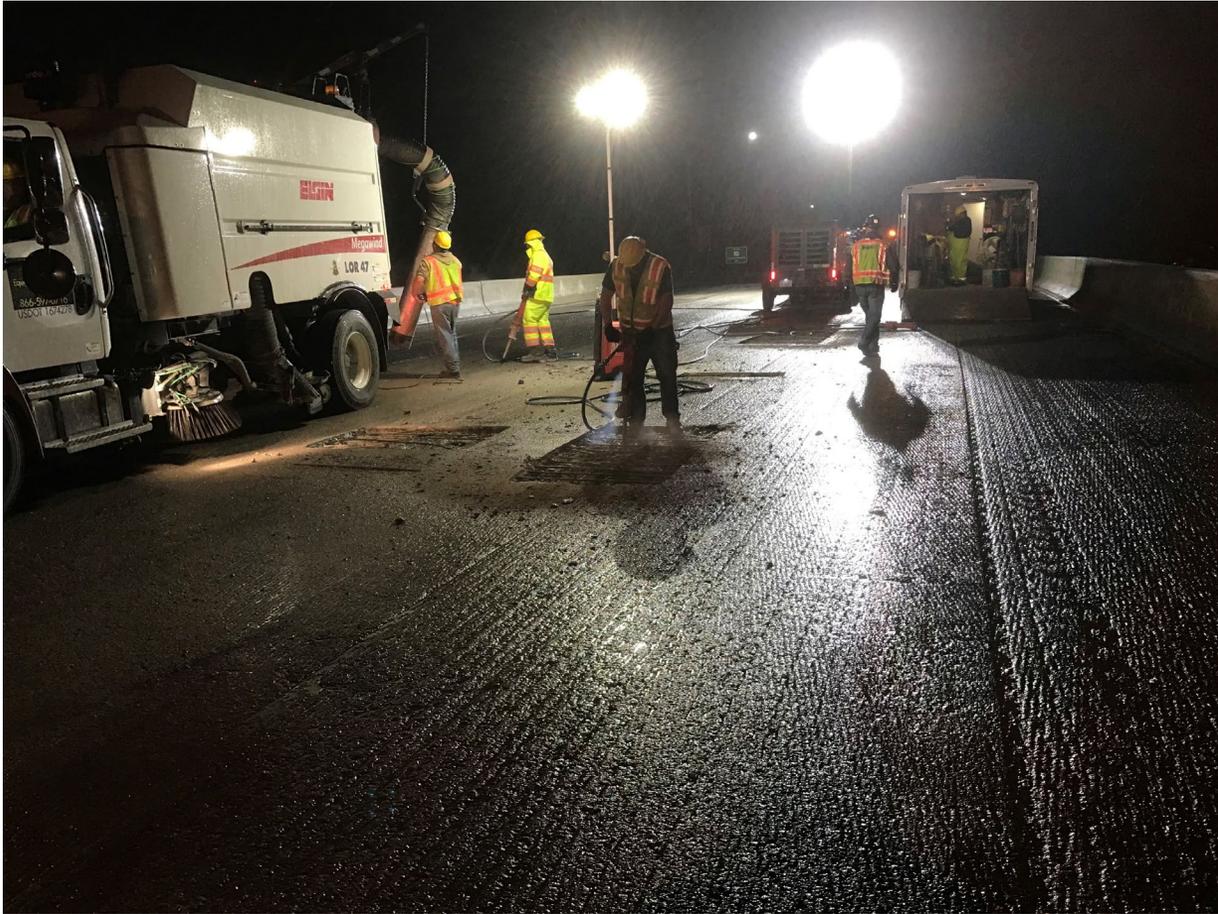
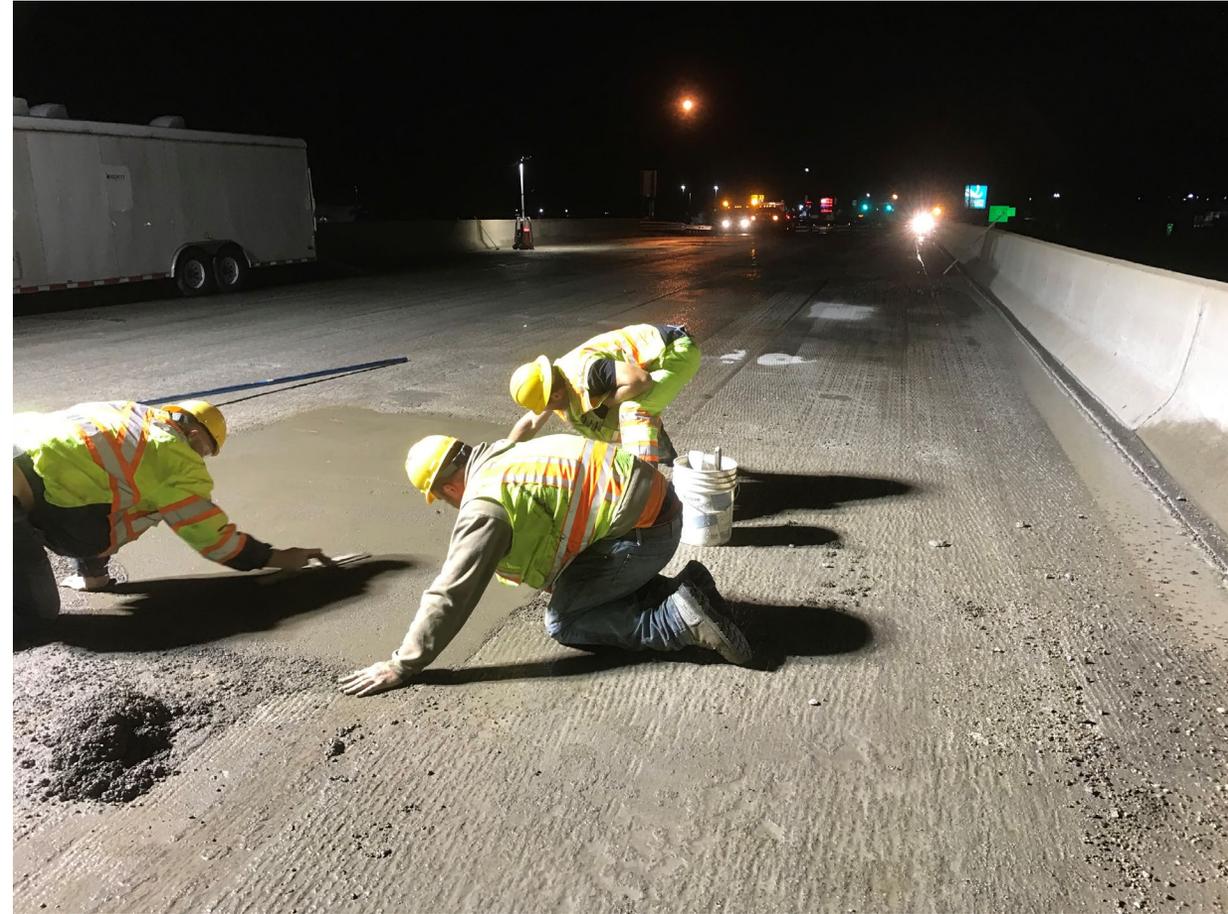
Structure Condition in 2021
