Effects of Concrete Cure Time on Healer Sealer Performance

Upul Attanayake, Ph.D., P.E.

Bridge Maintenance Workshop

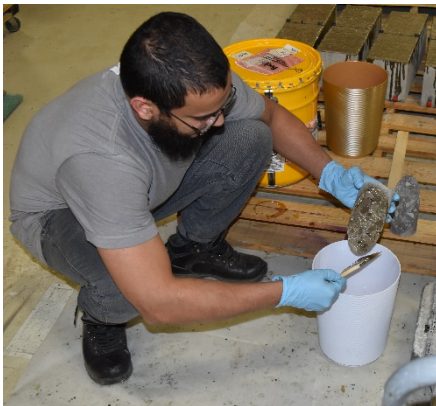
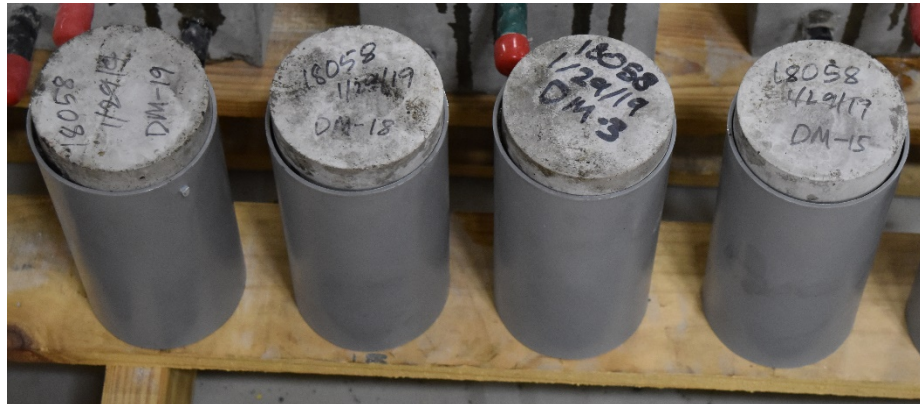
SLANT SHEAR BOND STRENGTH

- Slant shear bond strength > 2000 psi, 2-day dry cured

Healer Sealer	Specimen no.	Slant shear bond strength (psi)	Average strength (psi)
S1	1	2413	2339
	2	2379	
	3	2224	
S2	1	1584	2141
	2	2870	
	3	1968

S2 is a low viscous sealant. The average of all 3 values was considered instead of considering 2870 psi as an outlier.

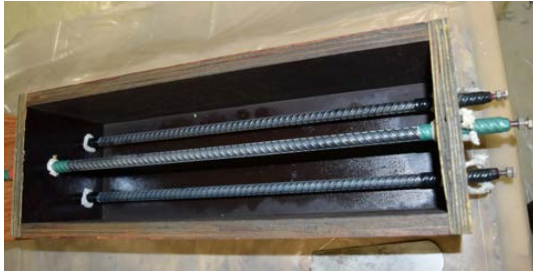
Mold with rebar

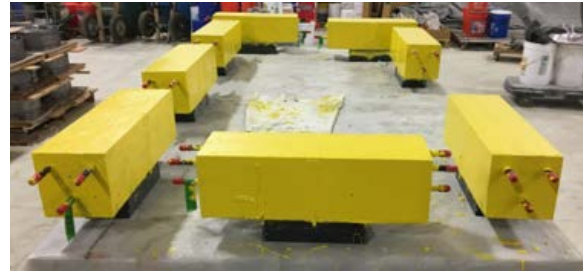
Epoxy painted surfaces

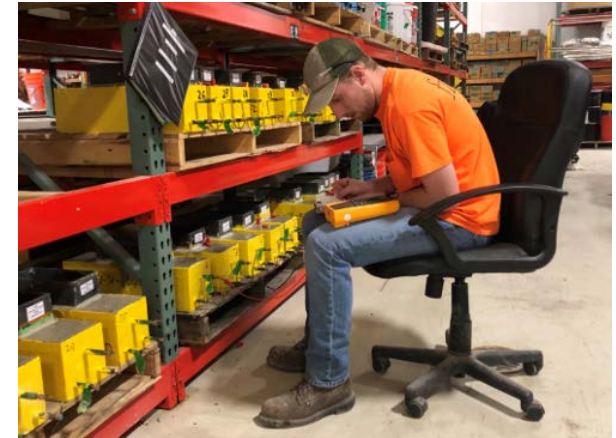
$P = 75\%$ of the 28-day flexural capacity

Voltage measurement across a $10\ \Omega$ resistance

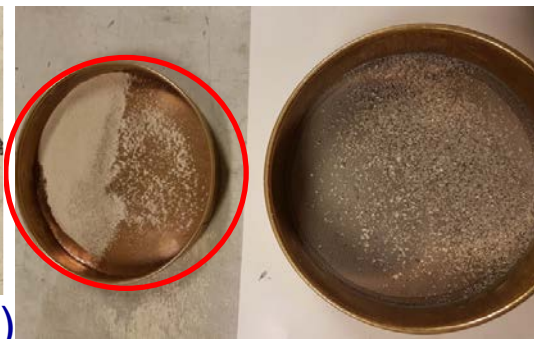
Samples passing #20 sieve

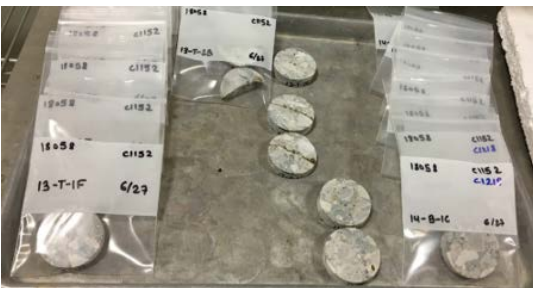
0.5 in. thick slices

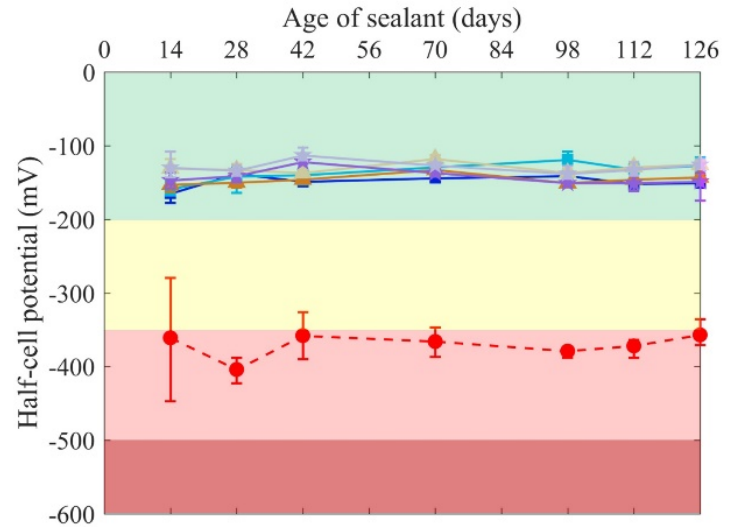
Away from crack center

$t_4 \approx 14$ days

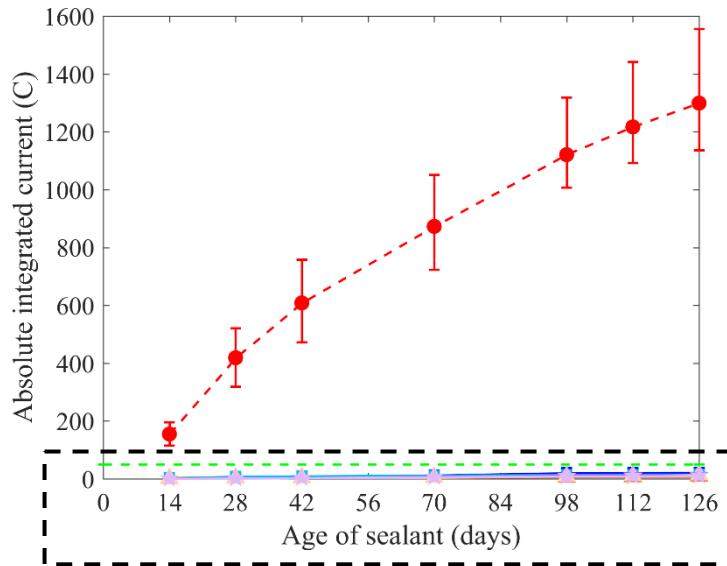
Absolute integrated current (< 50 C approximately)

Control and treated beams

$t_4 \cong 14$ days

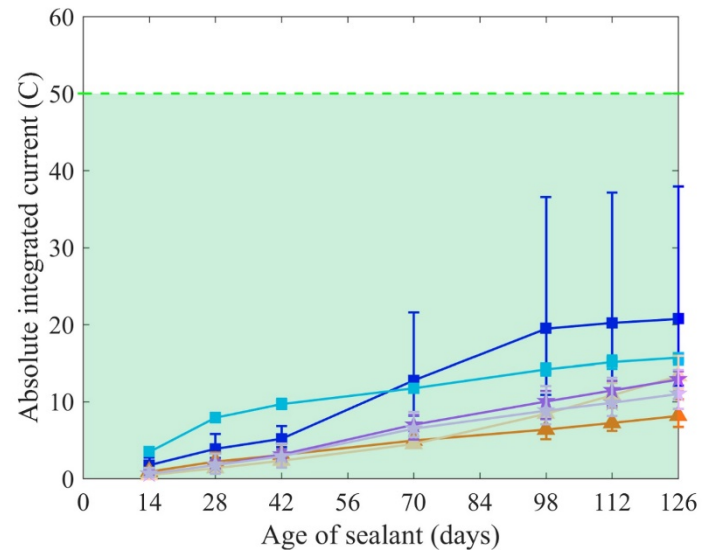
Treated beams

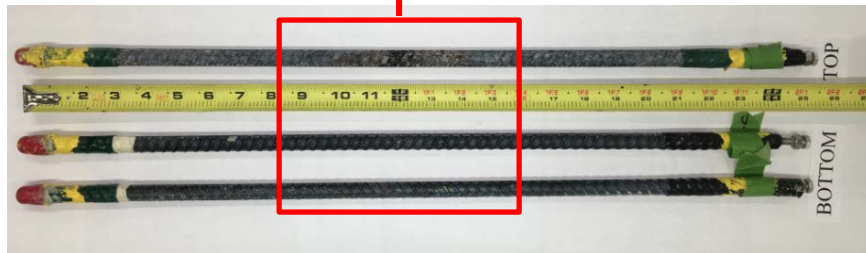
Rebar conditions

Control specimen

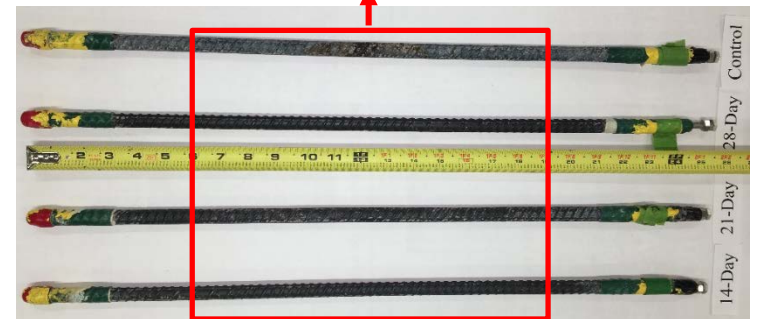
Top rebar of control and treated specimens

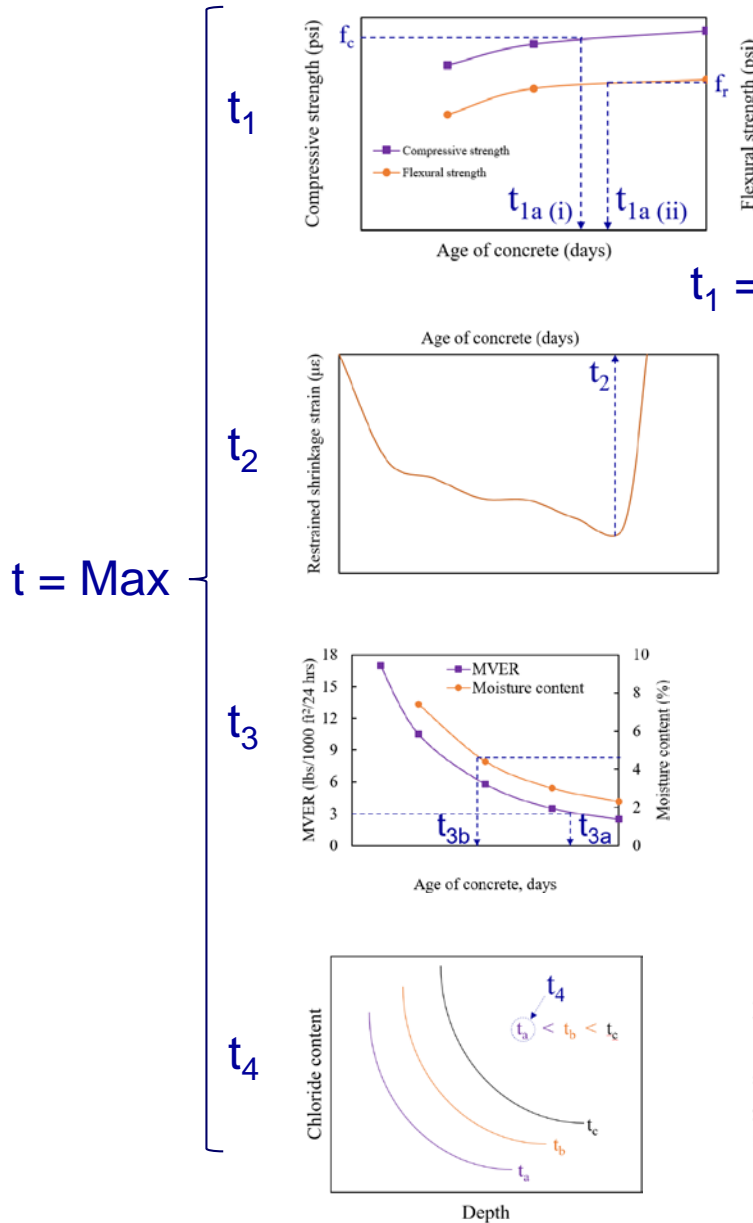
$$t_1 = \max(t_{1a}, t_{1b}, \text{ and } t_{1c})$$

Grade DM	BDJR
$t_1 = 9$	$t_1 = 7$
$t_2 = 20$	$t_2 = 18$
$t_{3a} > 28$	$t_{3a} \cong 28$
$t_{3b} \cong 14$	$t_{3b} \cong 17$
$t_4 = 14$	$t_4 = 14$

- ❑ A set time is identified to place healer sealers on Grade DM and DBJR mixes.
- ❑ Healer sealers can be applied on bridge decks when Grade DM concrete age is 20 days.
- ❑ Healer sealers can be applied on bridge decks when BDJR concrete age is 18 days.
- ❑ The special provision 12SP-710B-03 can be revised as follows:

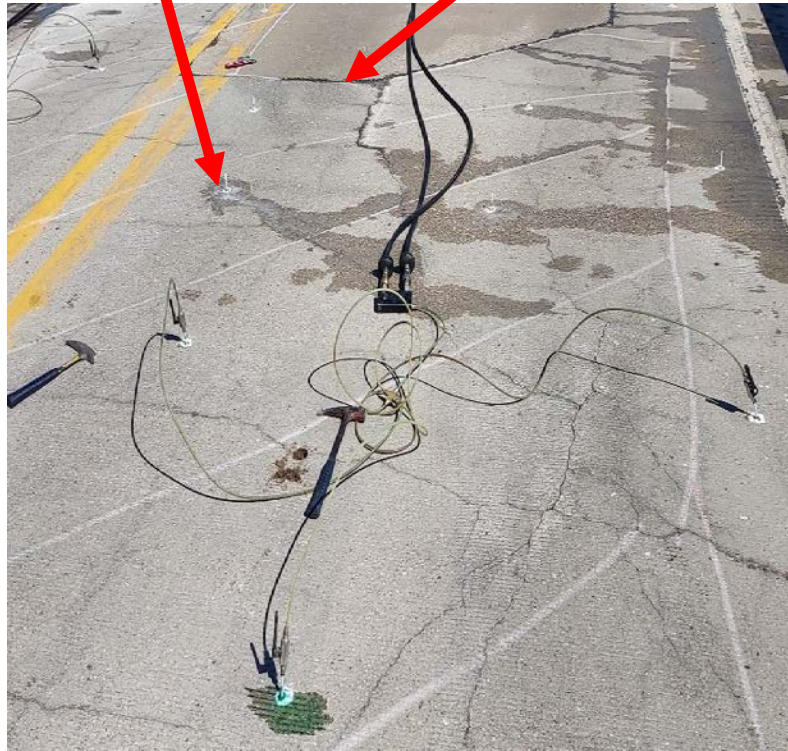
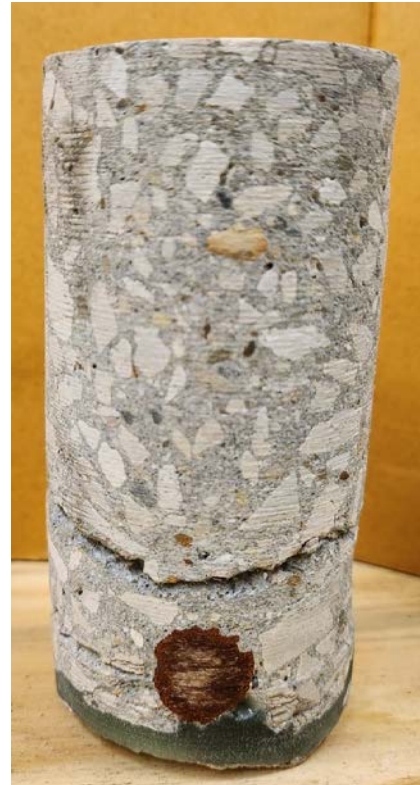
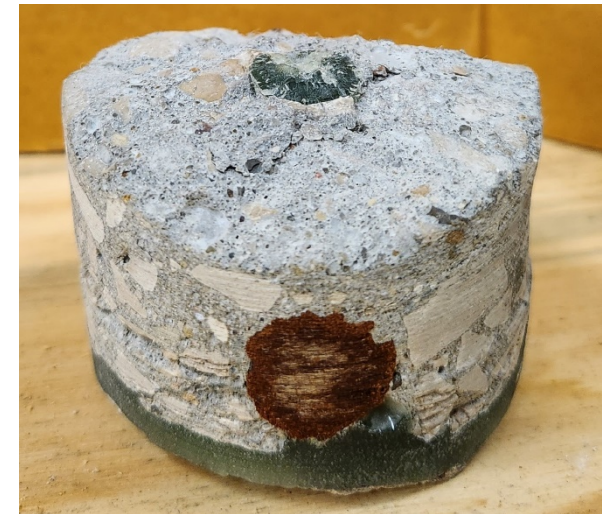
Injection of Epoxy Adhesive

Water coming out from an epoxy injection port

Water coming out from a crack

Epoxy Injection Process

2 x 4.5 in. core

A close-up near the rebar

2 x 4.5 in. Core Showing Injected Epoxy Adhesive

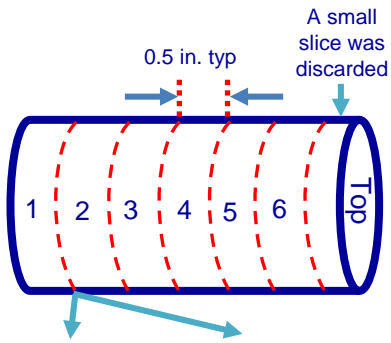
Specimen: T-1

2 x 2.5 in. core

- ❑ Blue dye was not observed in the crack, an indication of a sealed crack.
- ❑ Slice # 5 broke into two pieces along the crack indicating a maximum healer sealer penetration depth of about 0.5 in.

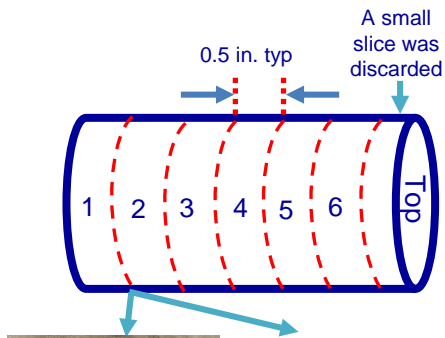
Specimen: T-2

2 x 2.5 in. core

- ❑ Blue dye was not observed in the crack, an indication of a sealed crack.
- ❑ Slice # 5 broke into two pieces along the crack indicating a maximum healer sealer penetration depth of about 0.5 in.

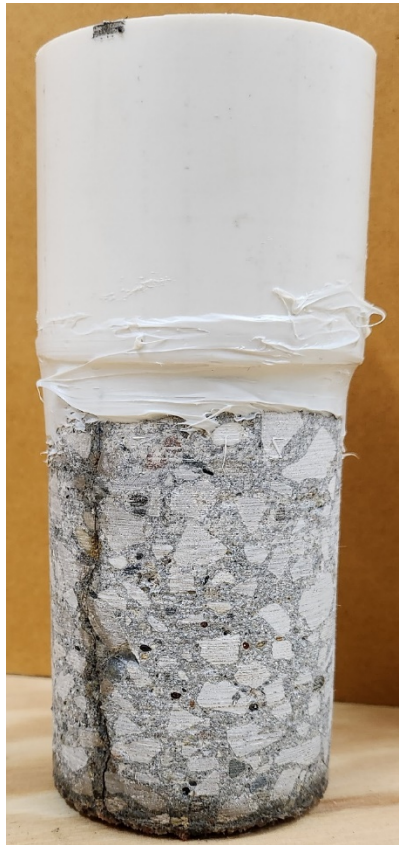
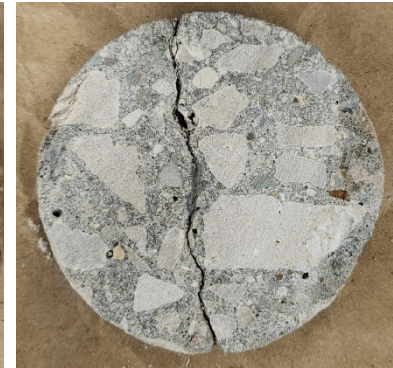
- ❑ A pond was attached to the bottom surface of the core and filled it with a blue dye mixed water for 8 to 10 hrs to evaluate the integrity of the sealed crack.
- ❑ After removing the ponds and allowing the cores to get dried for 24 hours, the specimen was sliced starting from the top surface (the surface with the overlay).
