Structural Rehabilitation of Culverts Using UV-Cured CIPP Liners

Where Trenchless Rehabilitation Fits in Bridge & Culvert Maintenance

Mike Czartoszewski – Pipeline Management

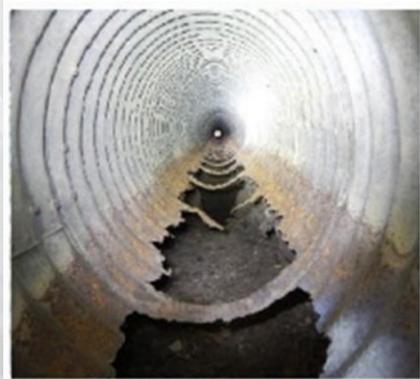
(b) Invert Abrasion

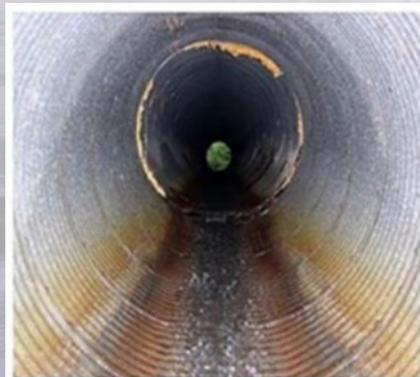
(a) Corrosion of Invert

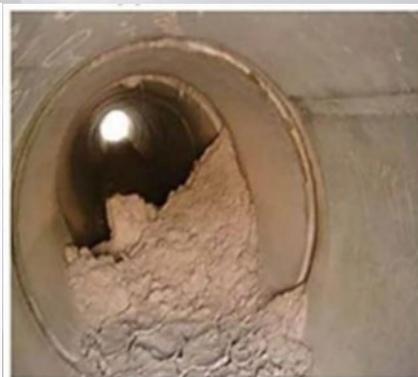
(e) Joint Infiltration

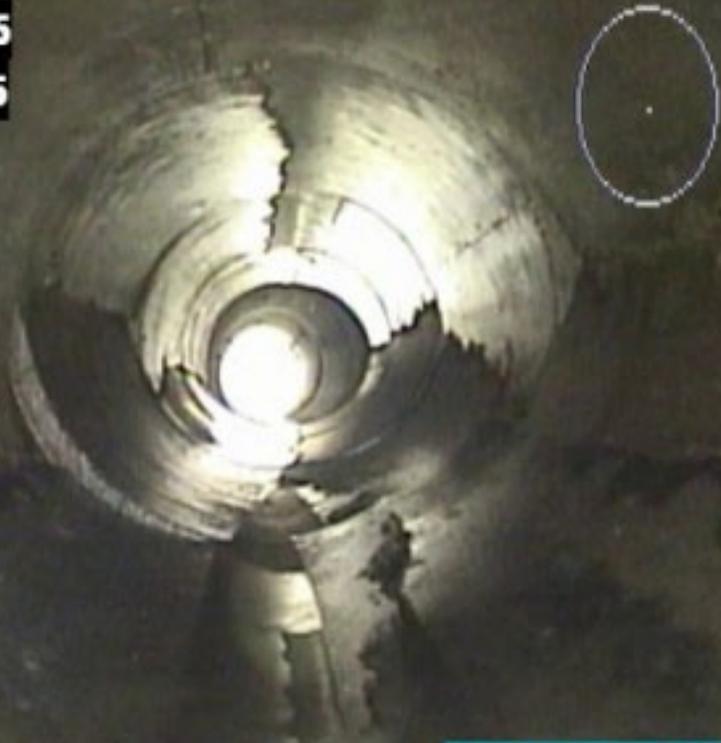
USMH: A 13475+35
DSMH: B 13475+35

24" RCP w/ Longitudinal Cracking

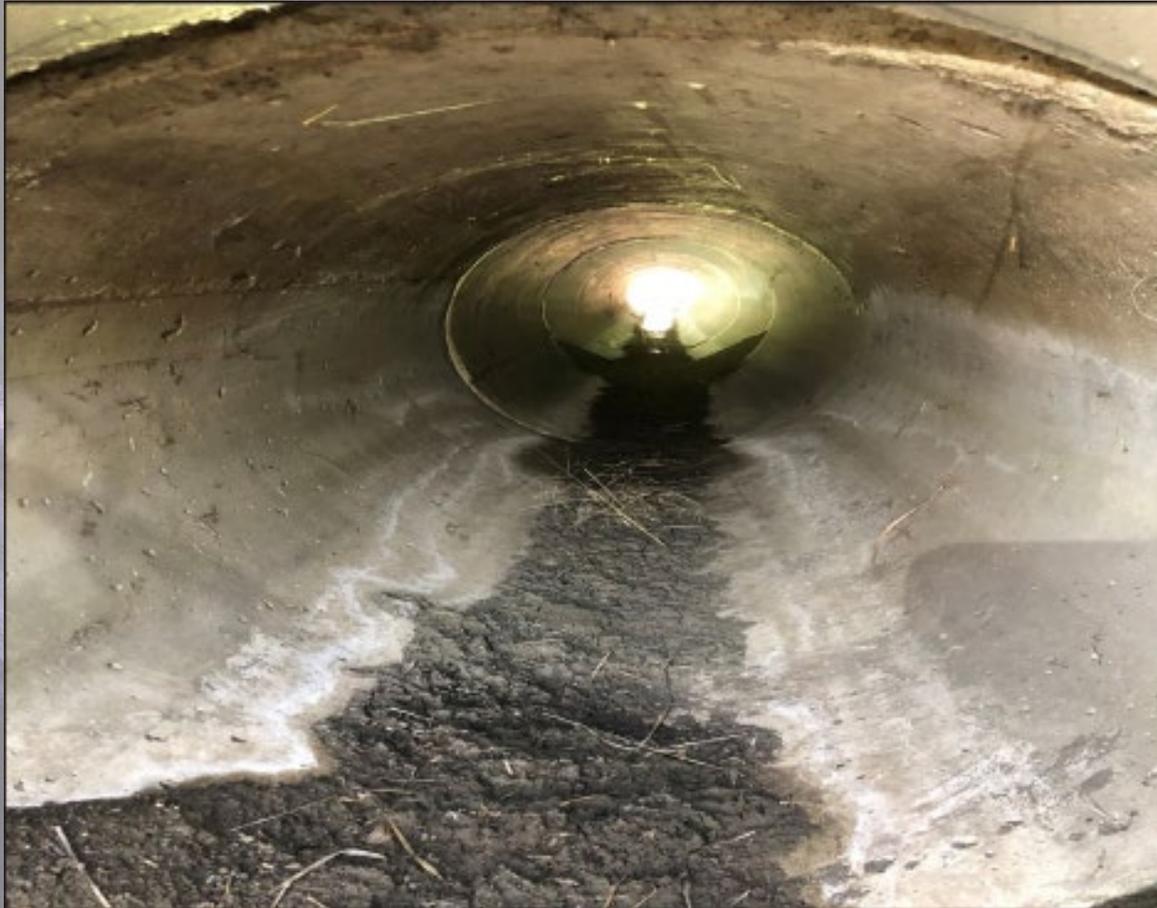
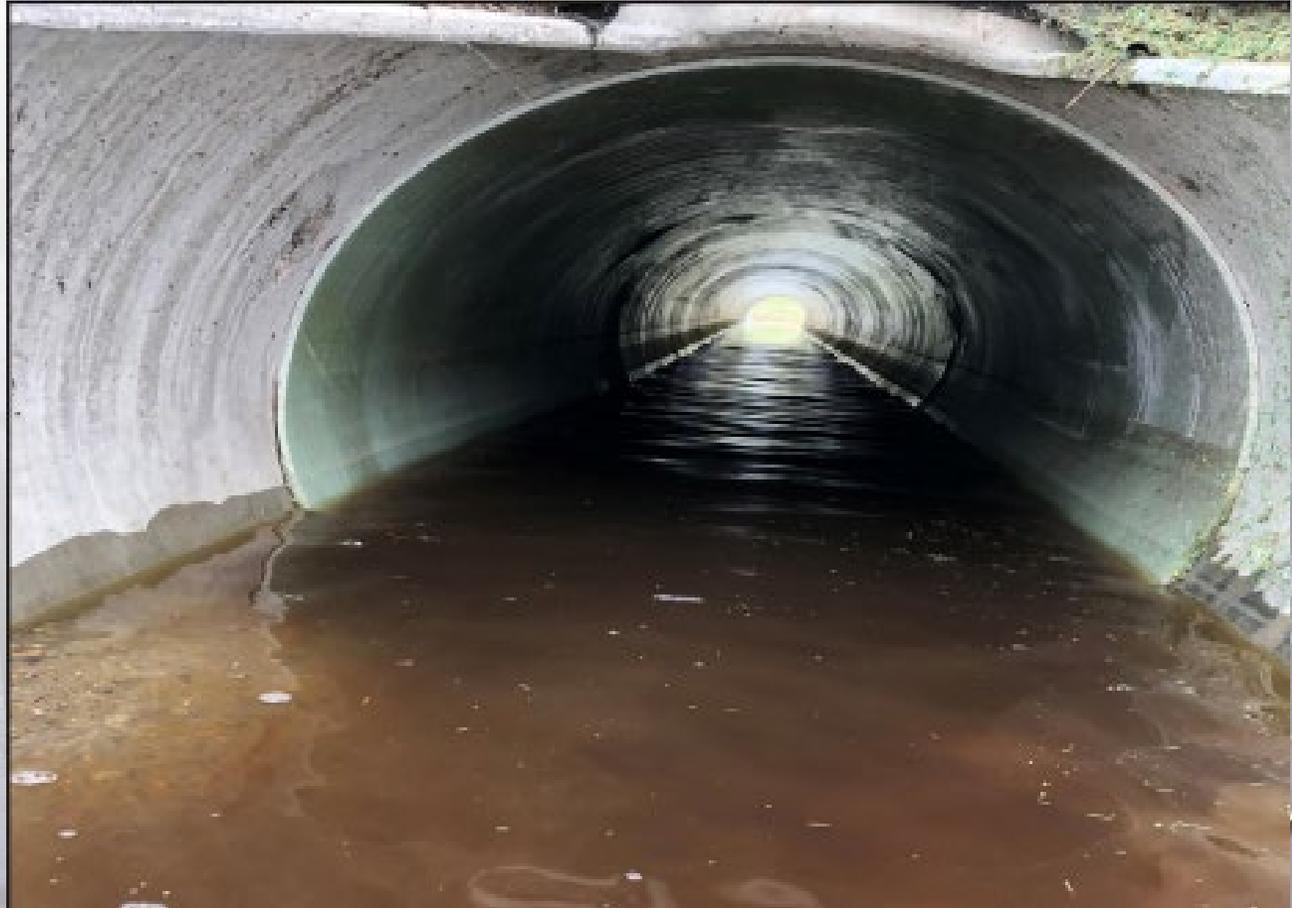
**30" RCP w/ Joint
Separation**

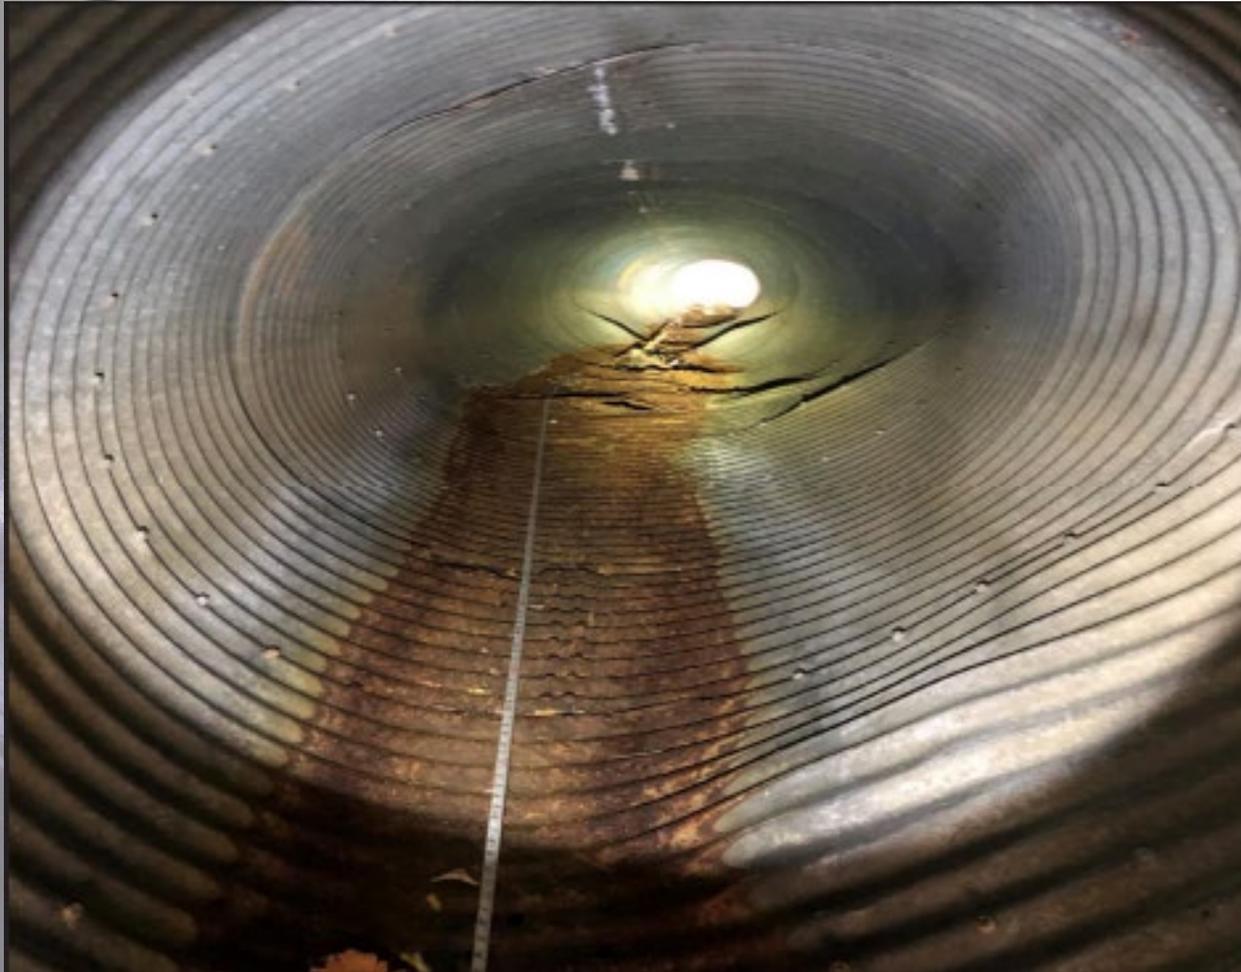
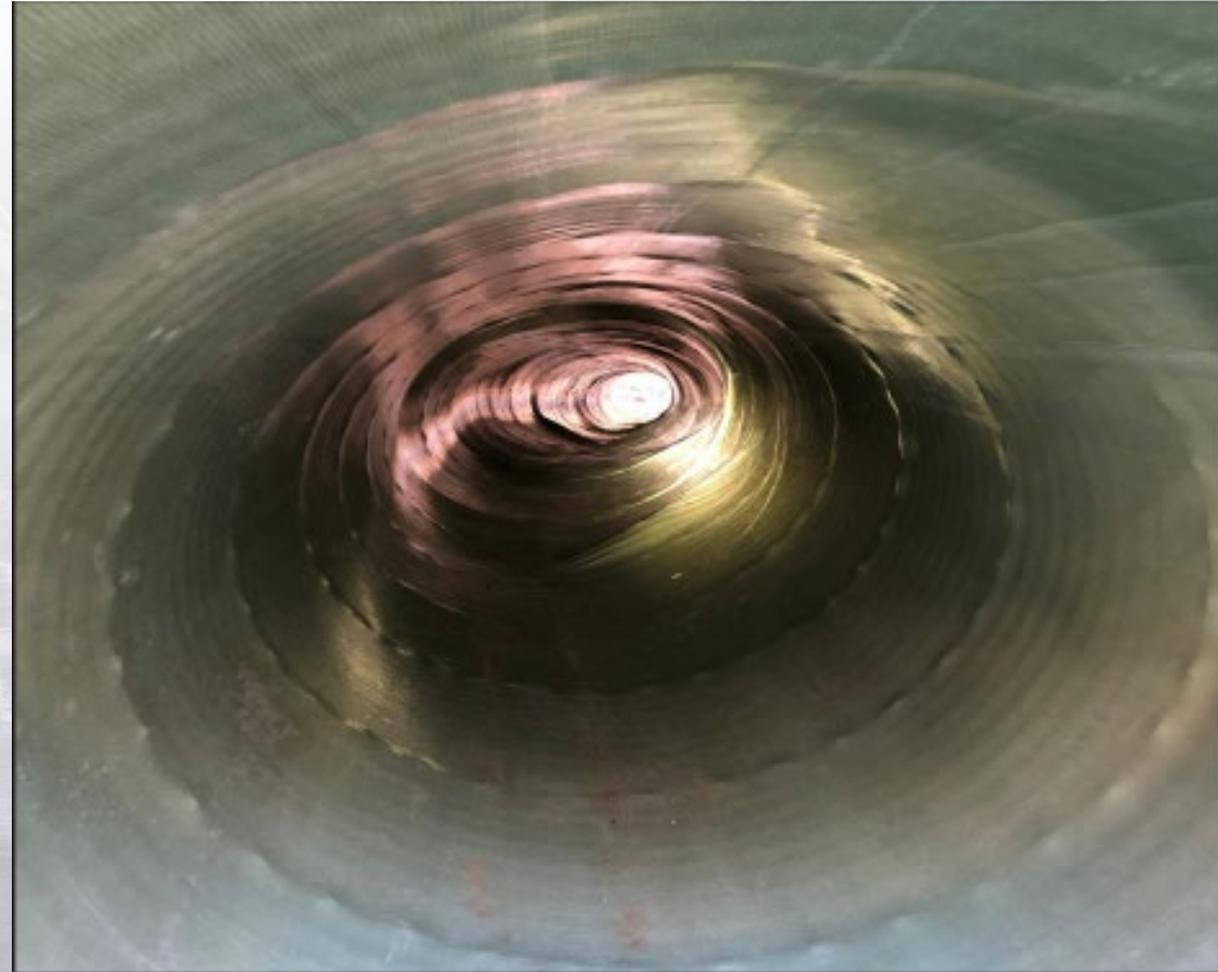
**54" CMP w/
Abnormalities**

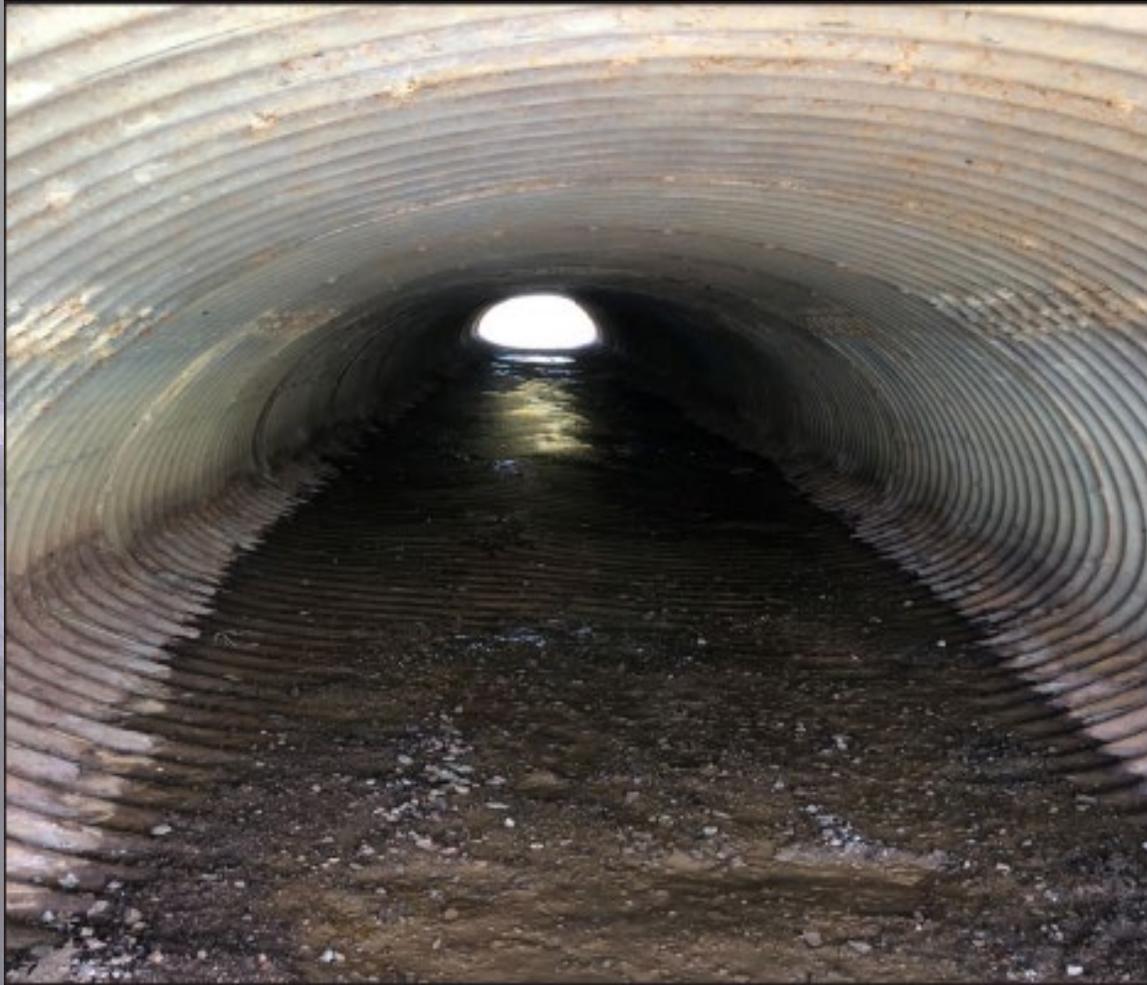
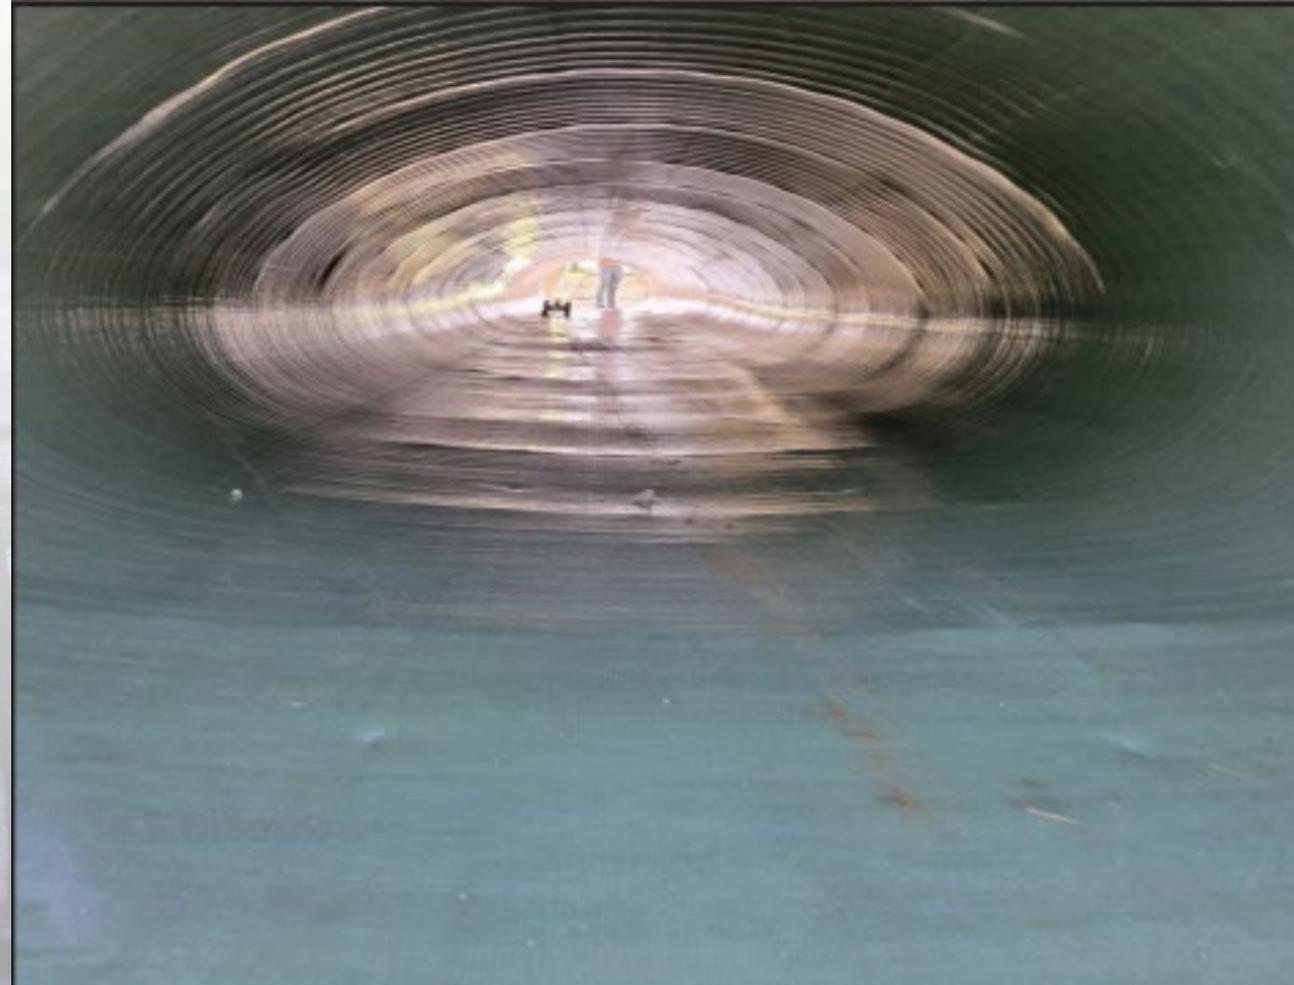
48" Arch Pipe

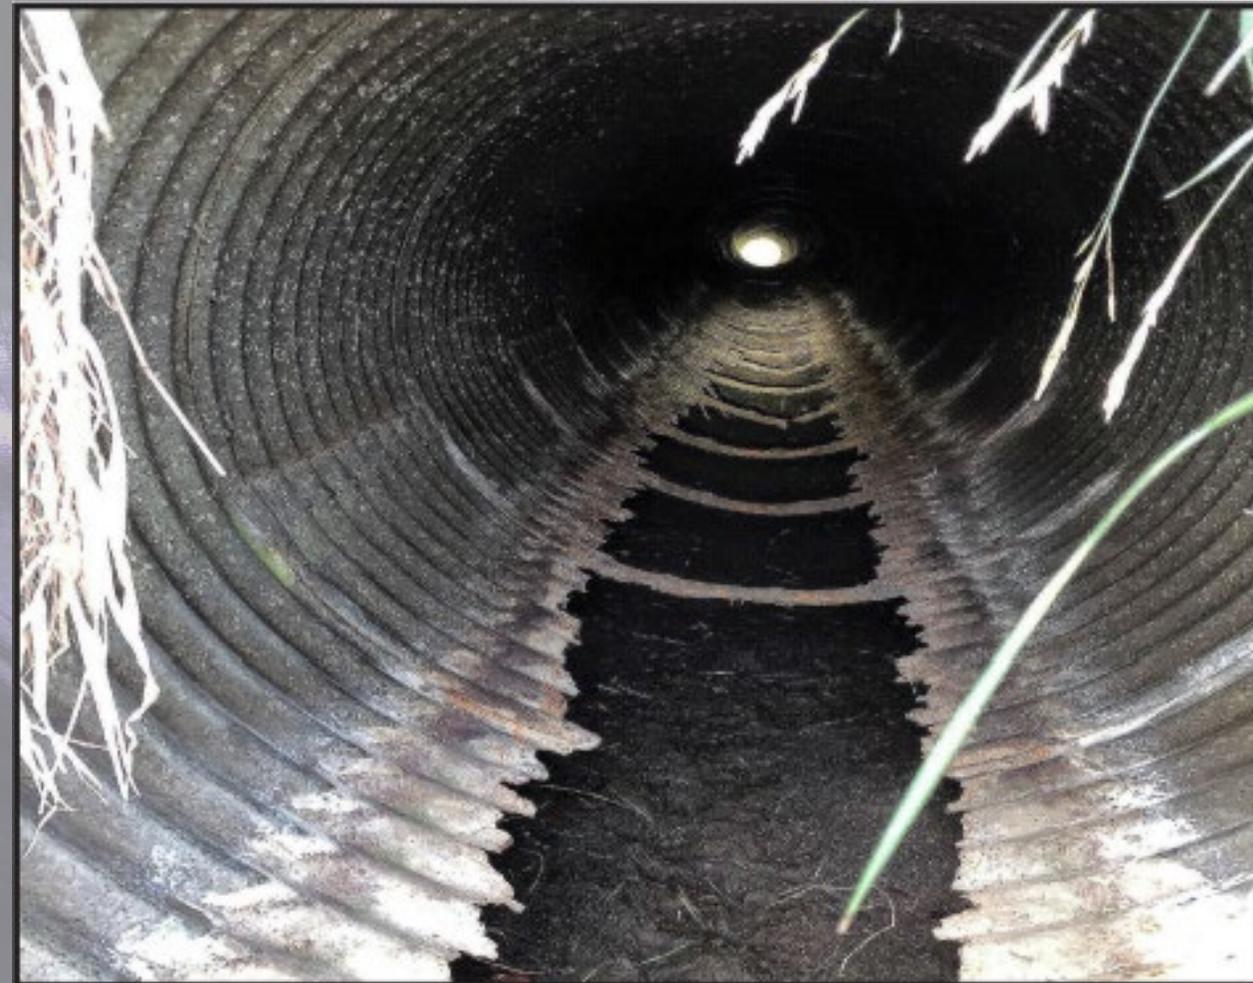
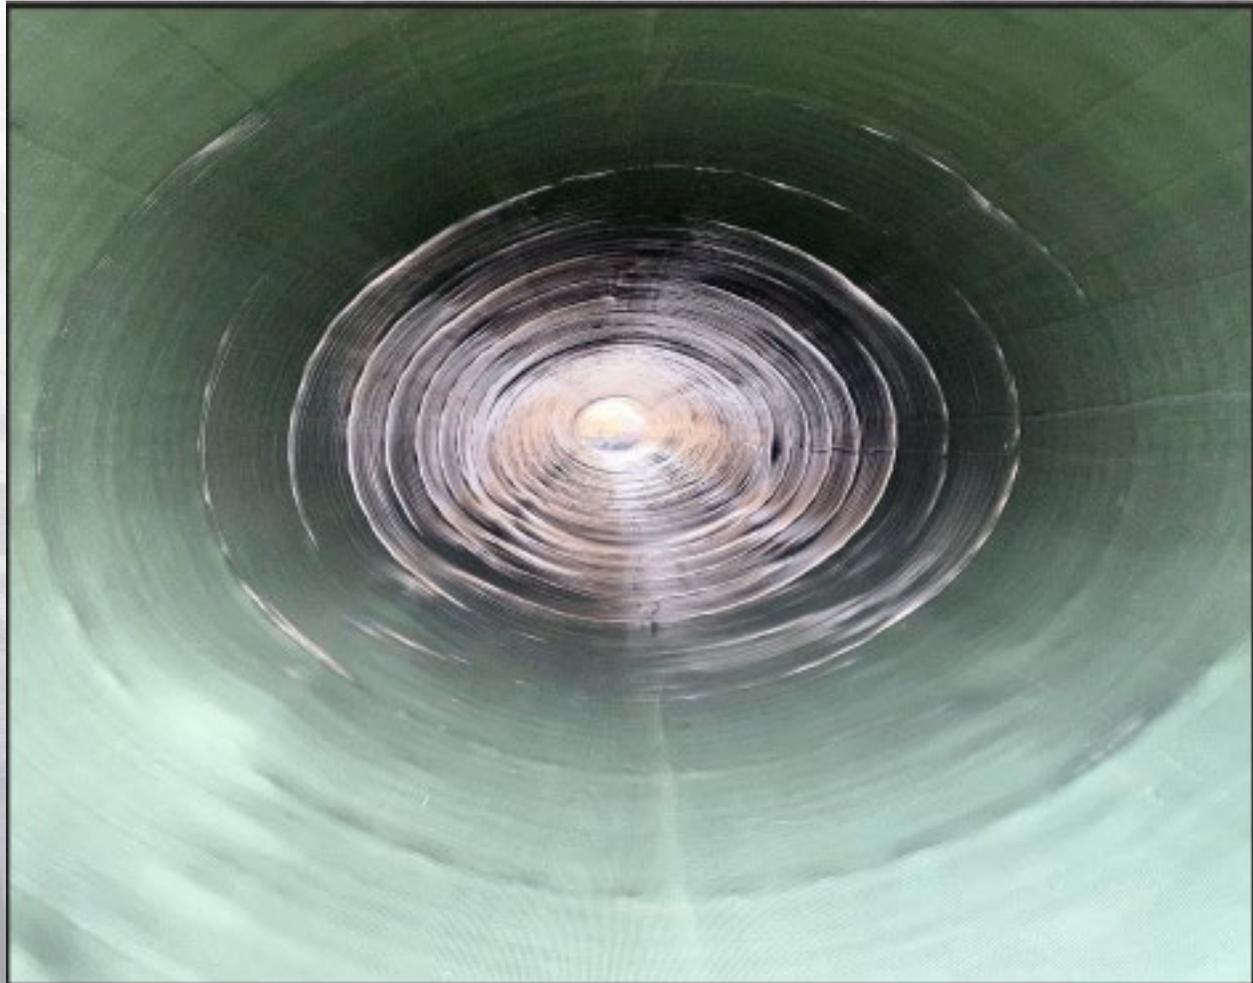
**CMP w/ Deteriorated
Invert**
