2018

Michigan Local Agency Culvert Inventory Pilot Evaluation Report

PURPOSE OF LOCAL AGENCY CULVERT INVENTORY PILOT

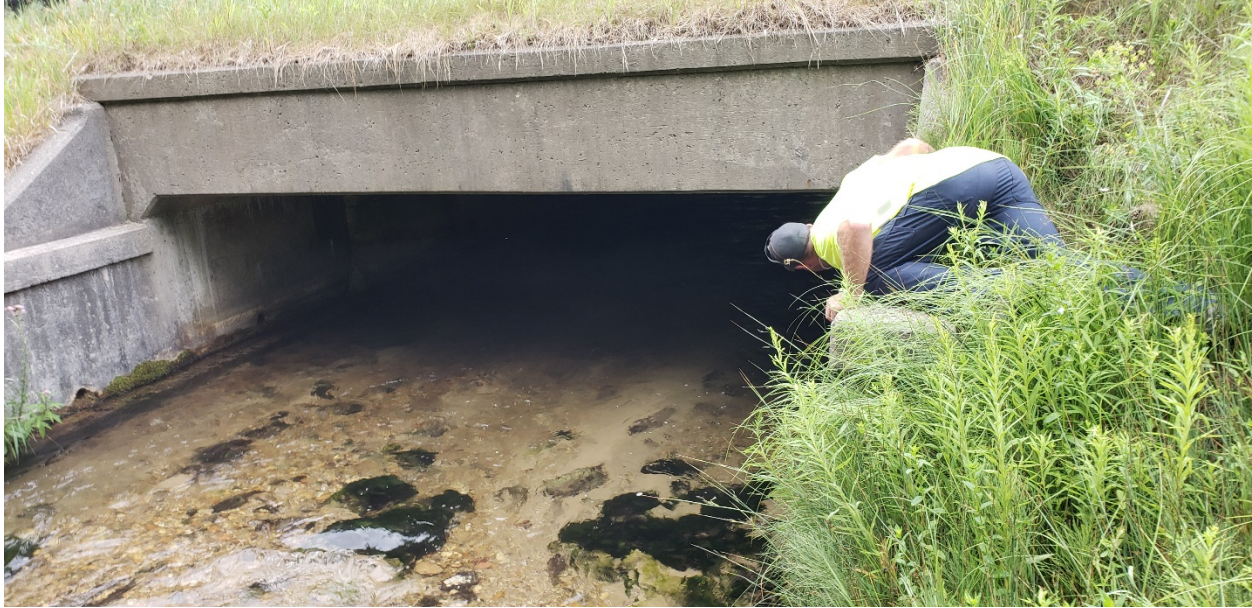
Figure 4-1: Antrim CRC inspecting a concrete box culvert

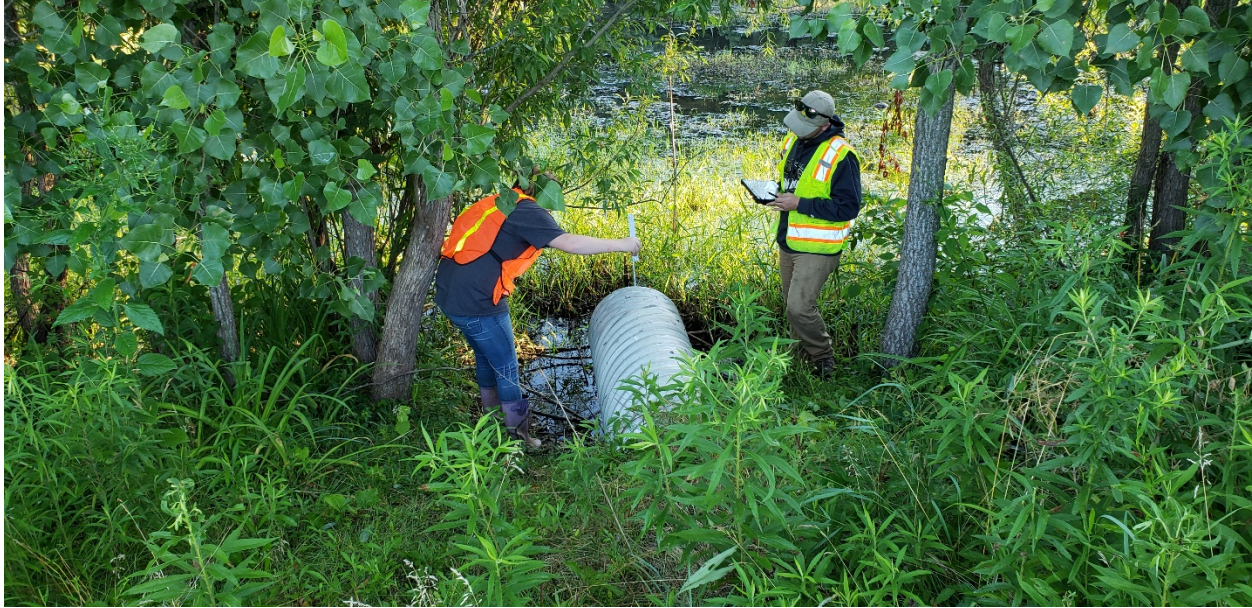
Figure 6-1: The Van Buren CRC collected stream crossing survey information in addition to collecting data for the pilot project

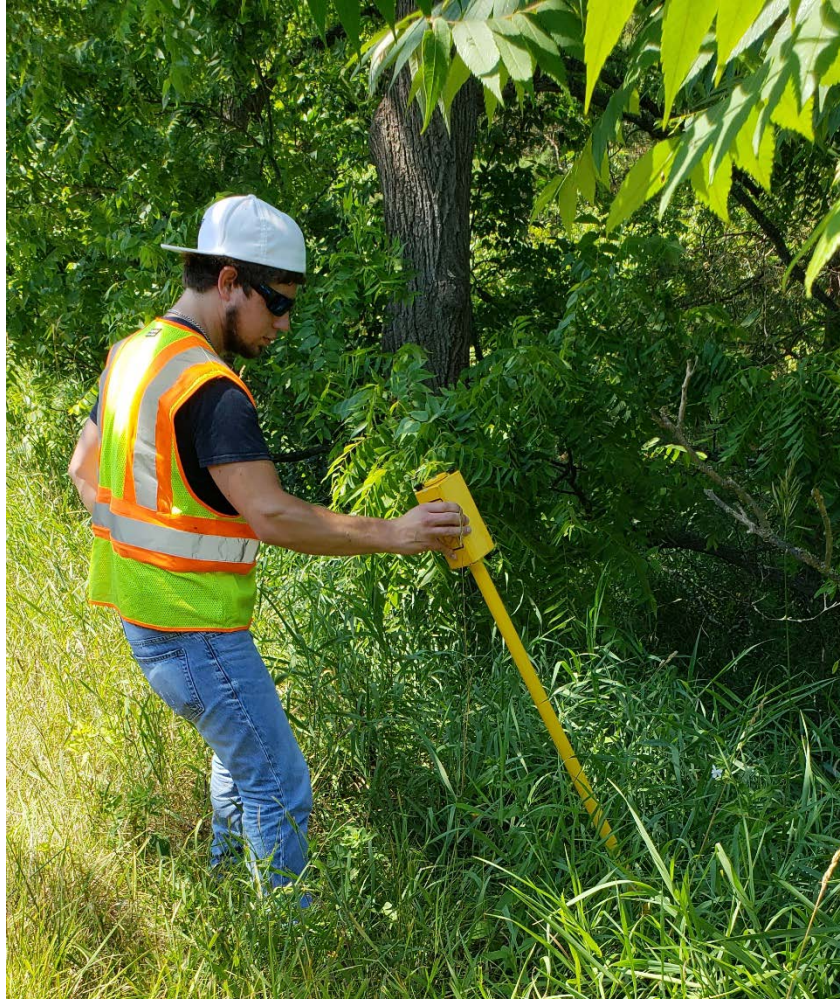
Figure 6-2: Oceana CRC using a metal detector to try and locate a culvert

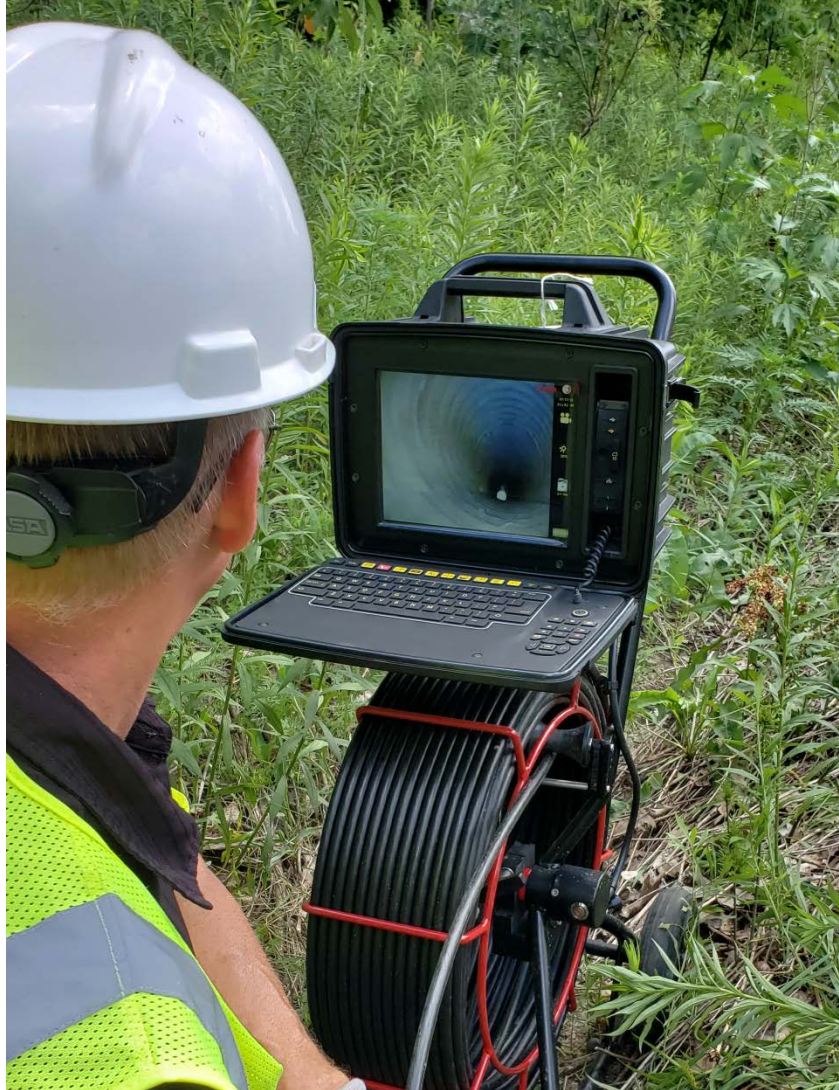
Figure 6-4: The Road Commission for Kalamazoo County used a sewer camera to inspect some culverts
