2018 Michigan Local Agency Pavement Treatment Life Study

Michigan
Transportation Asset
Management Council

Michigan Technological University

October 25, 2018

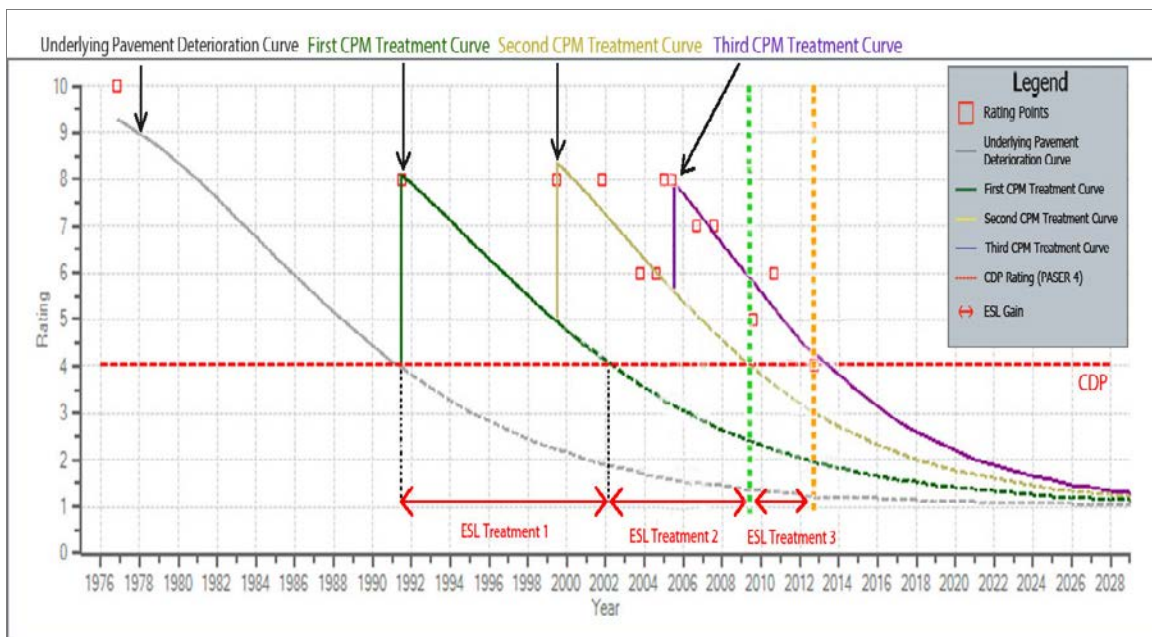
Figure 1: Example of multiple chip seal treatments. Note the diminishing ESL with successive treatment applications.

Modeling the extended service life resulting from repair treatments can effectively illustrate the value gained by applying repair treatments (Colling, Kiefer, & Farrey; 2014). Figure 1 shows a pavement that has been maintained in fair condition for nearly 22 years with three successive chip seal applications.

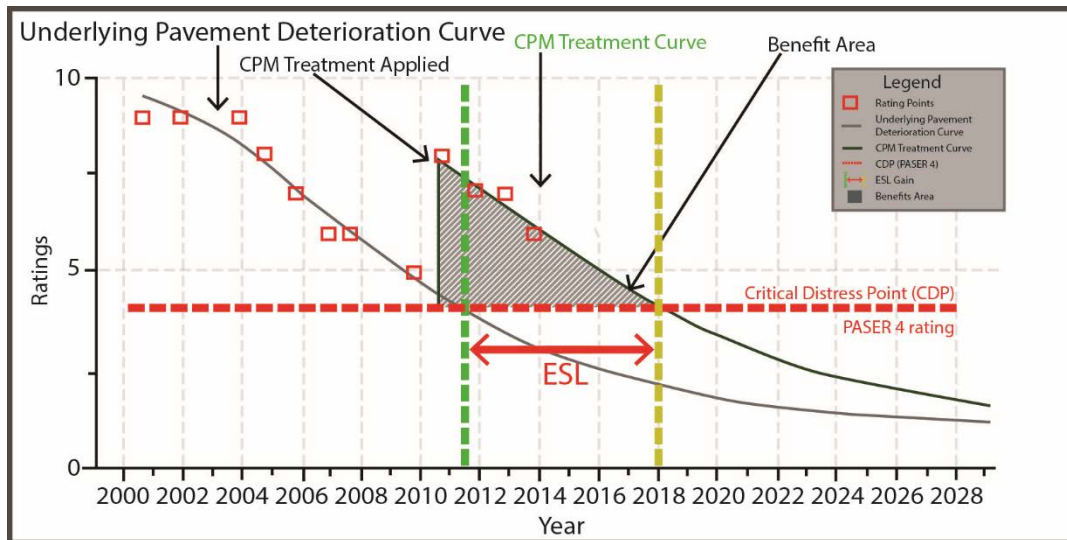
Figure 2: Example deterioration curve for the underlying pavement and subsequent repair treatment

The following terms refer to elements of the pavement deterioration curves¹:

Underlying pavement deterioration curve: deterioration for the asphalt pavement prior to repair treatment

Repair treatment curve: deterioration for the asphalt pavement following the application of a repair treatment

Treatment applied: the time when the repair treatment was applied over the asphalt surface

Rating points: actual pavement condition ratings (using PASER) documented during TAMC data collection

Critical distress point (CDP): the PASER 4 line—when pavement deterioration changes from exhibiting age-related to structural distresses

Benefits area: the area above the CDP that lies between the underlying pavement deterioration curve and the repair treatment curve.

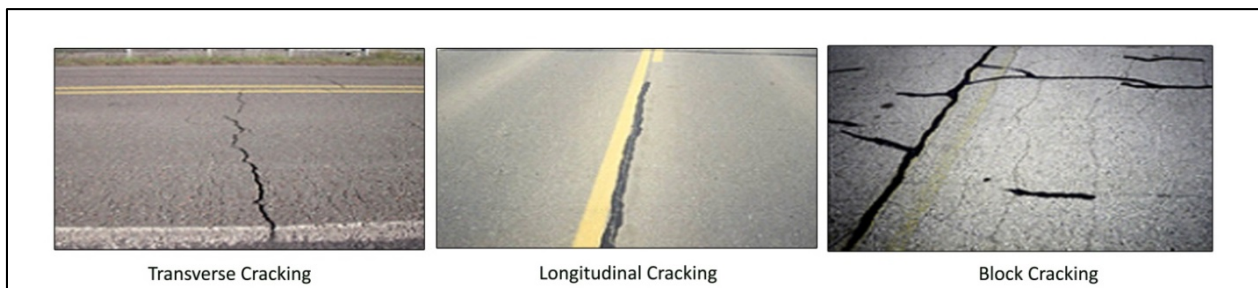
Figure 3: Age-related distresses

Age-related distresses result from exposure to the environment over time. The primary environmental factors driving age-related distresses are water (which enters the pavement structure and weakens it), ultra-violet light, and atmosphere (which causes degradation of the asphalt binder and subsequent hardening). Asphalt binder is the “glue” that holds together the aggregates in an asphalt pavement. As the asphalt binder hardens, it becomes less flexible and is subject to cracking from tensile forces that develop during low-temperature events when the pavement contracts. Cracking allows the intrusion of water into the underlying pavement structural layers. Excess water makes the aggregate base and sub-base layers less rigid, which results in a larger magnitude displacement of the pavement layers at a given load. Distressed asphalt is then subject to increased vertical displacement of the pavement due to traffic loads, causing increased cracking and structural damage to the asphalt layer. Examples of age-related distresses include transverse cracking, longitudinal joint cracking, and block cracking (Figure 3). These cracks are “non-working” cracks: the pavement on each side has the ability to transfer load from one side of the crack to the other so the pavement on each side moves in unison as a load passes over.

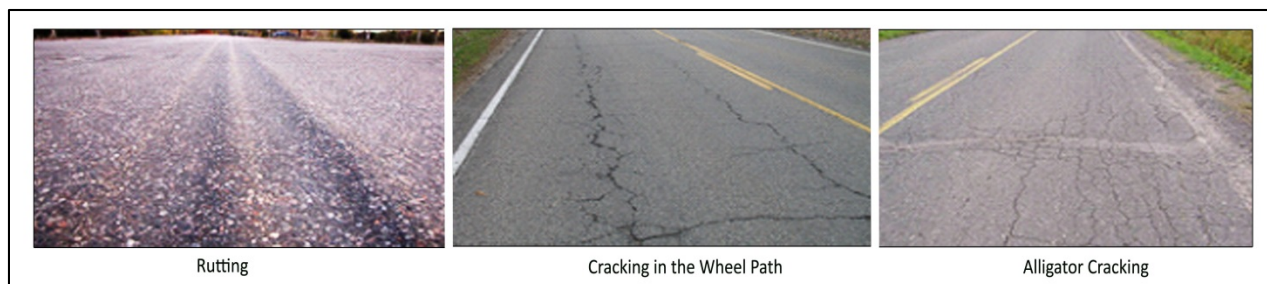
Figure 4: Structural distresses

Structural distresses can occur at any time in the life of a pavement. These distresses typically result from traffic loading. Traffic loads in excess of the pavement’s design load can speed the occurrence of structural distress. Examples of structural distresses include rutting, cracking in the wheel path, and alligator (fatigue) cracking (Figure 4). Structural-distress-related cracks are “working” cracks: the pavement on each side of a working crack moves independently as a load passes over. Capital preventive maintenance treatments are not structural in nature and, therefore, have a limited ability to span and maintain continuity across a working crack.

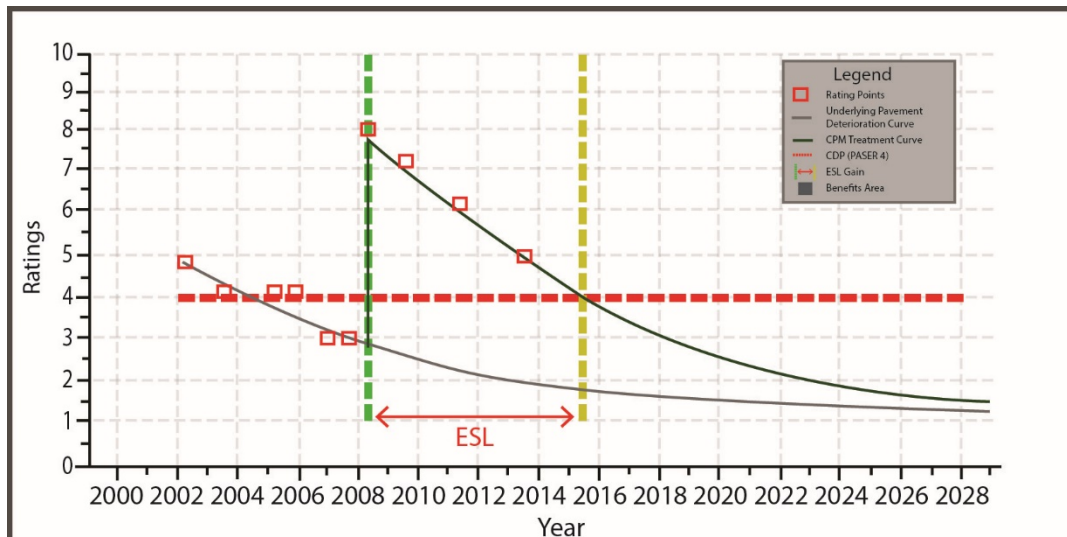
Figure 5: Example segment showing ESL with a positive improvement (gain) resulting from repair treatment and a decrease in pavement condition over time. In this instance, the underlying pavement deterioration curve crosses the CDP (PASER 4 line) prior to the pavement receiving a repair treatment.

Measuring the ESL created by a given treatment can help determine the benefit of repair treatments. ESL is the additional time in years that the pavement is above the CDP—or the additional time in years before the pavement experiences structural distresses (PASER 4 or below)—due to the repair treatment (Figure 5). This method evaluates the additional time before a pavement needs expensive treatments like rehabilitation or reconstruction. The ESL benefit directly affects the cost of roadway maintenance since it creates a tangible extension in pavement life.

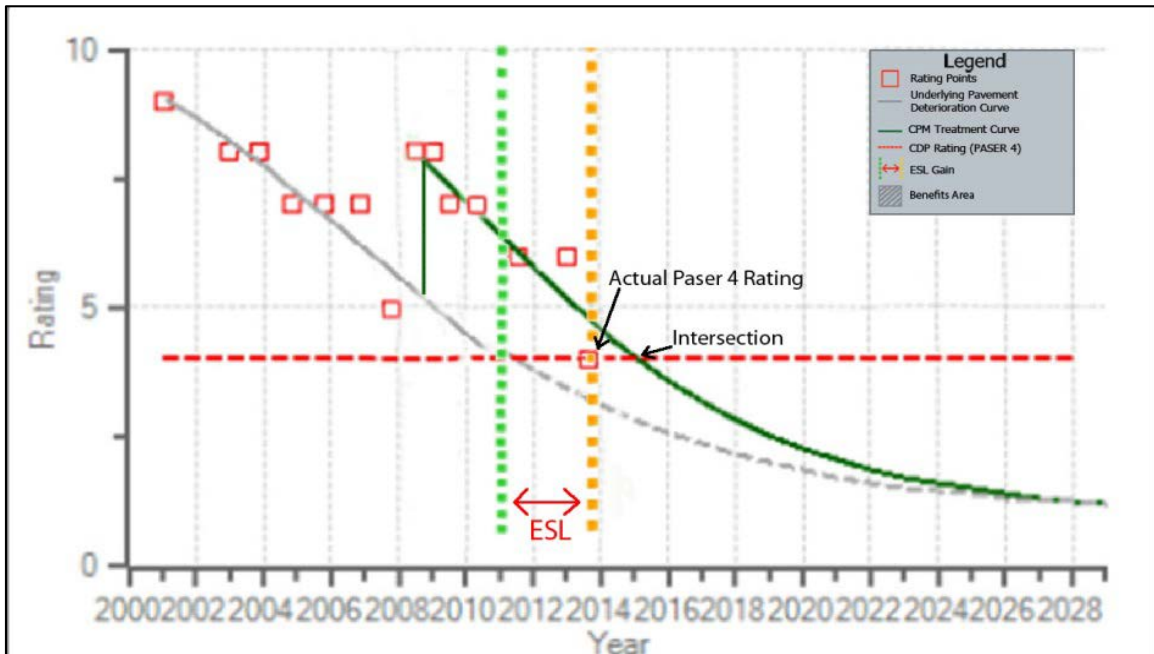
Figure 6: PASER 4 following repair treatment

regardless of where the repair treatment curve intersected the CDP (Figure 6). This was an additional conservative measure to eliminate modeling effects.

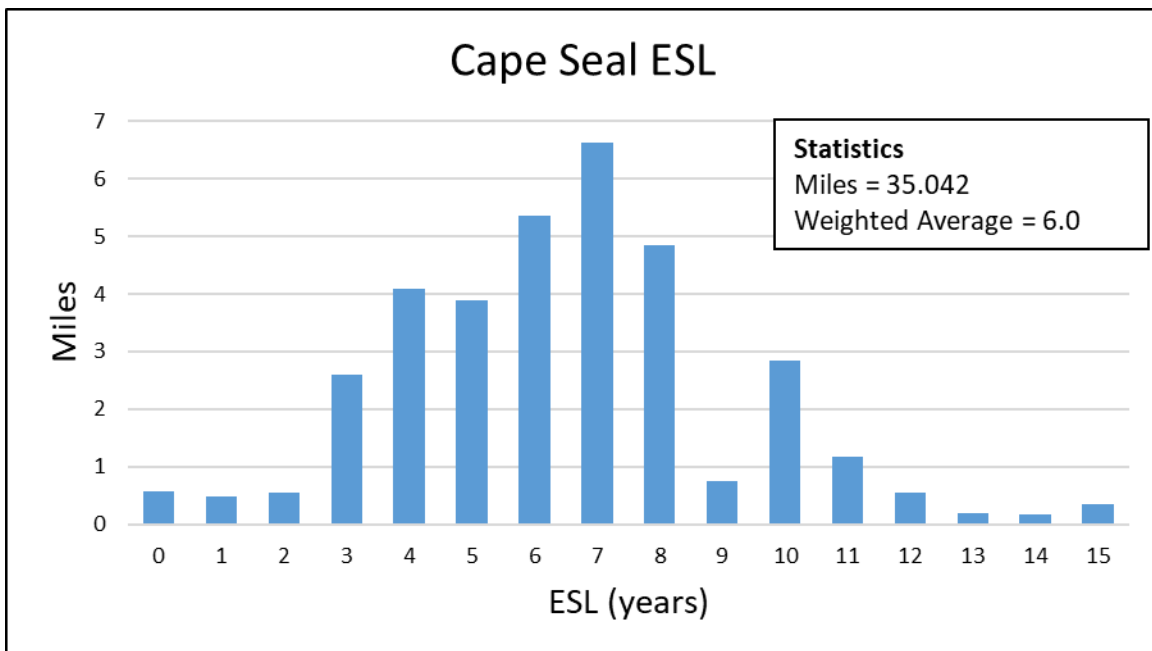
Figure 7: Cape seal qualifying miles distribution by ESL

Figure 7 shows a fairly-uniform bell-curve shaped distribution with the most frequently observe cohort of seven years of ESL. This is indicative of a normally distributed data set. The box plot of this data is depicted in Figure 8 which illustrates the distribution of data points. The non-weighted average is represented as a blue line and the median is represented as a black line in Figure 8. The left side of Figure 8's black skeletal box plot represents the first quartile, the center is the median, and the right side is the third quartile. Black tick marks represent the minimum and maximum on the left and right side, respectively. The black dashed-line area illustrates the 95% confidence interval containing the median; the blue dashed-line area is the 95% confidence interval containing the unweighted average. The blue dashed-line area centers over the unweighted average. Since these data points are not weighted by miles, the box plot and mean plot will show a skew due to segment length.

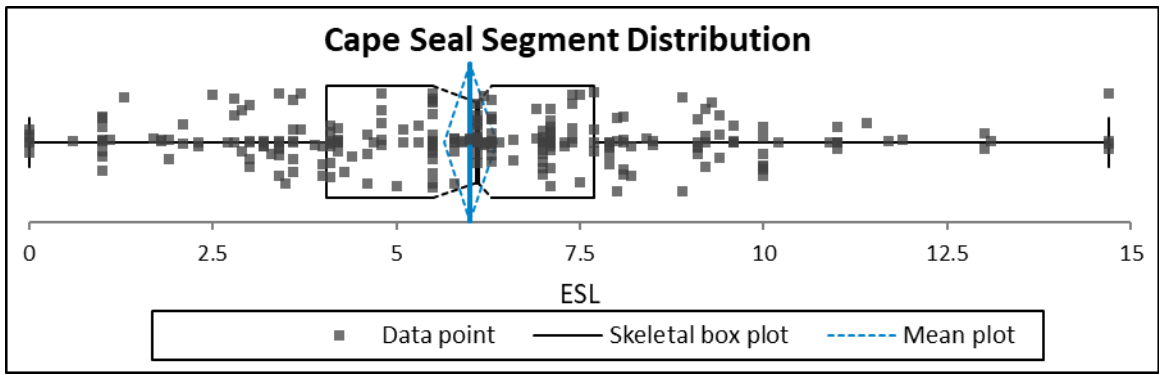
Figure 8: Cape seal non-weighted average ESL segment distribution

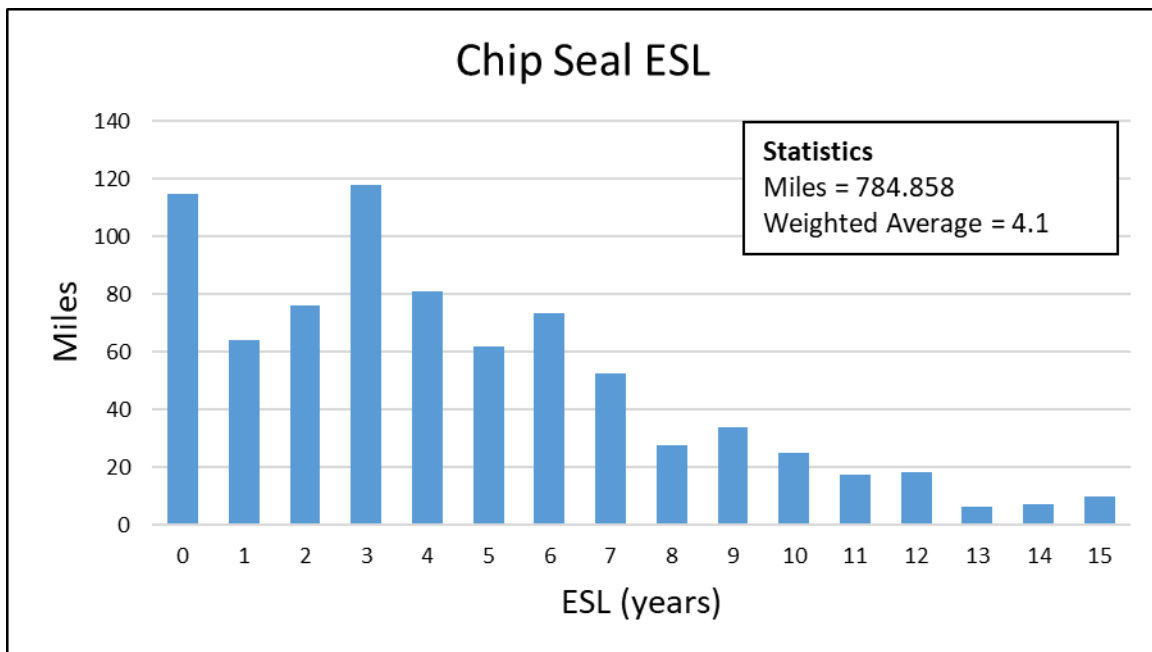
Figure 9: Chip seal qualifying miles distribution by ESL

As Table 2 indicates, chip seals meeting the selection criteria totaled 784.858 miles (1,263.107 kilometers). Twenty-one agencies indicated use of chip seal; their total segment count was 2,372. A fairly-uniform trend in a histogram plot of increasing ESL values indicates that ESL gains of over 9 years are uncommon and ESL gains between 0 and 7 years are frequent (Figure 9). This data set did have 114.59 miles (184.415 kilometers) with an ESL gain of zero, which is depicted as 364 segments in Figure 10. The weighted average ESL for the data set was 4.1 years and is the same weighted average that was found in the 2014 ESL study (Colling, Keifer, & Farrey; 2014) using different data sets and different local agencies. This weighted average accounts for instances where no ESL was gained by the treatment.

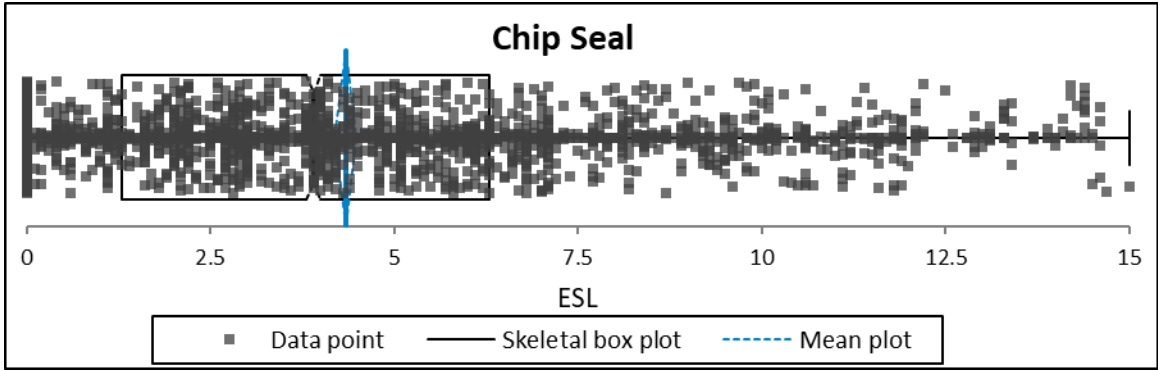
Figure 10: Chip seal non-weighted average ESL segment distribution

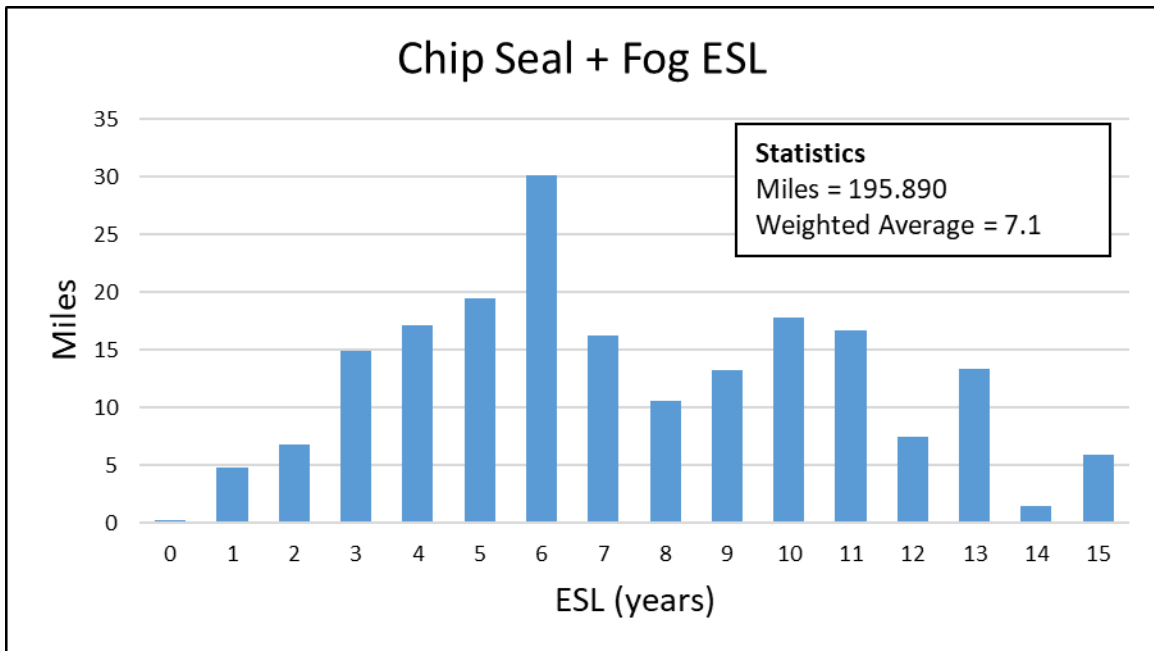
Figure 11: Chip seal plus fog seal qualifying miles distribution by ESL

This combination treatment was specifically identified in the data set and analyzed separately. Chip seal plus fog seal treatments that met the selection criteria totaled 195.890 miles (315.254 kilometers) (Figure 11). Ten agencies included this treatment as a distinct data set; with a total segment count of 514. Figure 11 shows a total of 44.769 miles (72.049 kilometers) of chip seal plus fog seal that have over 10 years of ESL, which is 22.8% of this data set. Another interesting find is that there is only 0.222 miles (0.357 kilometers) with zero ESL gain, which is significantly lower than standard chip seals. The weighted average ESL for the data set was 7.1 years. Of the six significant treatments, chip seal plus fog seal had the most change in ESL after adjusting for skew due to segment size; this can be shown when comparing the weight average of 7.1 years to the non-weighted average of 6.4 years. Figure 12 shows the non-weighted data points for chip seal plus fog seal treatment.

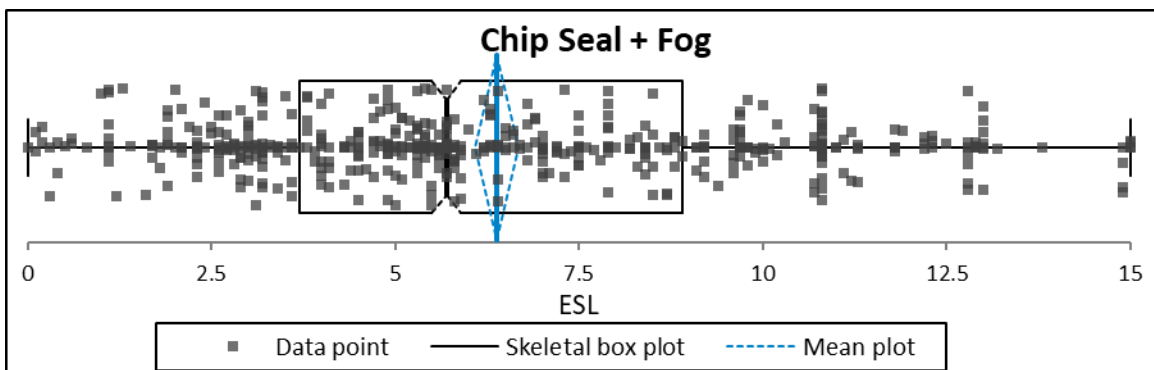
Figure 12: Chip seal plus fog seal non-weighted average ESL segment distribution

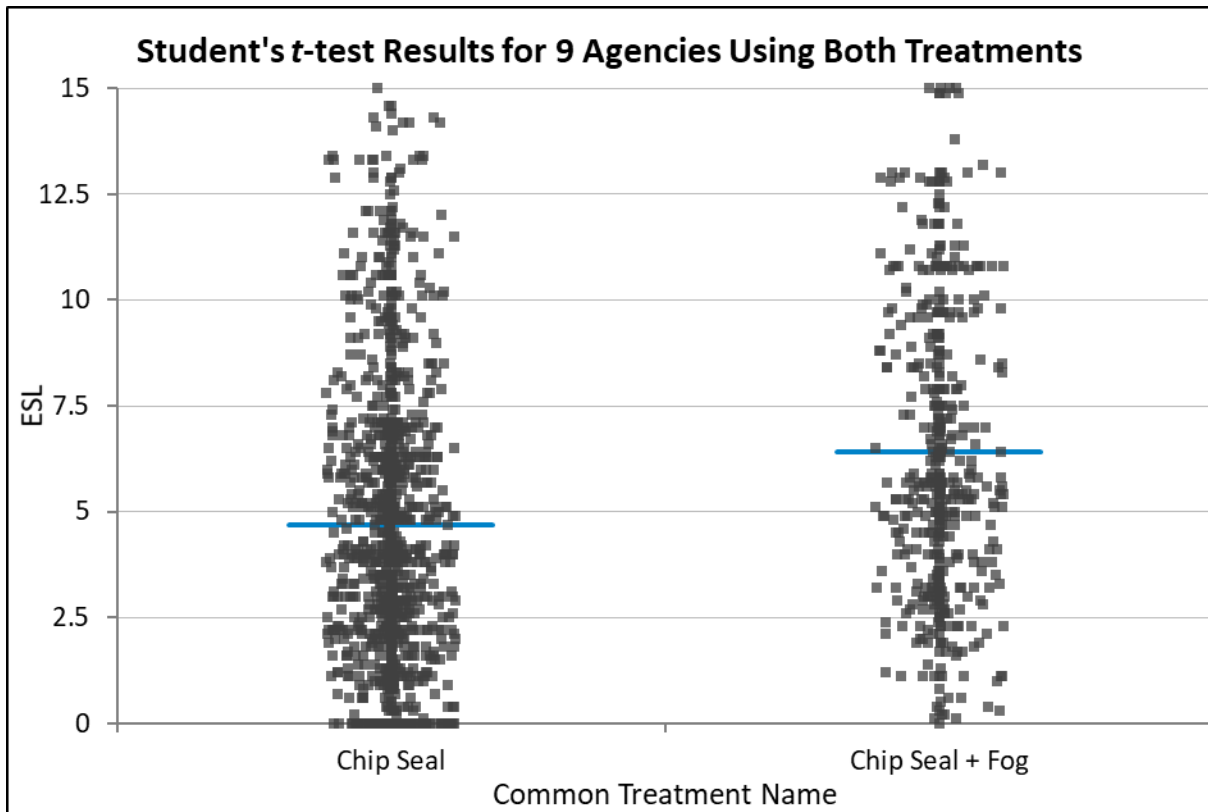
Figure 13: Chip seal vs. chip seal plus fog seal non-weighted average ESL segment distribution

An interesting finding was the increased ESL for placing a fog seal on top of a chip seal. Twenty-one agencies used chip seal alone and had a weighted average ESL of 4.1 years. Ten agencies used chip seal plus fog seal and had a weighted average ESL of 7.1 years; nine of these agencies used both chip seal and chip seal plus fog seal. The nine agencies were analyzed separately to minimize uncontrollable factors influencing treatment life (Figure 13 and Table 3). Applying the Student's *t*-test analysis to the central tendency of the two treatments—chip seal and chip seal plus fog seal—used by these nine agencies revealed that their average ESL gains are statistically significant. This means that there are differences in the central tendency (average ESL) for both of these treatments that is not a result of the variability of the data. The non-weighted average ESL gain for chip seal plus fog seal was 1.7 while the weighted average ESL gain was 2.9 years.

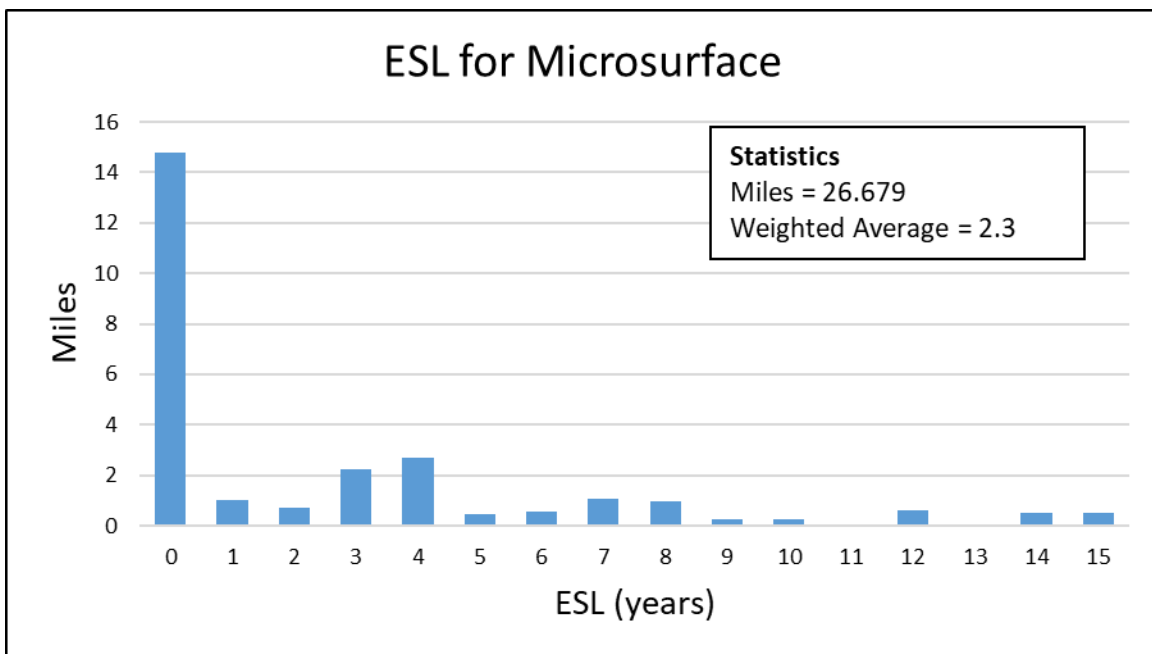
Figure 14: Microsurface qualifying miles distribution by ESL

Microsurface treatment meeting the selection criteria totaled 26.679 miles (42.936 kilometers) (Figure 14). Three agencies indicated use of microsurface; their total segment count was 129. The weighted average ESL for the limited data set was 2.3 years, however, this average ESL has an unacceptable margin of error due to the small number of segments available for analysis making the results inconclusive. Figure 15 shows the non-weighted average ESL median as 2.4 years and the mean as 2.9 years. The 2014 ESL study calculated a weighted average ESL of 5.4 years from a 7.9-mile (12.7-kilometer) data set (Colling, Kiefer, & Farrey; 2014). Whereas the 2014 study analyzed only one agency, this study analyzed three agencies' microsurface treatment segments. Both studies did not contain large enough sample sizes for microsurfacing to draw conclusions about the effectiveness of this treatment.

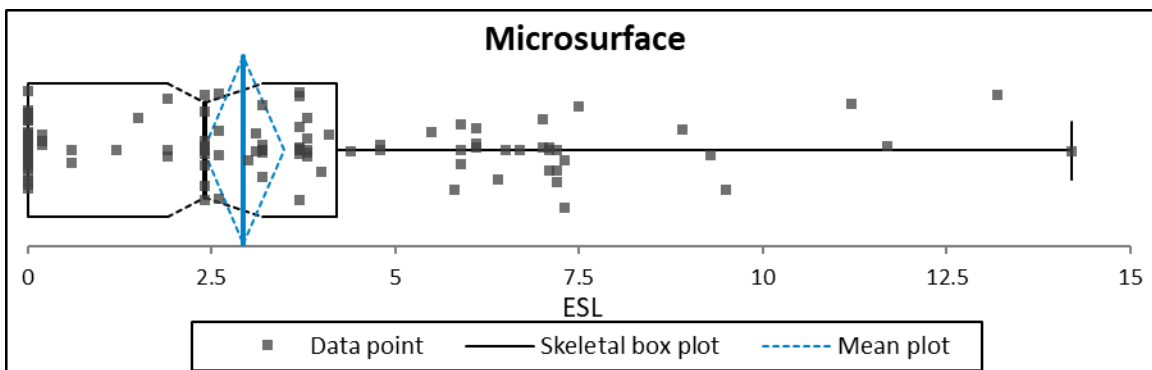
Figure 15: Microsurface non-weighted average ESL segment distribution

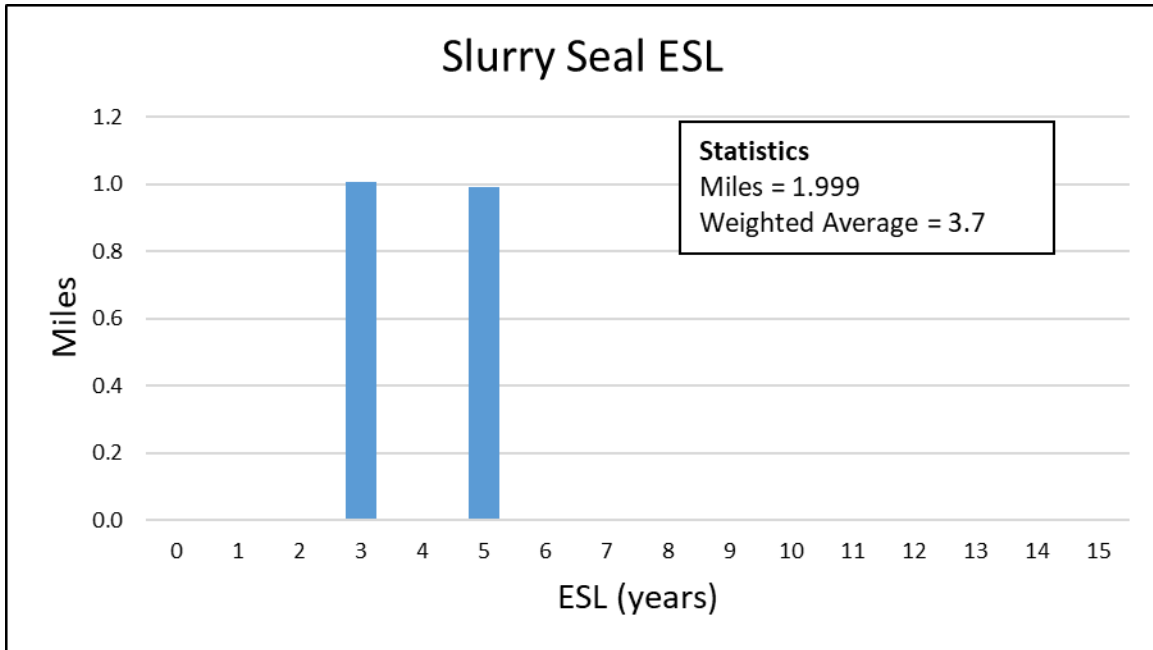
Figure 16: Slurry seal qualifying miles distribution by ESL

Slurry seal treatments meeting the selection criteria totaled 1.999 miles (3.217 kilometers) (Figure 16). One agency indicated use of slurry seal; their total segment count was 20. The weighted average ESL for the limited data set was 3.7 years, however, this average ESL has an unacceptable margin of error due to the small number of segments available for analysis making the results inconclusive (Figure 17).

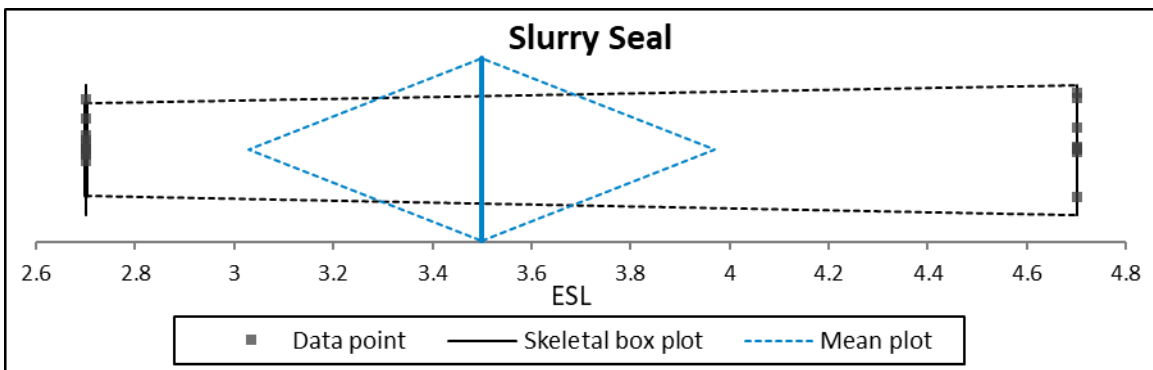
Figure 17: Slurry seal non-weighted average ESL segment distribution

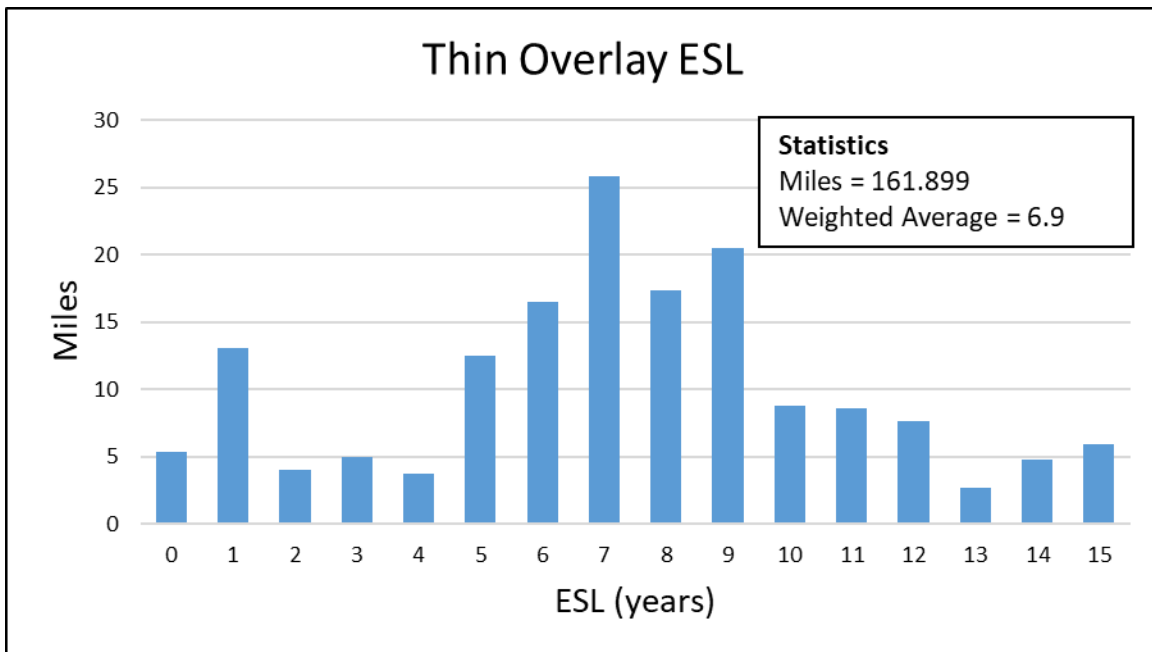
Figure 18: Thin overlay qualifying miles distribution by ESL

Thin overlay treatments meeting the selection criteria totaled 161.899 miles (260.551 kilometers) (Figure 18). Twenty agencies indicated use of thin overlay; their total segment count was 666. The weighted average ESL for the data set was 6.9 years. There were 8.071 miles (12.989 kilometers)—or 21 segments—having more than 15 years of ESL (ESL ranging from 16 to 36 years) and a weighted average ESL of 18.7 years; these segments were excluded from Figure 19. There could be many reasons (e.g. agency policy, traffic volumes, and, underlying distresses, more careful selection criteria) why the chip seal plus fog achieved a higher ESL weighted average as compared to thin overlay treatments, which could only be identified with a more intensive study.

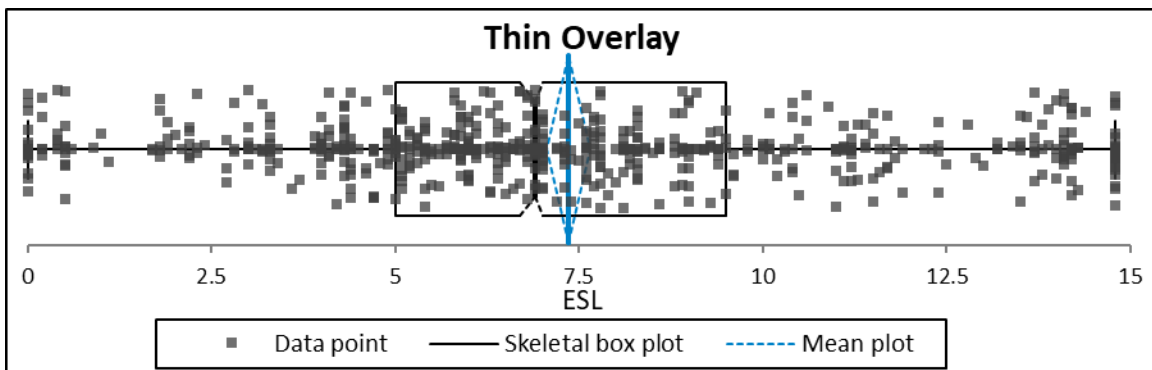
Figure 19: Thin overlay non-weighted average ESL segment distribution

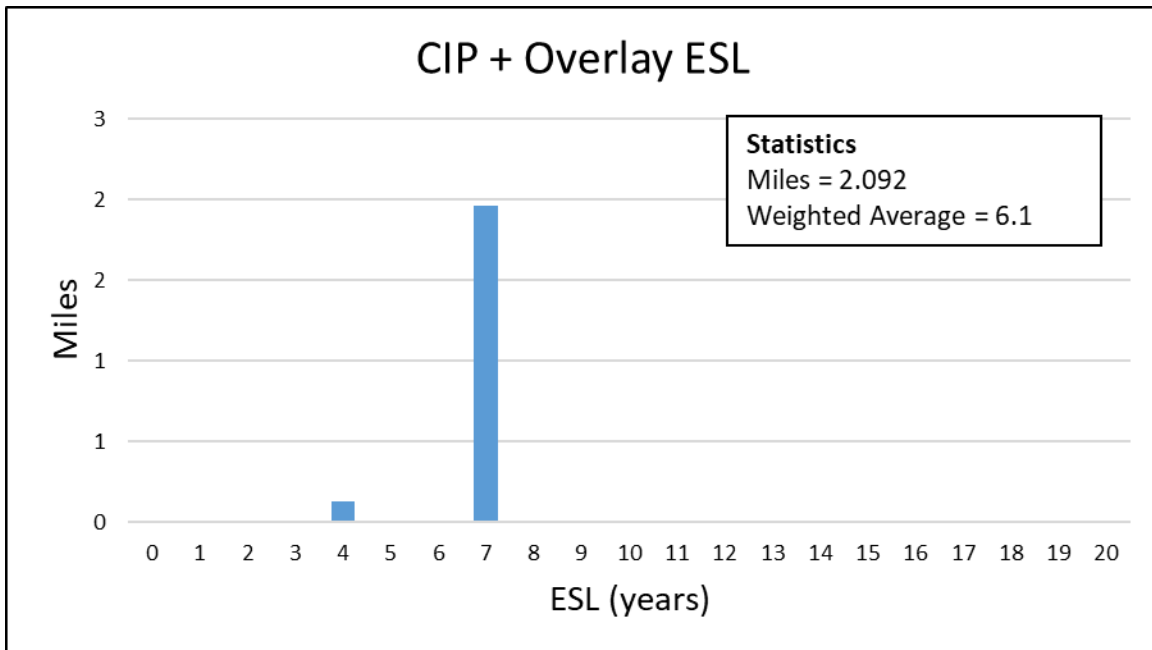
Figure 20: CIP plus overlay qualifying miles distribution by ESL

Cold-in-place (CIP) plus overlay treatments meeting the selection criteria totaled 2.092 miles (3.367 kilometers) (Figure 20). One agency indicated use of CIP plus overlay; their total segment count was 7. The weighted average ESL for the limited data set was 6.1 years, however, this average ESL has an unacceptable margin of error due to the small number of segments available for analysis making the results inconclusive (Figure 21).

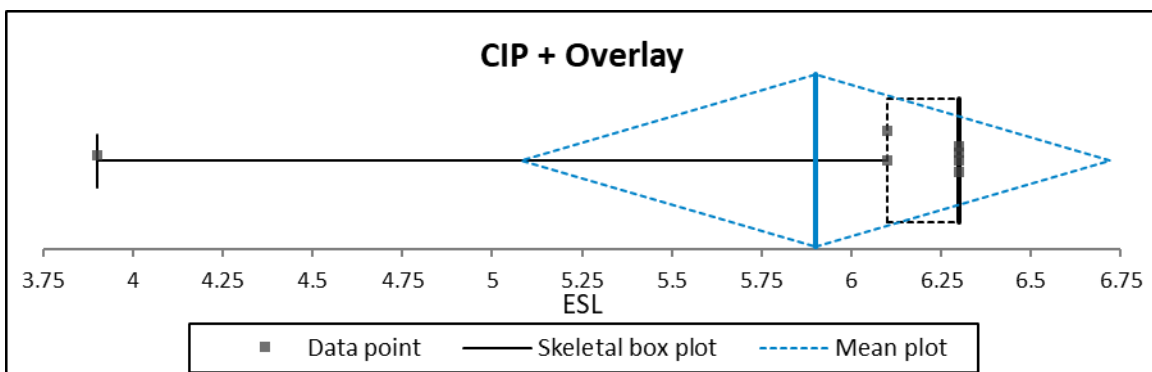
Figure 21: CIP plus overlay non-weighted average ESL segment distribution

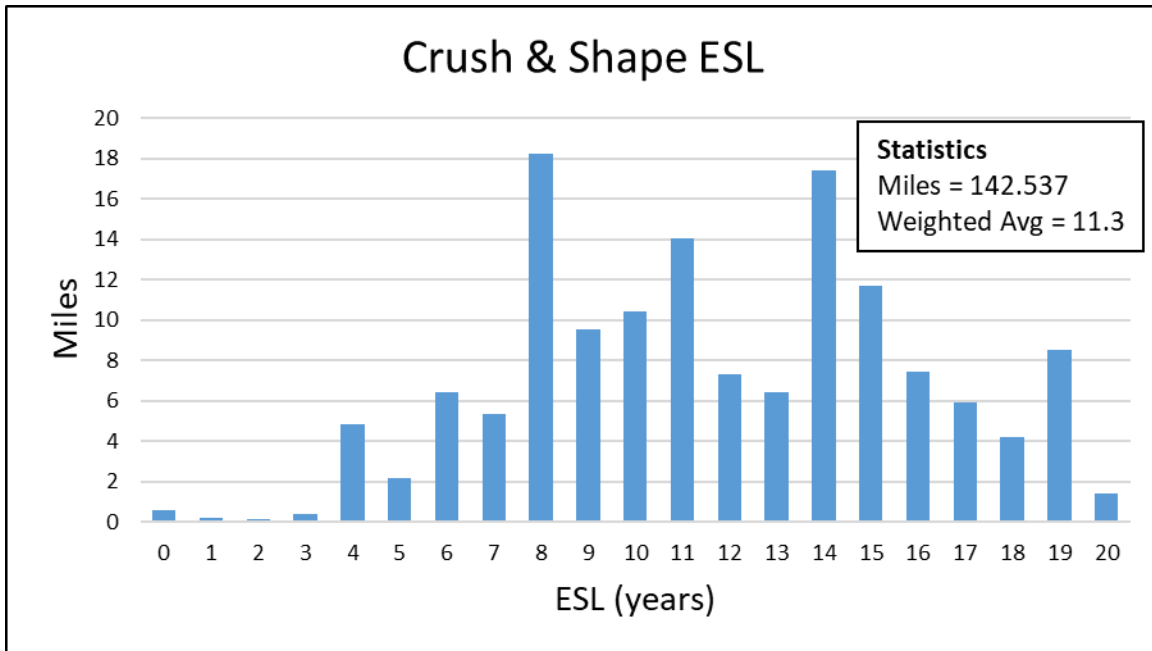
Figure 22: Crush and shape qualifying miles distribution by ESL

Crush-and-shape treatments meeting the selection criteria totaled 142.537 miles (229.391 kilometers) (Figure 22). Ten agencies indicated use of crush and shape; their total segment count was 453. The weighted average ESL for the data set was 11.3 years (Figure 23).

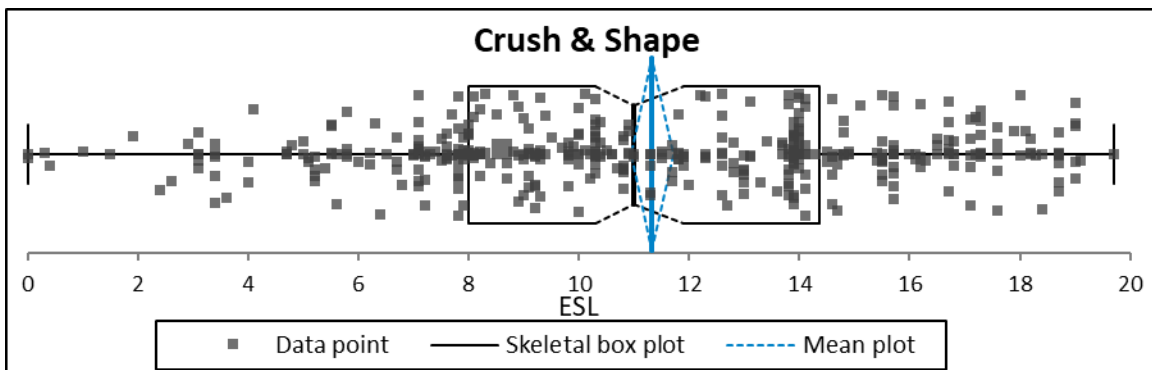
Figure 23: Crush and shape non-weighted average ESL segment distribution

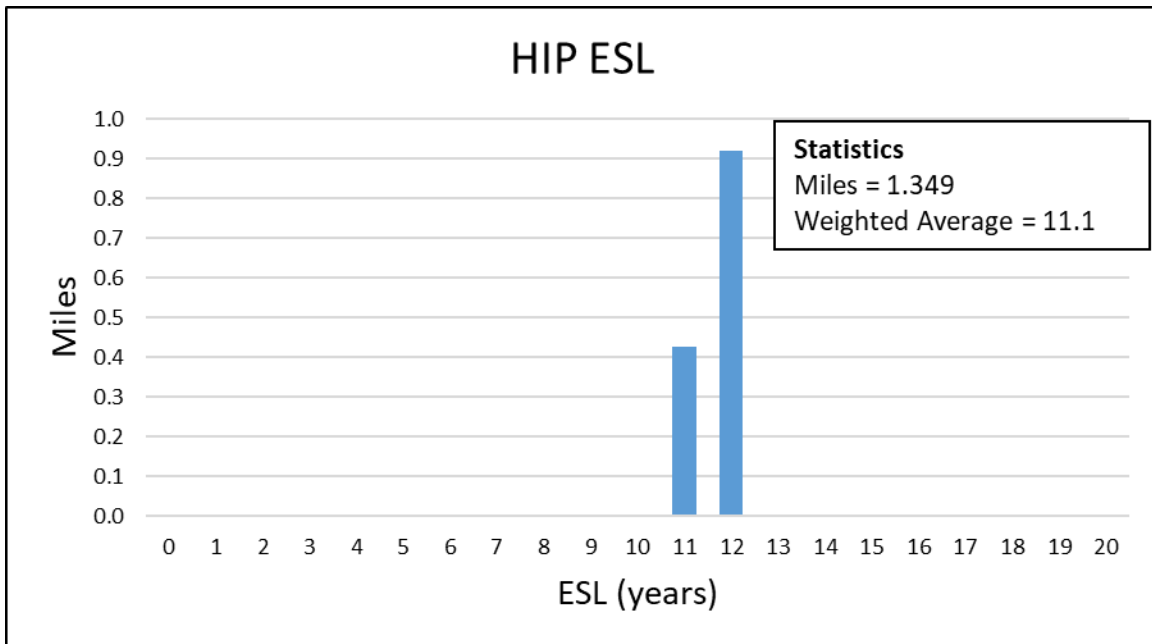
Figure 24: HIP qualifying miles distribution by ESL

Hot-in-place (HIP) treatments meeting the selection criteria totaled 1.349 miles (2.171 kilometers) (Figure 24). One agency indicated use of HIP; their total segment count was 12. The weighted average ESL for the limited data set was 11.1 years, however, this average ESL has an unacceptable margin of error due to the small number of segments available for analysis making the results inconclusive (Figure 25).

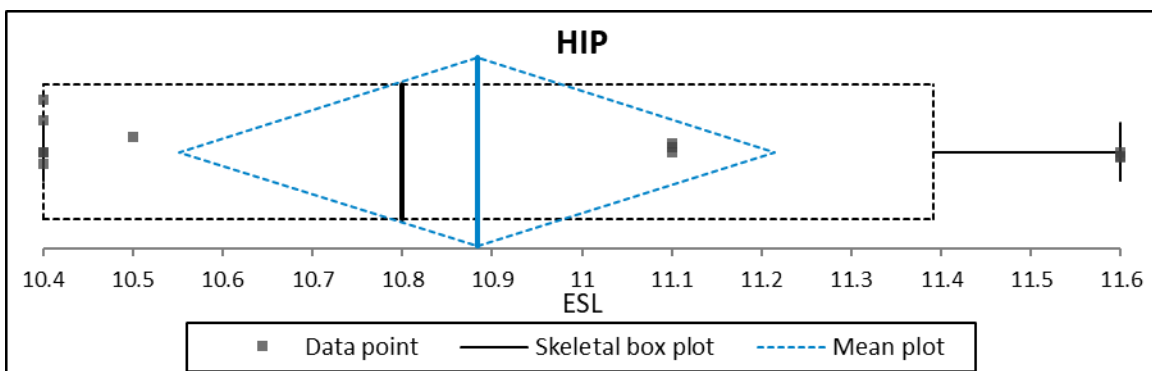
Figure 25: HIP non-weighted average ESL segment distribution

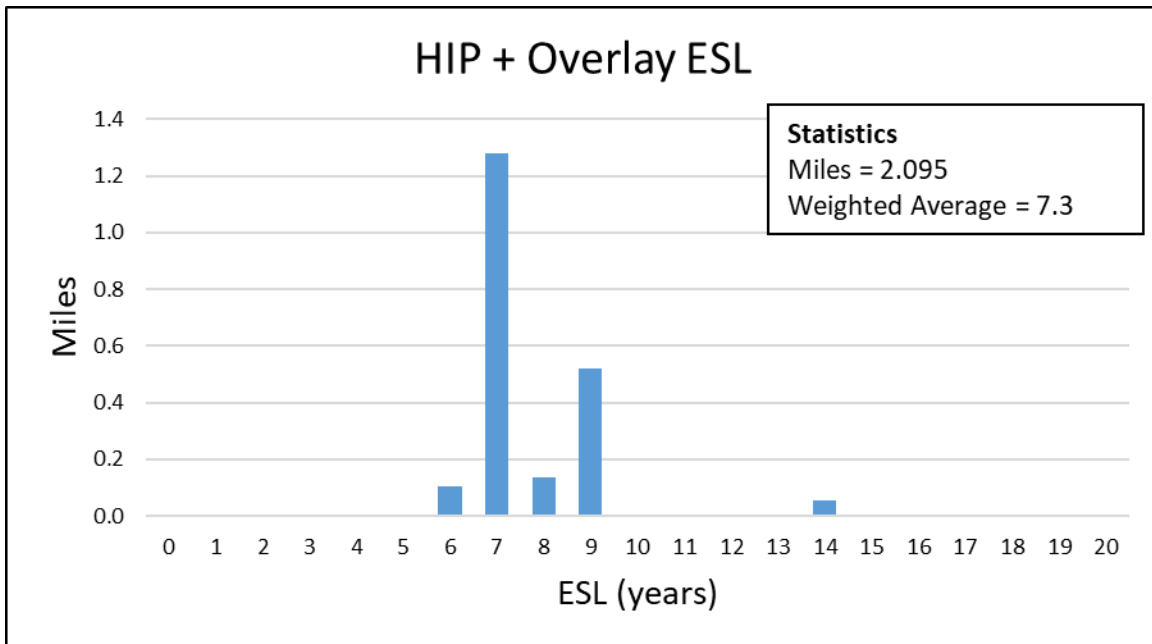
Figure 26: HIP plus overlay qualifying miles distribution by ESL

Hot-in-place (HIP) plus overlay treatments meeting the selection criteria totaled 2.095 miles (3.372 kilometers) (Figure 26). Two agencies indicated use of HIP plus overlay; their total segment count was 15. The weighted average ESL for the limited data set was 7.3 years, however, this average ESL has an unacceptable margin of error due to the small number of segments available for analysis making the results inconclusive (Figure 27).

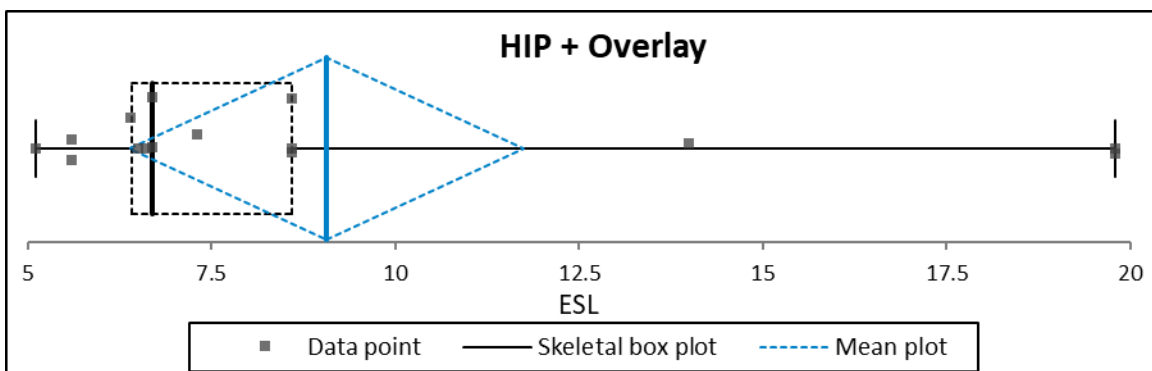
Figure 27: HIP plus overlay non-weighted average ESL segment distribution

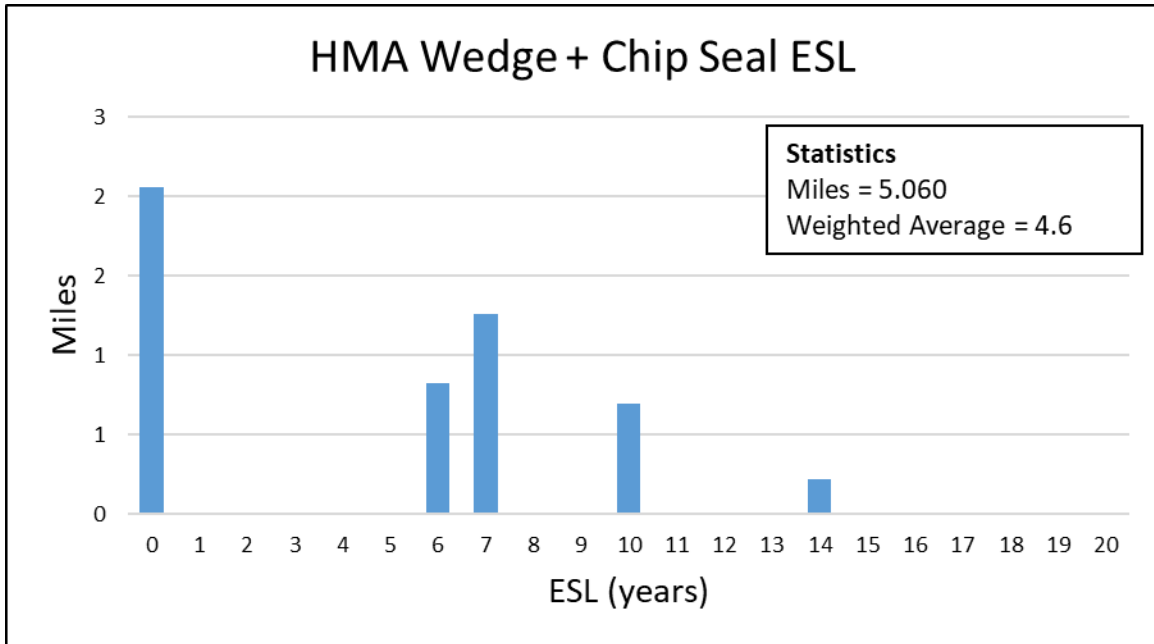
Figure 28: HMA wedge plus chip seal qualifying miles distribution by ESL

Hot-mix-asphalt (HMA) wedge plus chip seal treatments meeting the data selection criteria totaled 5.060 miles (8.143 kilometers) (Figure 28). One agency indicated use of HMA wedge plus chip seal; their total segment count was 13. The weighted average ESL for the limited data set was 4.6 years, however, this average ESL has an unacceptable margin of error due to the small number of segments available for analysis making the results inconclusive (Figure 29).

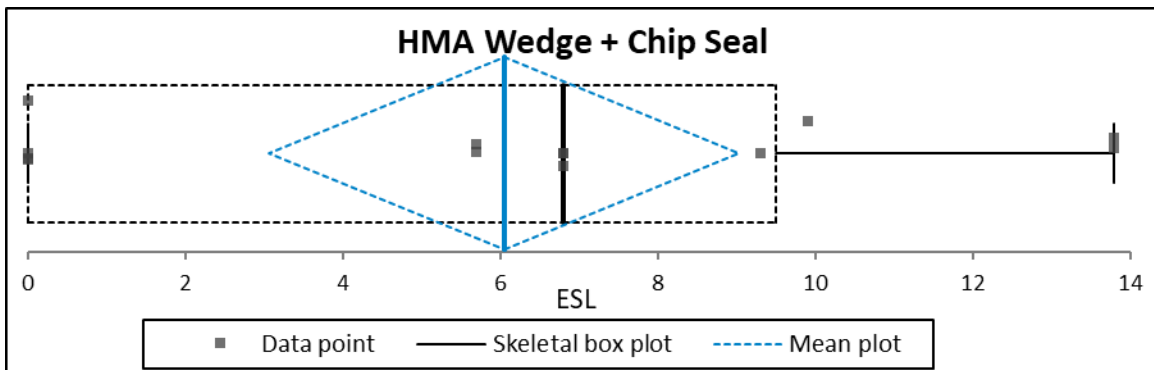
Figure 29: HMA wedge plus chip seal non-weighted average ESL segment distribution

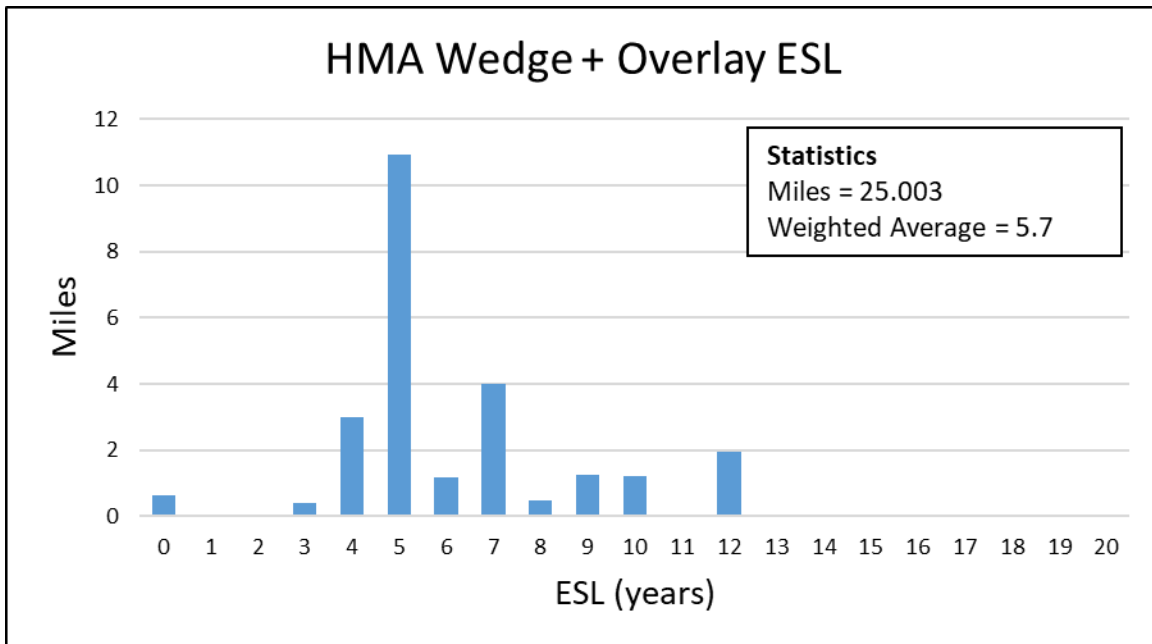
Figure 30: HMA wedge plus overlay qualifying miles distribution by ESL

Hot-mix-asphalt (HMA) wedge plus overlay treatments meeting the data selection criteria totaled 25.003 miles (40.238 kilometers) (Figure 30). One agency indicated use of HMA wedge plus overlay; their total segment count was 58. The weighted average ESL for the limited data set was 5.7 years, however, this average ESL has an unacceptable margin of error due to the small number of segments available for analysis making the results inconclusive. (Figure 31).

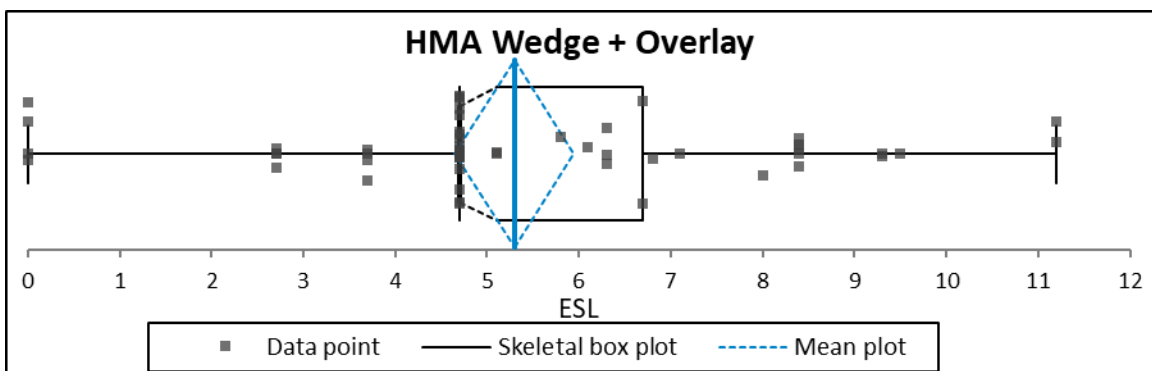
Figure 31: HMA wedge plus overlay non-weighted segment distribution
