2018 Michigan Local Agency Pavement Treatment Life Study

Michigan
Transportation Asset
Management Council

Michigan Technological University

October 25, 2018

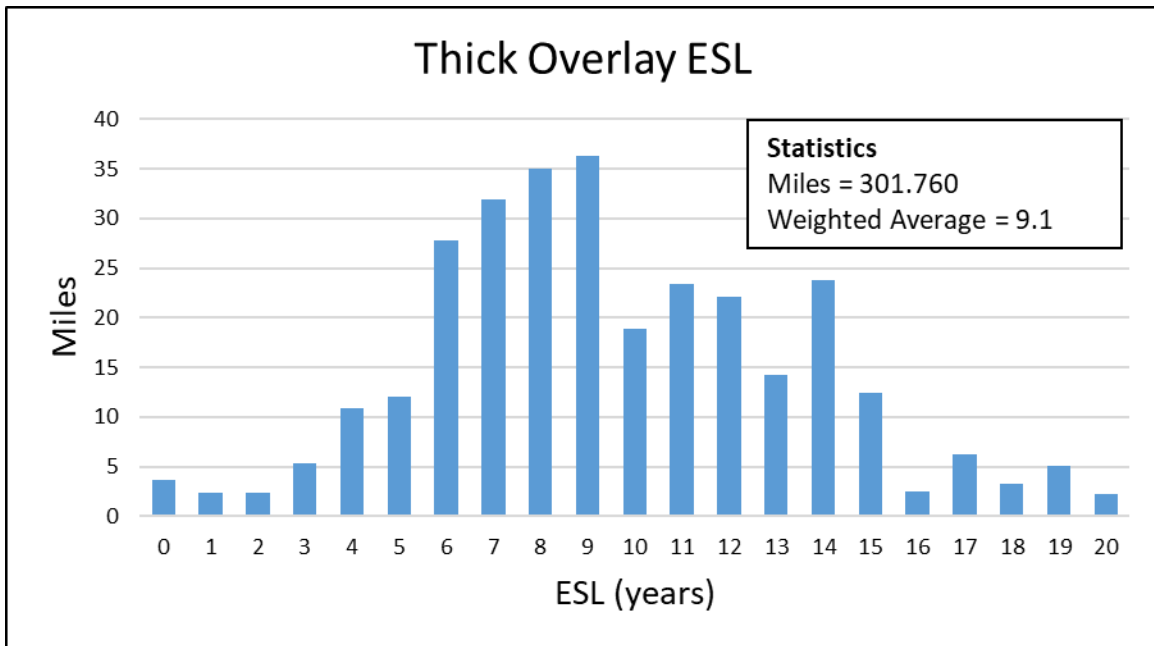
Figure 32: Thick overlay qualifying miles distribution by ESL

Thick overlay treatments meeting the data selection criteria totaled 301.760 miles (485.636 kilometers) (Figure 32). Twenty-five agencies indicated use of thick overlay; their total segment count was 1,584 (Figure 33). The weighted average ESL for the data set was 9.1 years. The thicknesses of the reported thick overlay treatments ranged from 1.75 to 5 inches (4.4 to 12.7 centimeters); a general trend showed an ESL gain as the thickness increased, which is what would be expected.

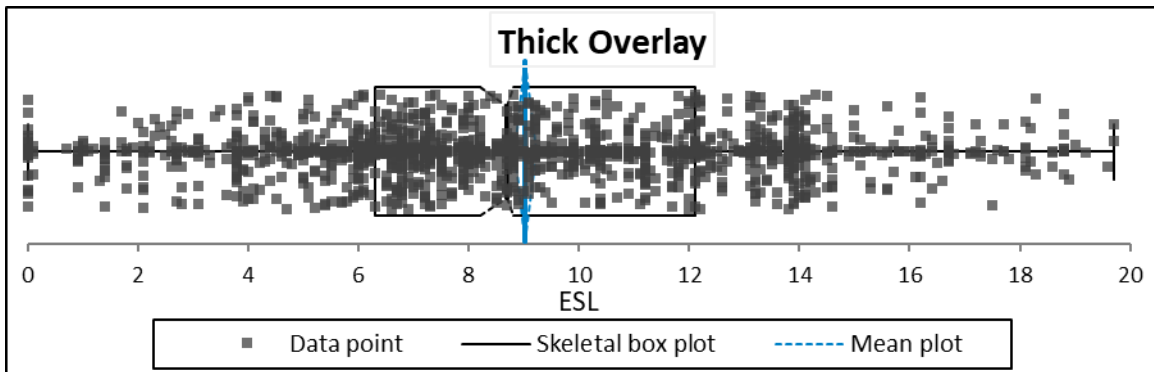
Figure 33: Thick overlay non-weighted average ESL segment distribution

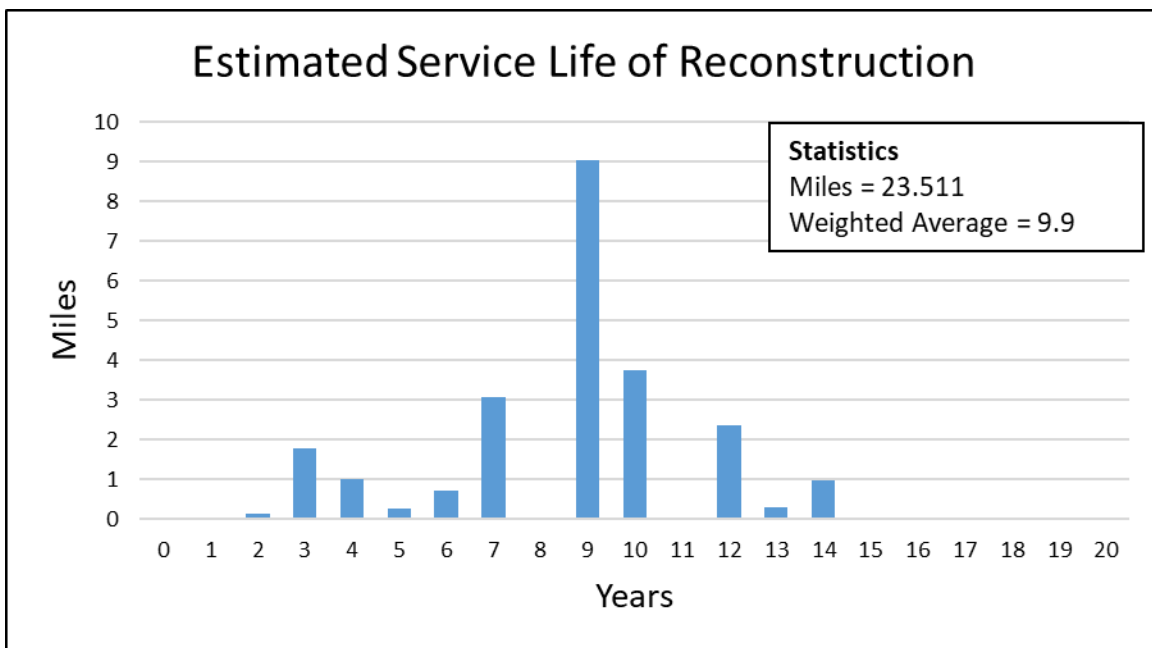
Figure 34: Reconstruction qualifying miles by estimated service life distribution

Reconstruction meeting the data selection criteria totaled 23.511 miles (37.837 kilometers) (Figure 34). Six agencies indicated use of reconstruction; their total segment count was 133. The HMA thickness layer of these reconstruction projects ranged from 1.5 to 3 inches (3.8 to 7.6 centimeters). This may help explain why the thicker HMA layers used in thick overlay treatments obtained a higher ESL value than the estimated service life of reconstruction. The estimated service life was used instead of extended service life because a reconstruction project creates a brand new pavement structure. The weighted average estimated service life for the limited data set was 9.9 years, however, this average has an unacceptable margin of error due to the small number of segments available for analysis making the results inconclusive (Figure 35). This data set included a large number of segments that were recently constructed, which limited the number of late age data points in this data group. As a result, the estimated service life calculated from this data is inconclusive.

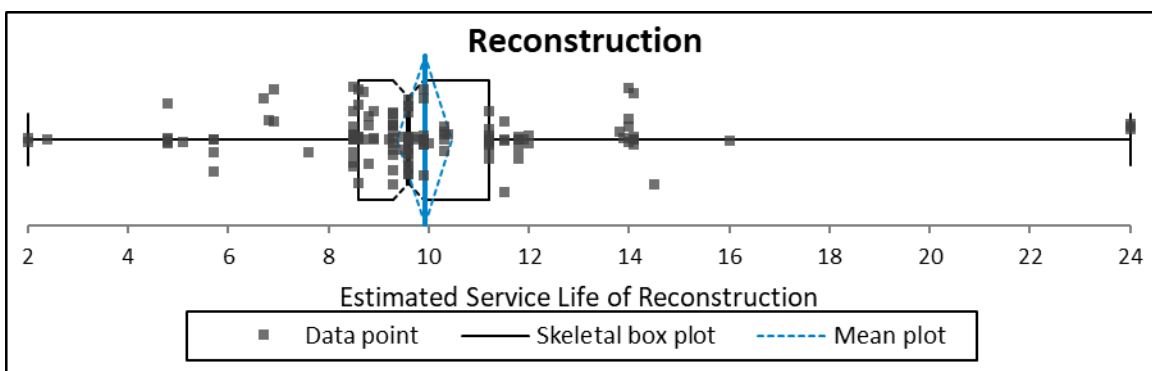
Figure 35: Reconstruction non-weighted average estimated service life segment distribution

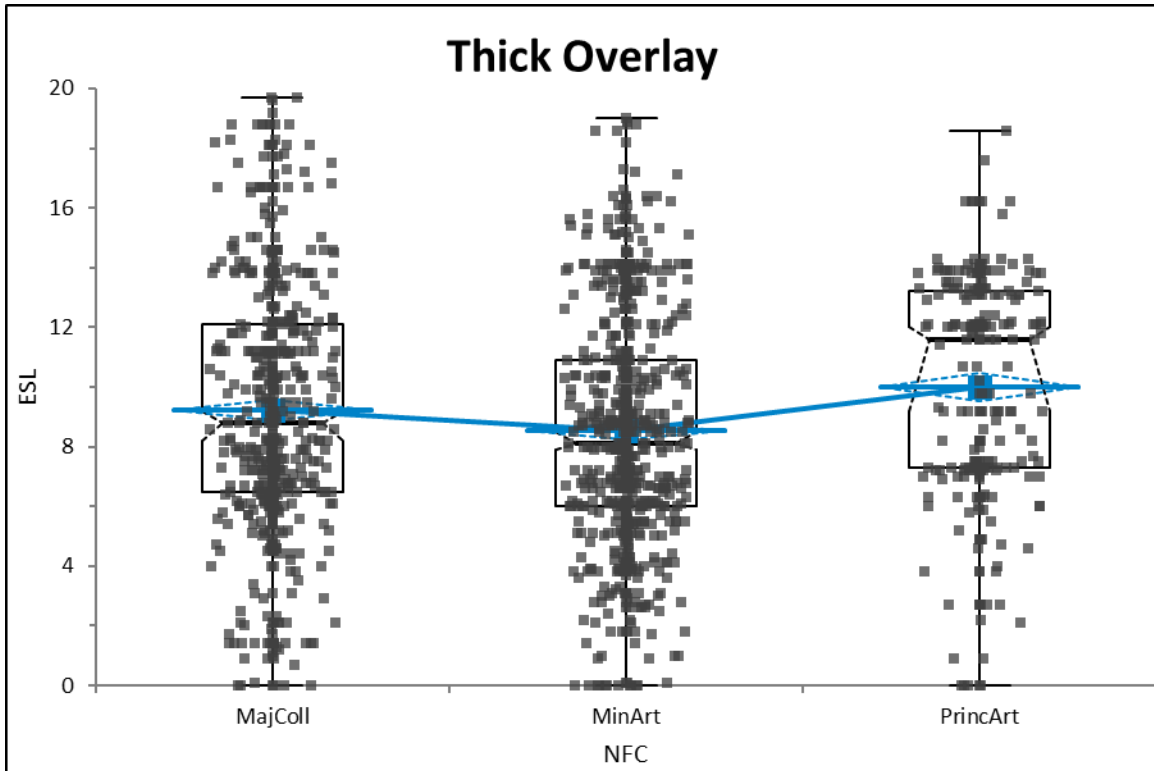
Figure 36: Thick overlay segment distribution by National Function Class

When broken down by NFC, all of the treatment classes either showed no difference in ESL or had too few miles (and segments) to make determinations on differences for treatments with the exception of thick overlay treatment. For thick overlay treatment distributed by NFC, the classifications of major collector, minor arterial, and principal arterial had enough miles (and segments) to be considered statistically significant (Figure 36). The weighted average ESLs are 9.4 years for major collectors, 8.4 years for minor arterials, and 10.2 years for principal arterial. The principle arterial median data has a higher variability (Figure 36); therefore, this data set should be considered less reliable than major collector and minor arterial.

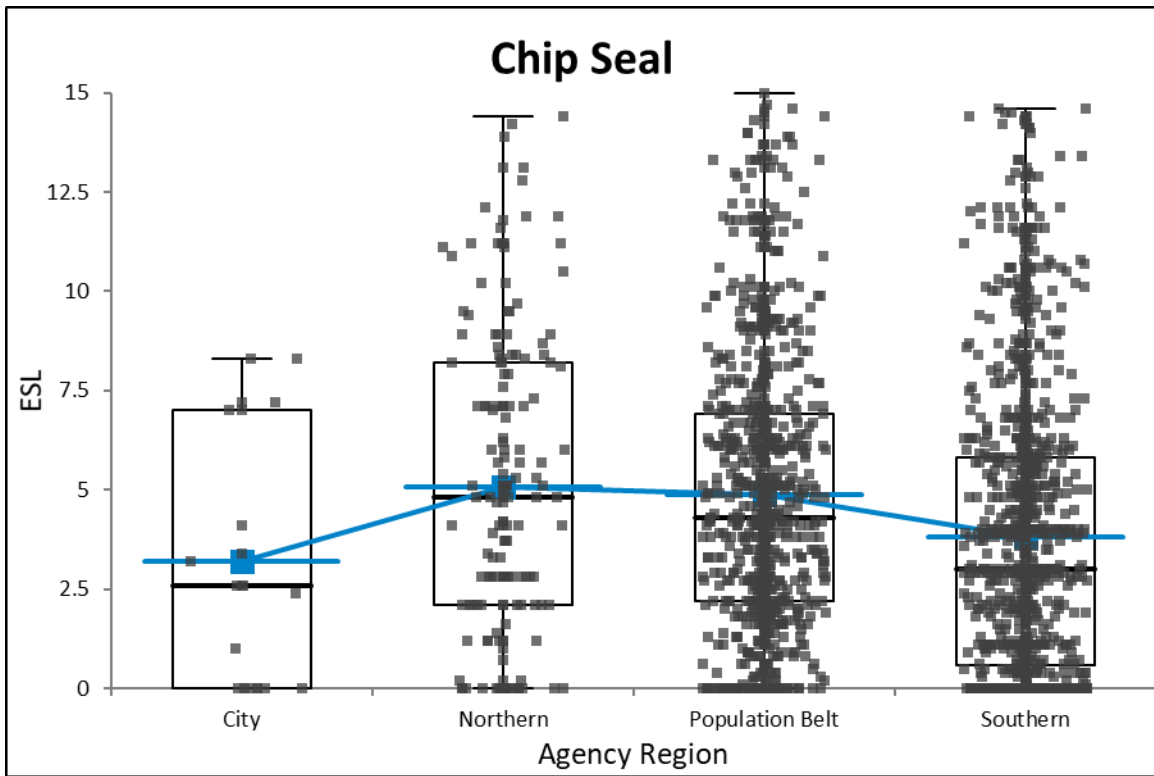
Figure 38: Chip seal non-weighted average ESL segment distribution by region

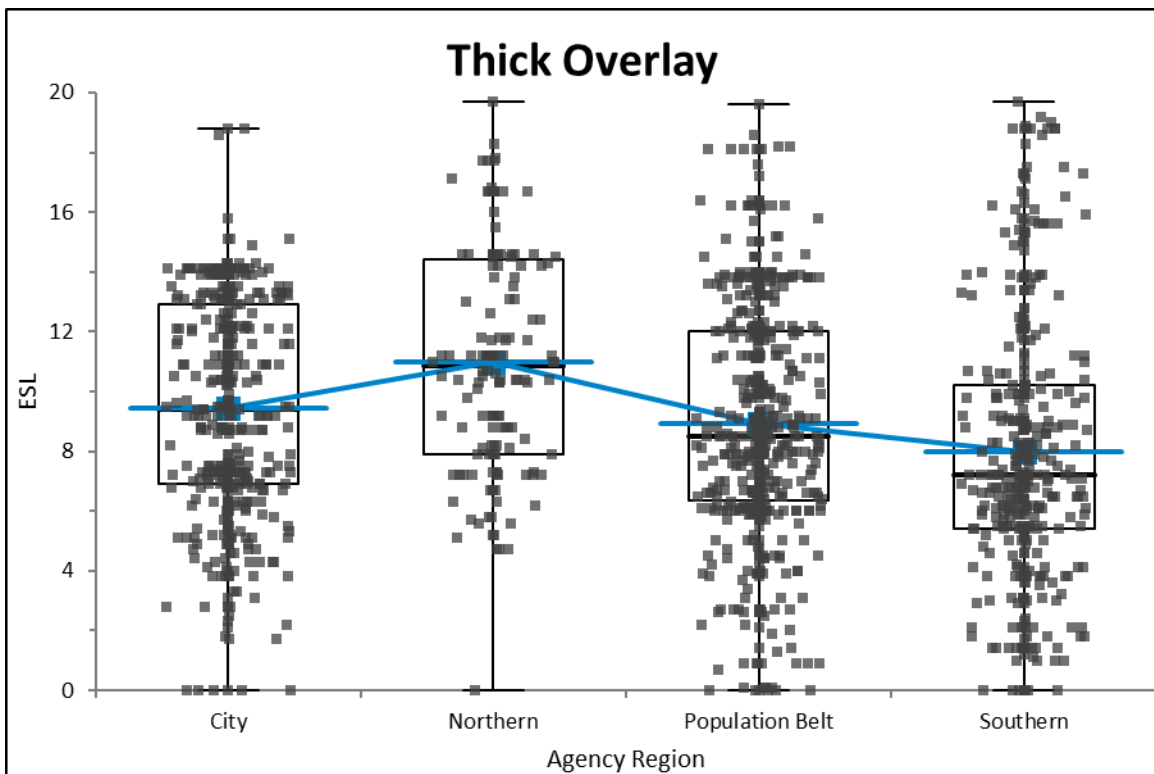
Figure 39: Thick overlay non-weighted average ESL segment distribution by region

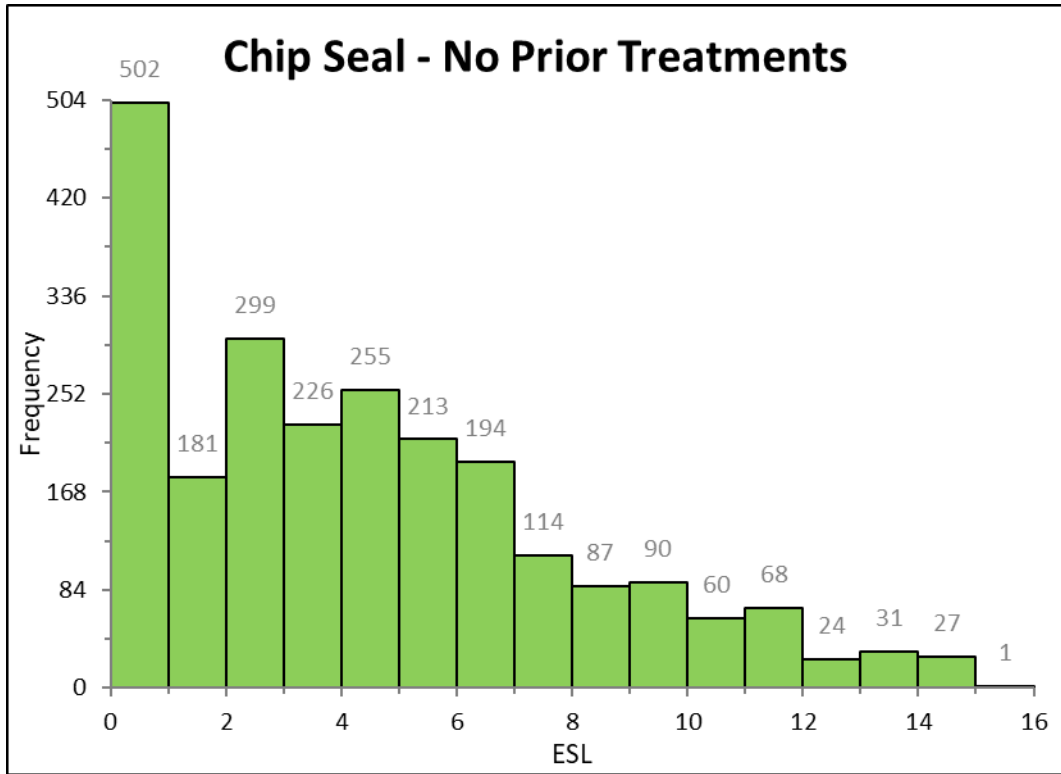
Figure 40: No prior chip seal treatment ESL segment count

Prior Chip Seal Treatments	Number of Agencies	Segment Count	Total Miles	Weighted Avg ESL
0	21	2372	784.858	4.1
1	15	1045	399.986	3.8
2	9	303	103.686	4.5
3	5	59	20.599	5.3
4	2	5	2.433	4.9
6	1	1	0.509	3.8
Total	21	3785	1312.071

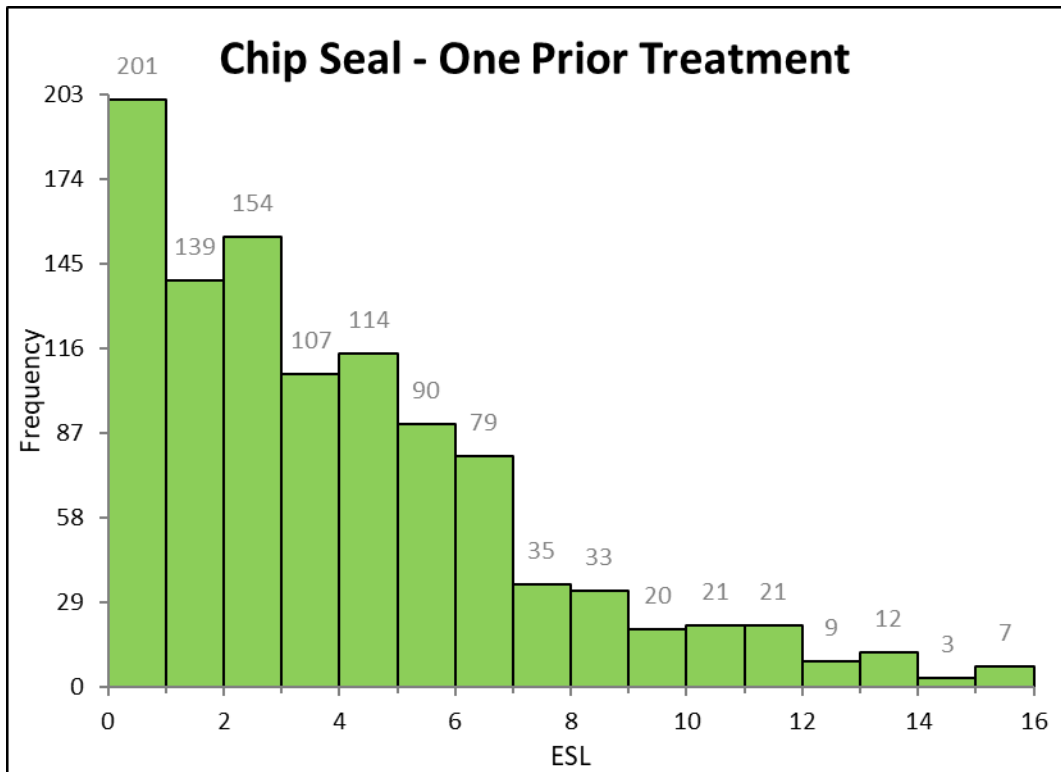
Figure 41: One prior chip seal treatment ESL segment count

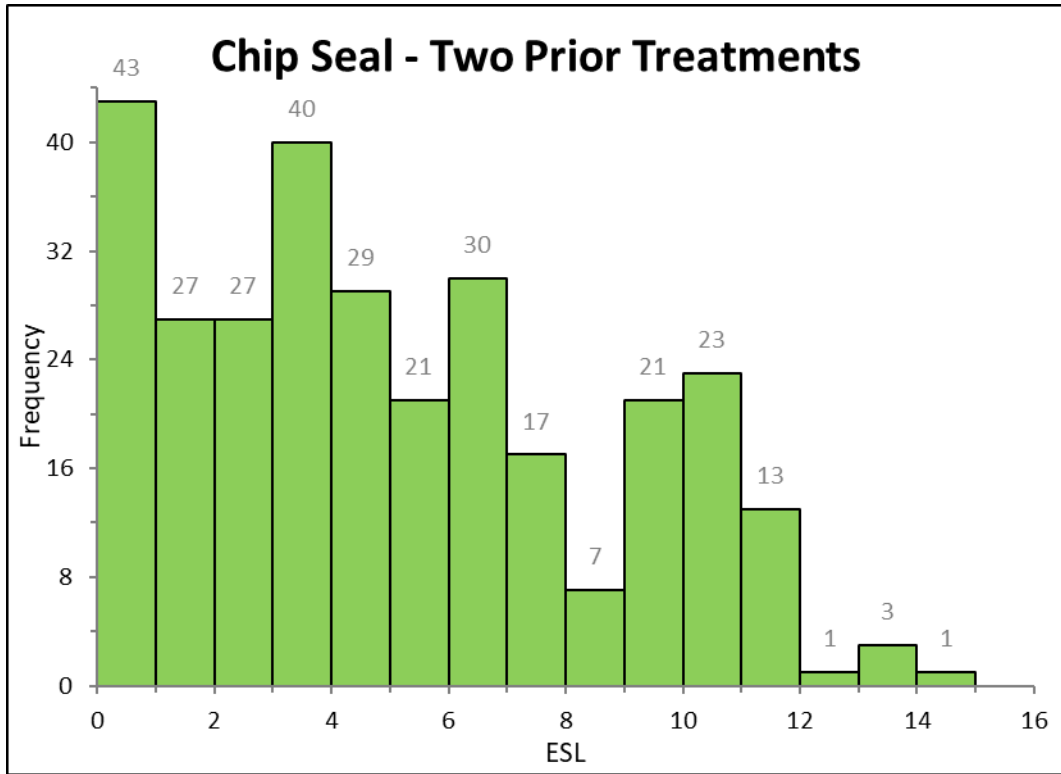
Figure 42: Two prior chip seal treatments ESL segment count

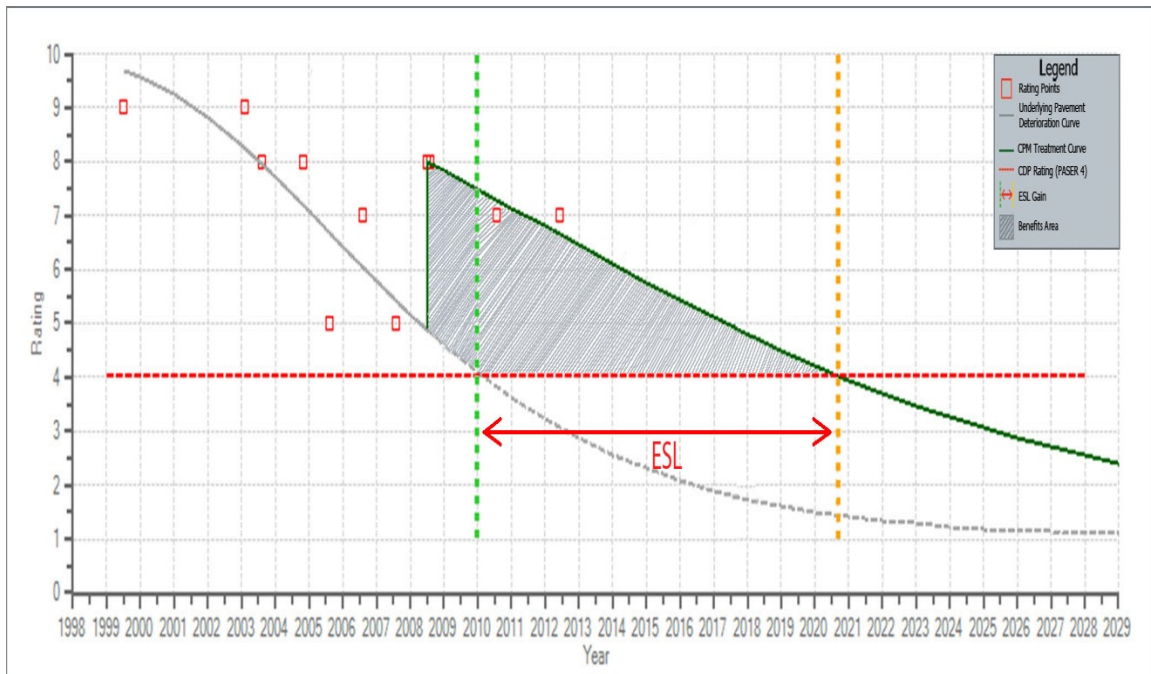
Figure 43: Example of High ESL

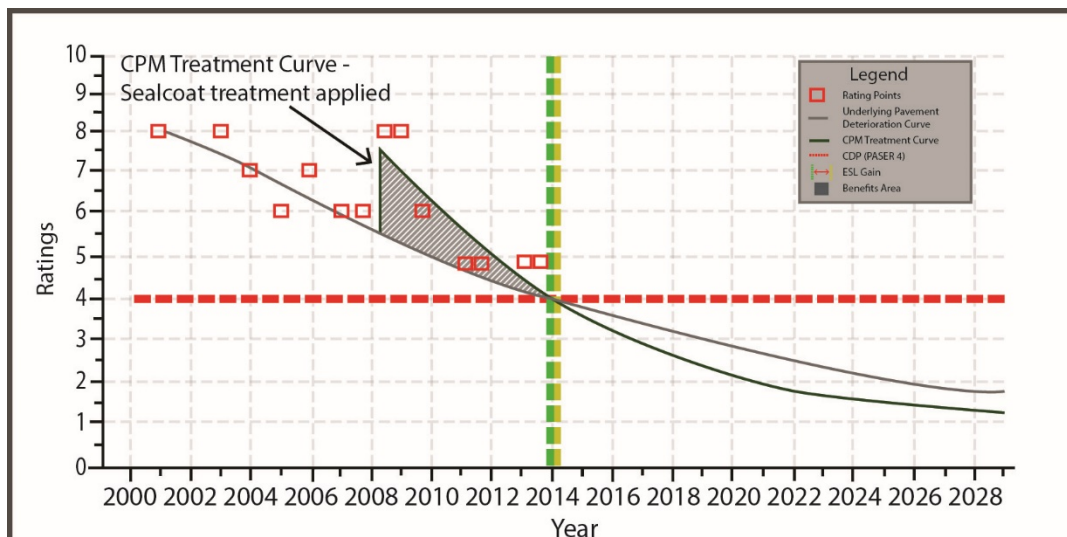
Figure 44: Example of Zero ESL Gain

The study identified approximately 142 miles (229 kilometers) of treated segments that did not produce a benefit in terms of ESL gain. After application of treatments, condition ratings initially jumped but quickly returned to the underlying pavement's deterioration pattern, thus producing no change in the pavement's predicted intersection with the CDP. Figure 44 illustrates an example of this type of behavior. Repair treatments and even structural improvements that provide no ESL have been observed by many other researchers. Weh-Hou Kuo outlined this behavior for structural overlays in Pavement Performance Models for Pavement Management Systems (MDOT unpublished report, 1995). Low-life extensions after a repair treatment can result from several factors related to either the underlying pavement or the treatment itself.

Repair treatments that are poorly placed with low-quality materials may fail early and constitute a portion of these low or zero ESL cases. Pavements that are deteriorating because of load-related distresses likely comprise a number of these zero ESL cases since repair treatments cannot fix or slow down structural distresses. It is beyond the scope of this study to identify the causes of low or zero ESL cases.
