2018

Michigan Local Agency Culvert Inventory Pilot Evaluation Report

PURPOSE OF LOCAL AGENCY CULVERT INVENTORY PILOT

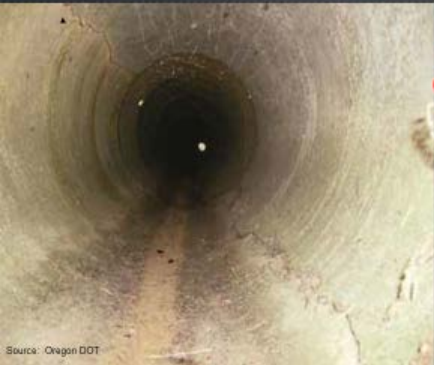
CONCRETE PIPE INVERT DETERIORATION EXAMPLE 1

6

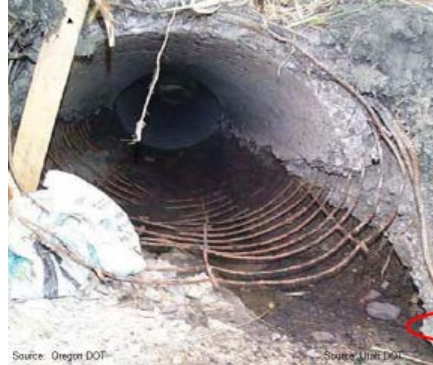
CONCRETE PIPE INVERT DETERIORATION EXAMPLE 2

2

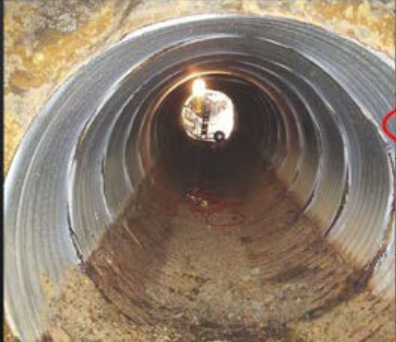
CMP JOINTS/SEAMS EXAMPLE

5

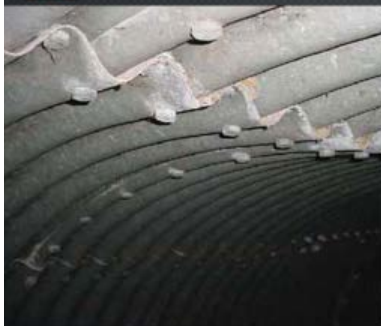
CMP JOINTS/SEAMS EXAMPLE

8

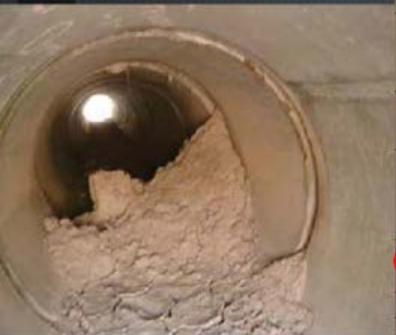
CONCRETE PIPE JOINTS/SEAMS EXAMPLE

3

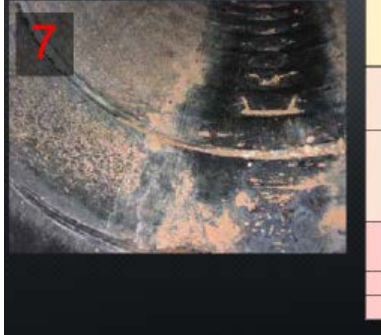
PLASTIC PIPE JOINTS/SEAMS EXAMPLE

7

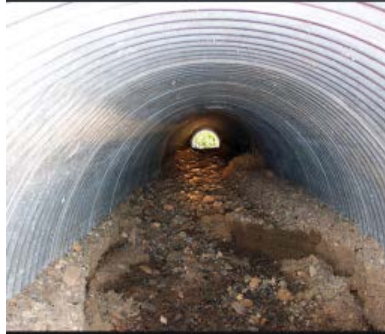
BLOCKAGE EXAMPLE 2

5

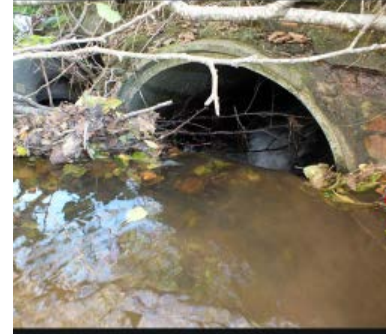
BLOCKAGE EXAMPLE 3

4
